# Facility Condition Assessment

Draft Report

May 14, 2024

# Facility Condition Assessment Moda Center & Garden Garage

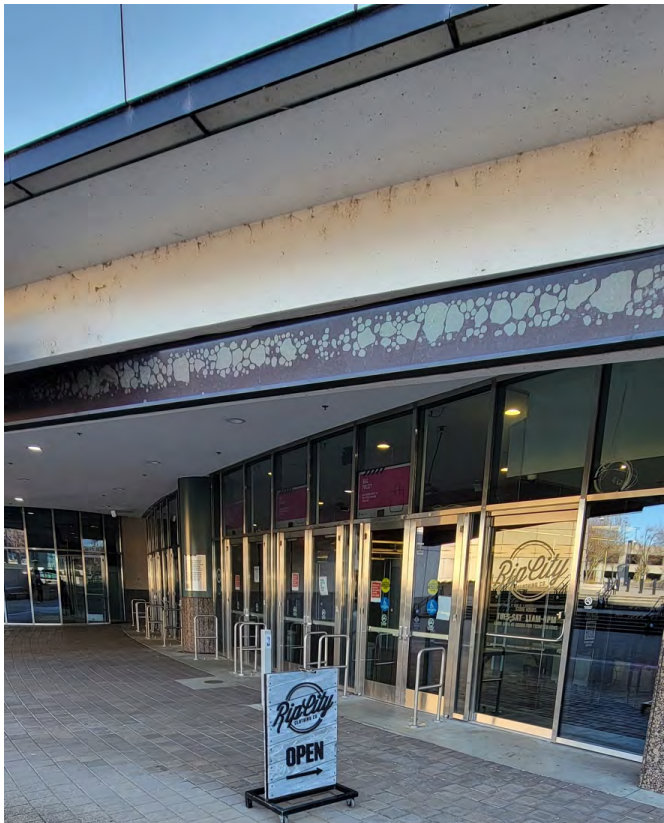
Electronic ribbon signage boards are located in the soffits of the 100 level entrances and are past their useful life.

Electronic ribbon panel and linear fluorescent box fixture

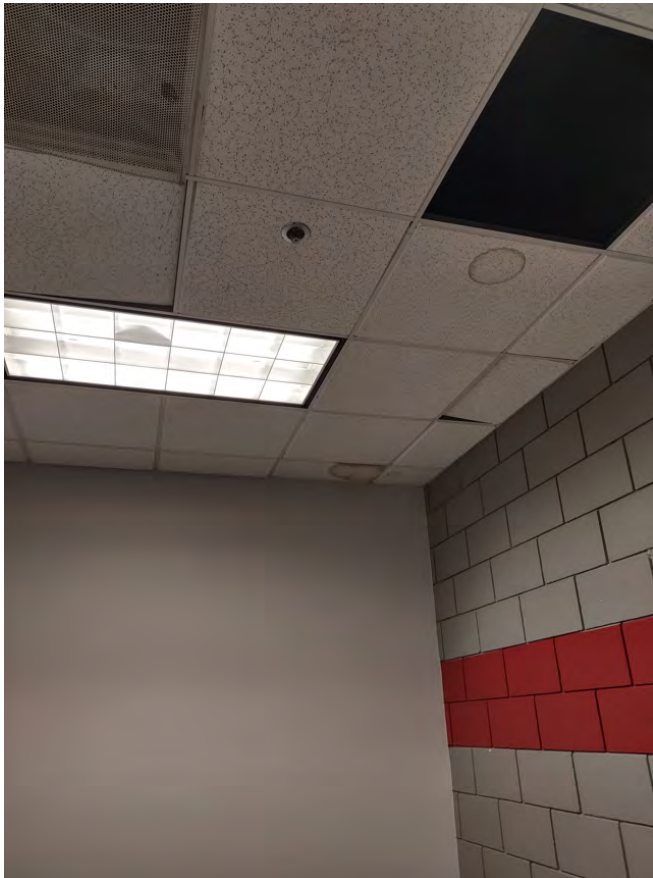
Water stain observed on ceiling tile in media workroom

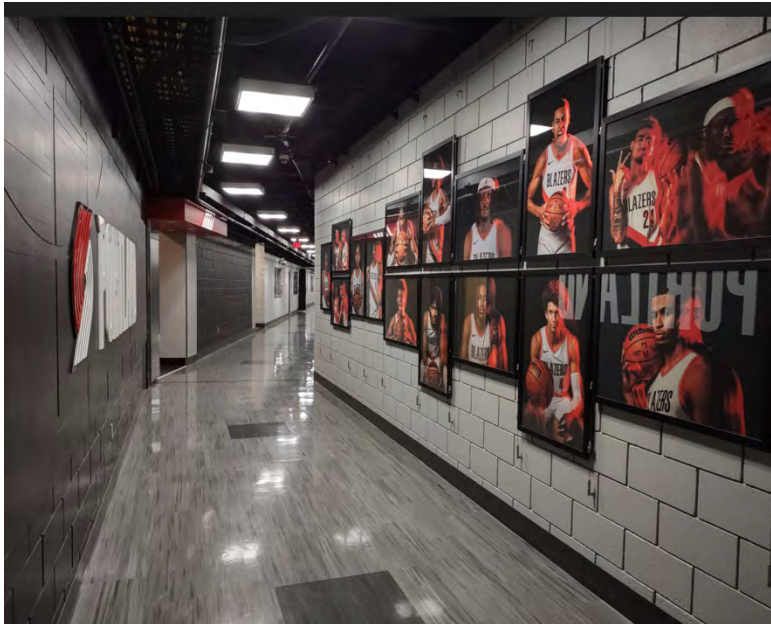
The locker room hallway is painted CMU with LVT flooring. The signage graphics blend into the wall color scheme making wayfinding somewhat unclear. The LVT shows signs of wear, as wheel indentations in the tile are pronounced. The acrylic wall graphics have locations with chipped edges.

Corridor outside team locker room are in fair to good condition

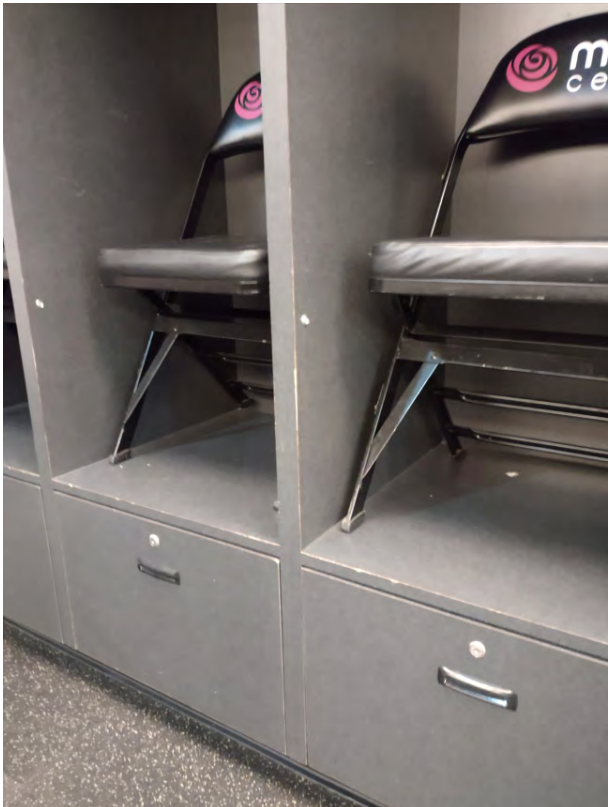
Lockers are original installation in Locker Rooms B and C, and show signs of wear and tear

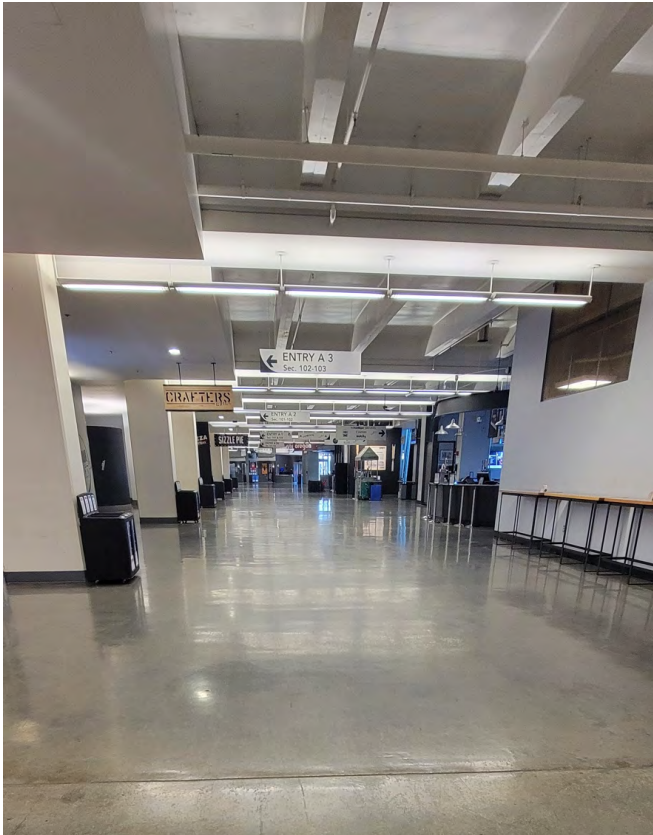
Wayfinding signage in the concourse is light in color and tends to blend with the white ceilings and overhead structure. Easy to read graphical wayfinding should be considered to help move patrons to their destination.

Concourse signage is difficult to read at distance and new wayfinding signage should be designed with a story to define pathways

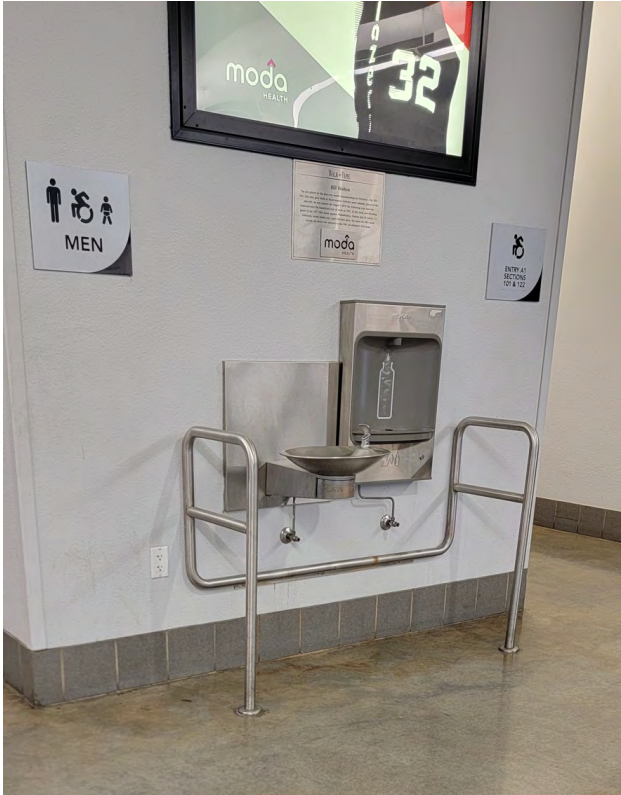
Polished concrete finish staining adjacent to walls

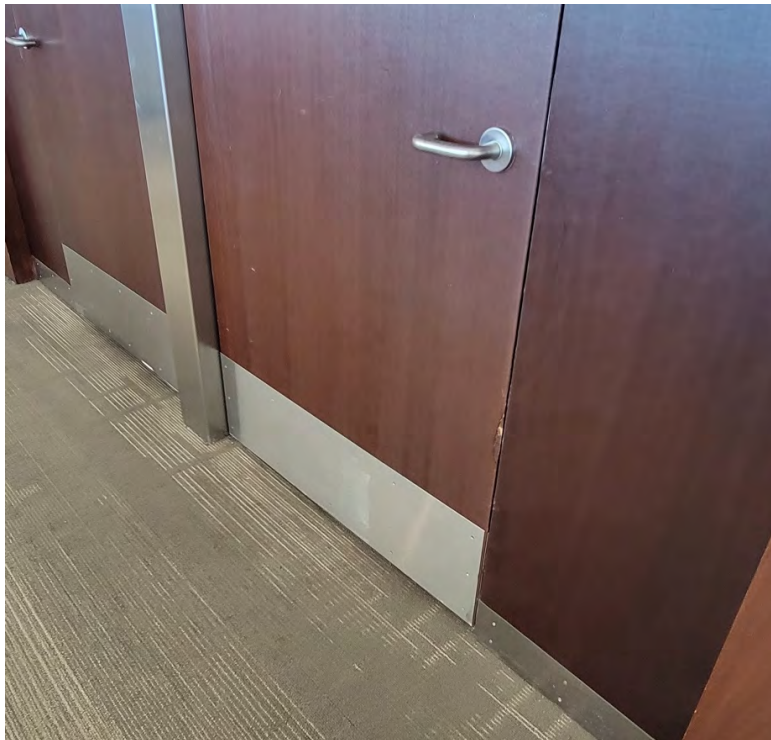
Wear at suite door

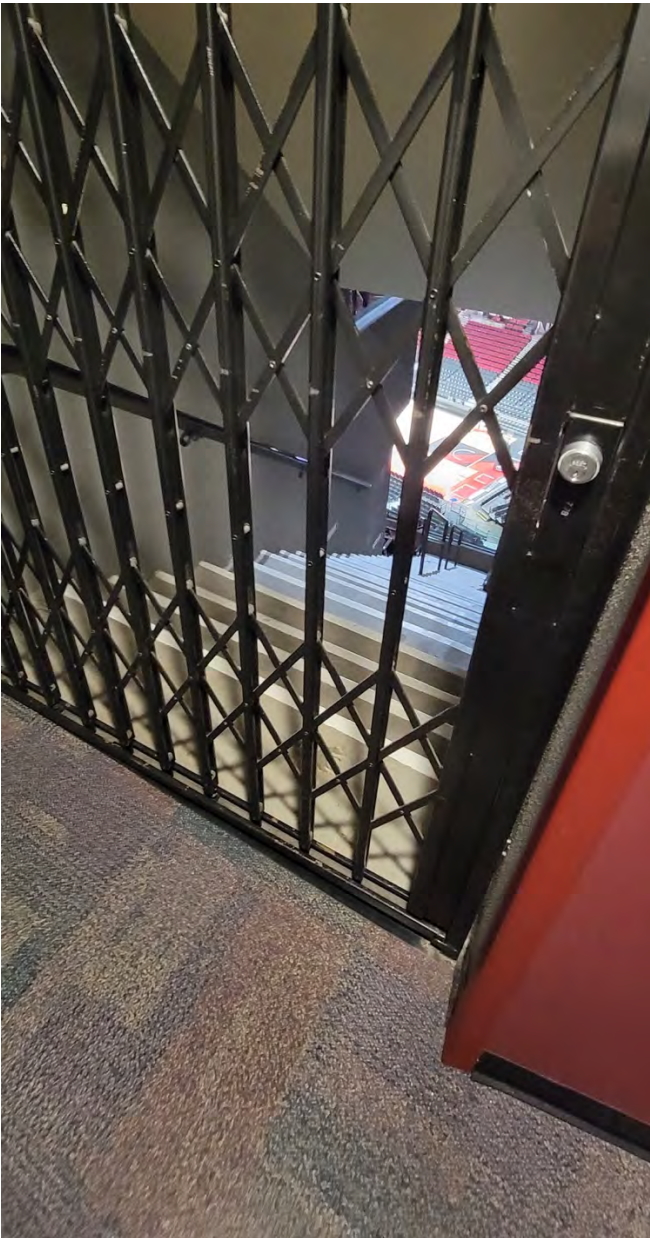
The upper bowl has a couple of locations where there is a door or gate at the upper extents of an aisle. These conditions should be reviewed to ensure there is not a “dead-end corridor” created by a locked door or gate and a clear egress path should be ensured and identified.

Potential restricted path of egress

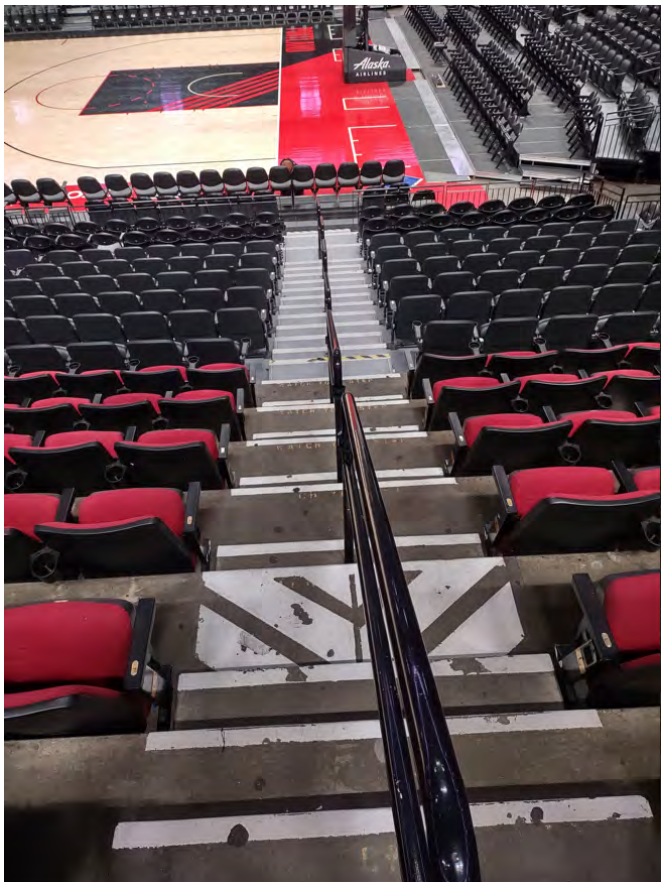
*Typical configuration of aisle steps on lower deck indicates potential safety issues*

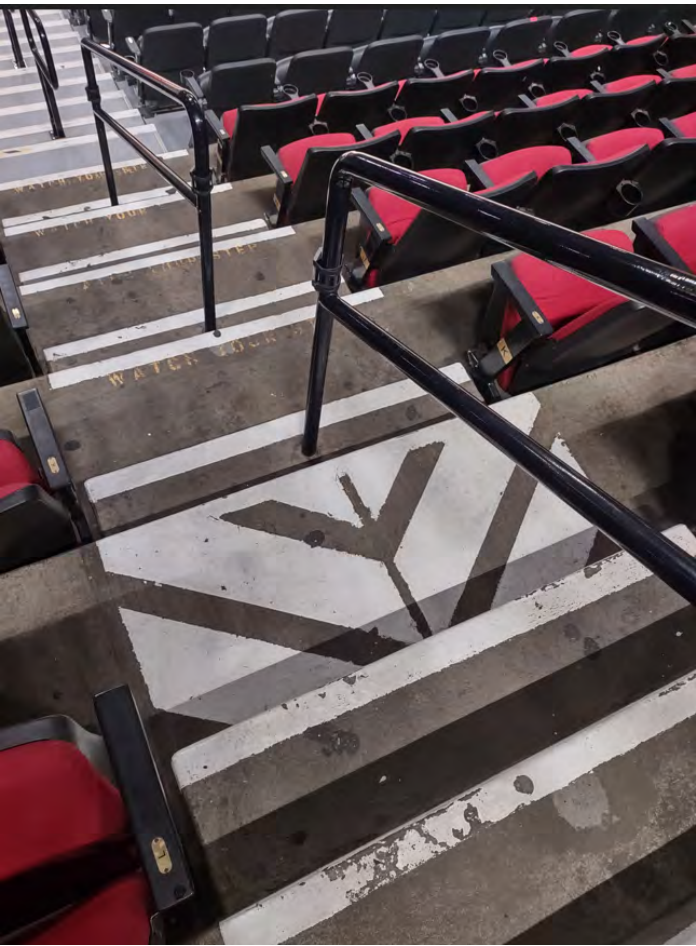
*Contrasting marking stripes have worn out at seating aisles and should be replaced as required by code*

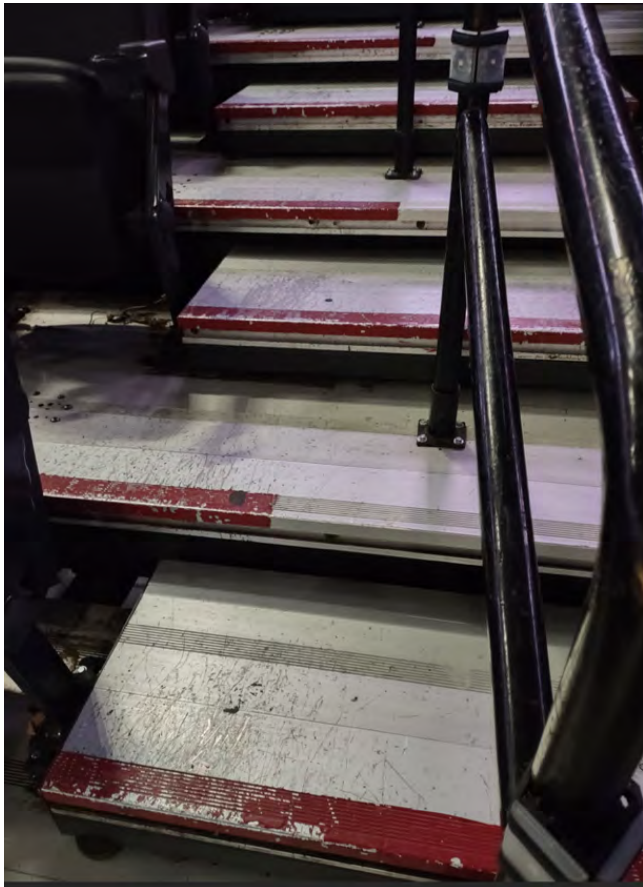
*The aluminum seating treads show signs of substantial wear and tear at Section 116*

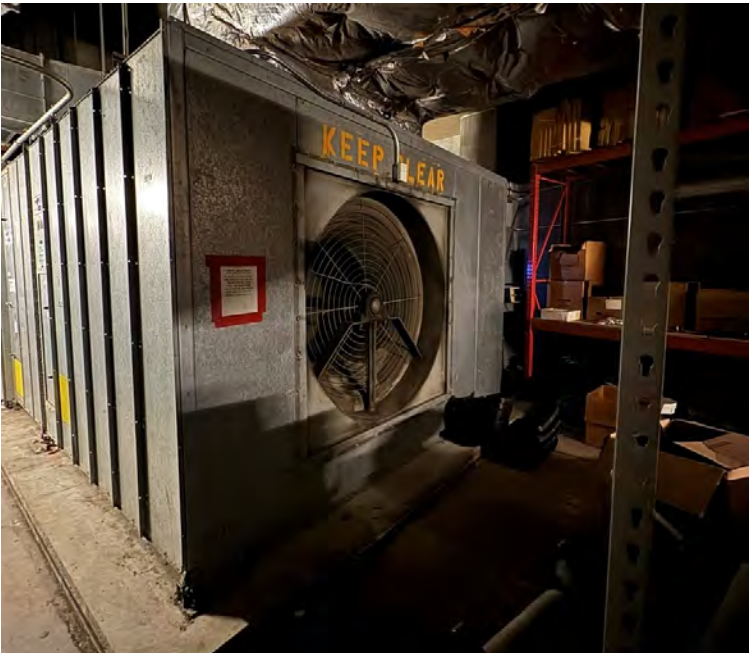
Several of the support air handling units have ducted return, however, there are a few where the return air is ducted back to the mechanical room and then the units have an open end that allows the fans to pull its own return air back into the unit.

Support AHU open return

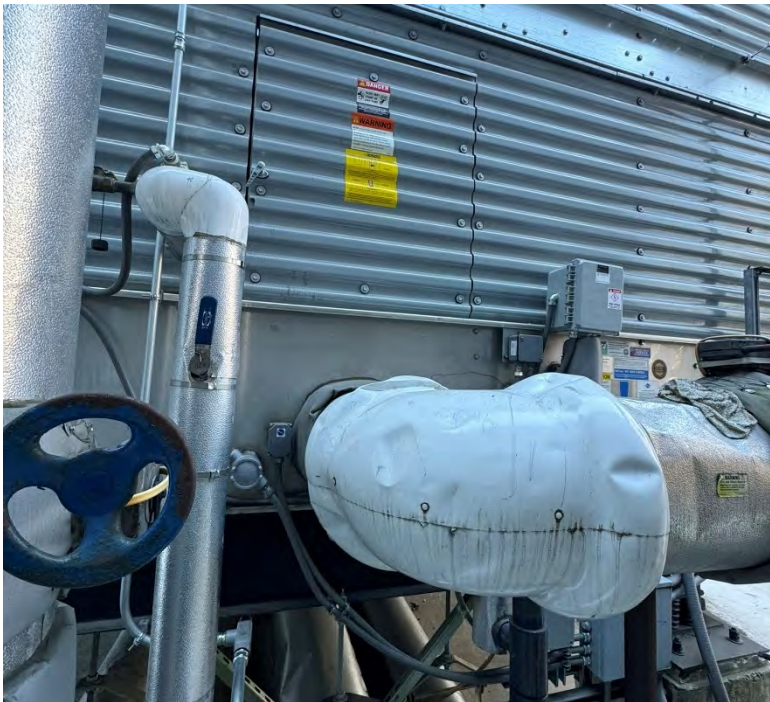
For each of the cooling towers, there are no access platforms provided, so in order to access the cooling tower basins, the operator has to either bring a ladder or step on the pipe. For all locations the pipe insulation was showing signs of damage which can effect the thermal performance of the system.

Cooling tower access

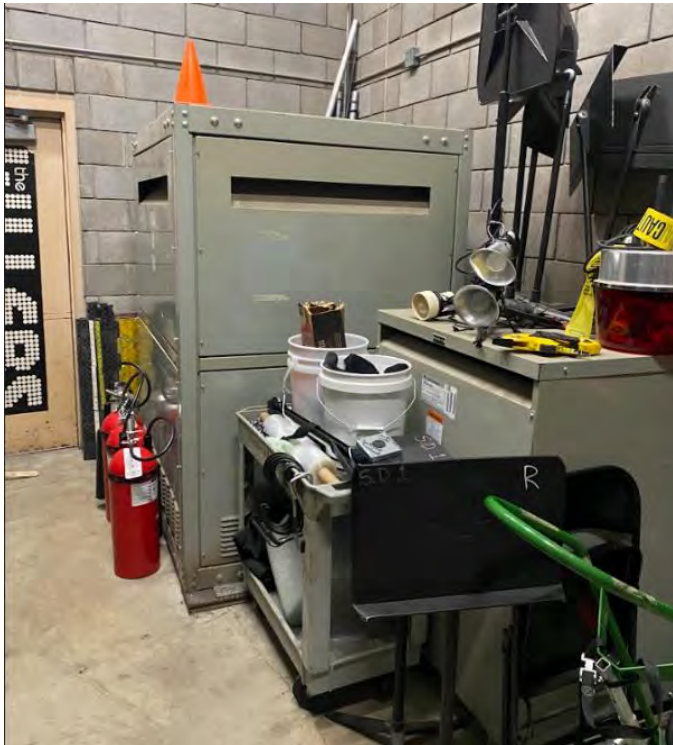
Storage violating NEC clearances

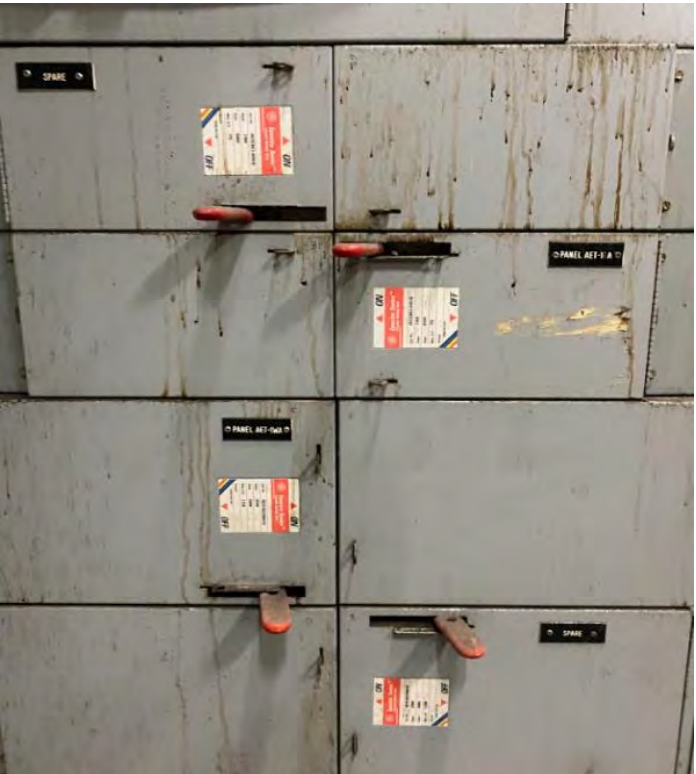
Much of the equipment in the emergency electrical room has debris and residue from liquid. While no damage has been reported as a result of this, it is recommended to clean, torque, and tighten equipment and lugs to ensure adequate operation and connections.

Liquid residue on motor control centers (MCC)

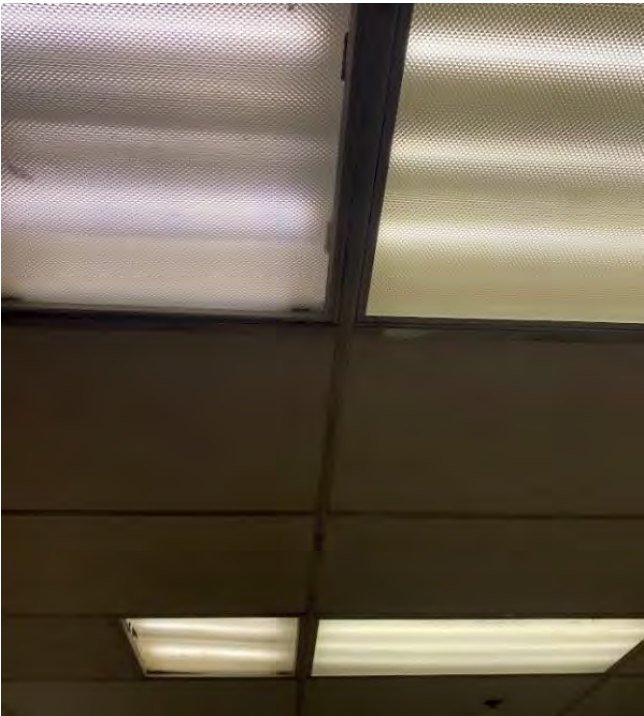
Original lighting in the arena consists of non-LED fluorescent, incandescent, or halogen fixtures. However, the electrical staff have systematically changed fluorescent lamps to LED in certain high use areas such as concourses, vomitories, and player/coaches areas. Most fluorescent tube fixtures have been replaced with LED tubes as the original fixtures burn out. The fixtures in the parking garage have also been recently replaced with high output LED fixtures with field selectable color temperatures. Issues with the existing interior lighting include broken lenses, non-operational ballasts, and aging fixtures that have irregular color temperatures.

Aged fixtures in kitchen

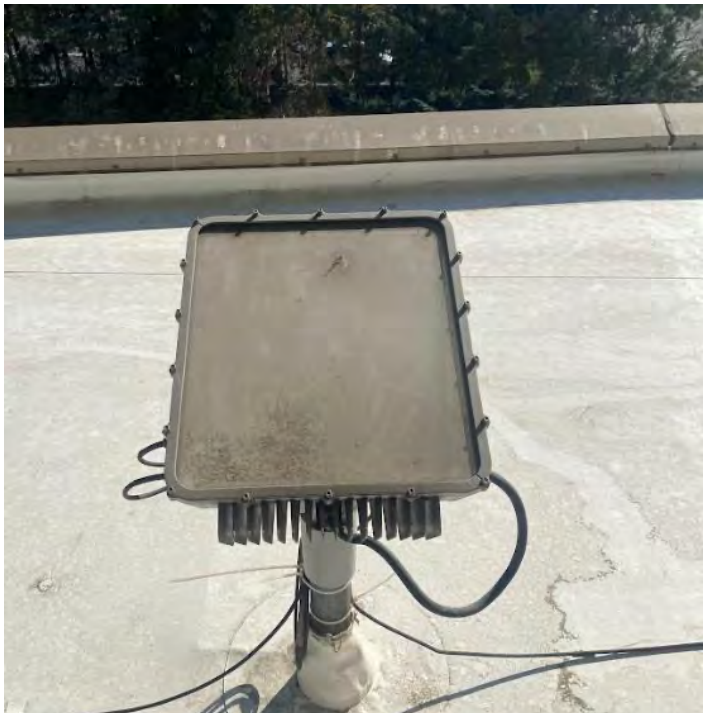
*Low roof RGB fixture with dirty lens*

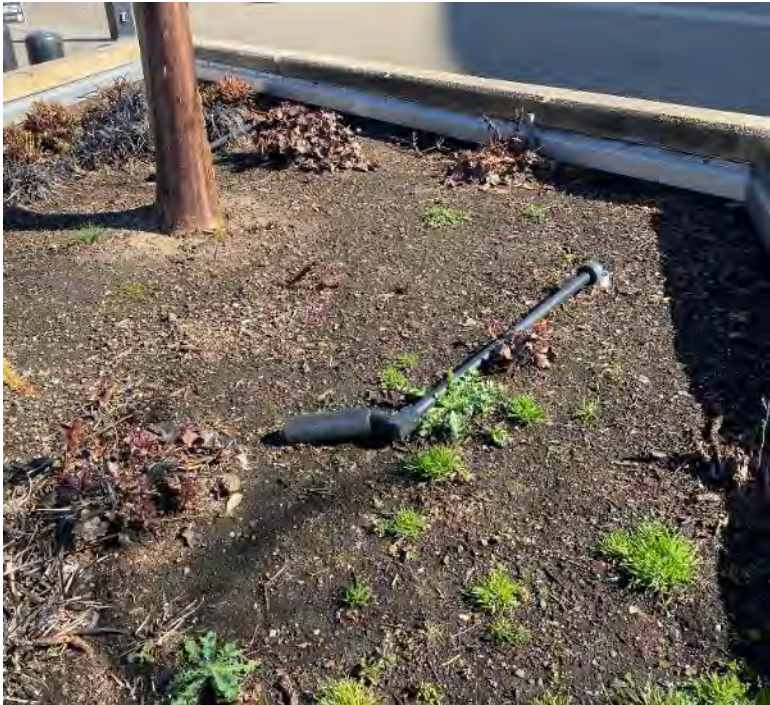
Small 120V fixtures are currently installed in exterior garden beds but experience a lot of vandalism. It was noted that a plan is in place to remove all of these fixtures and replace them with more durable fixtures in order to eliminate the maintenance and cost required to upkeep the fixtures.

*Vandalized garden bed fixture*

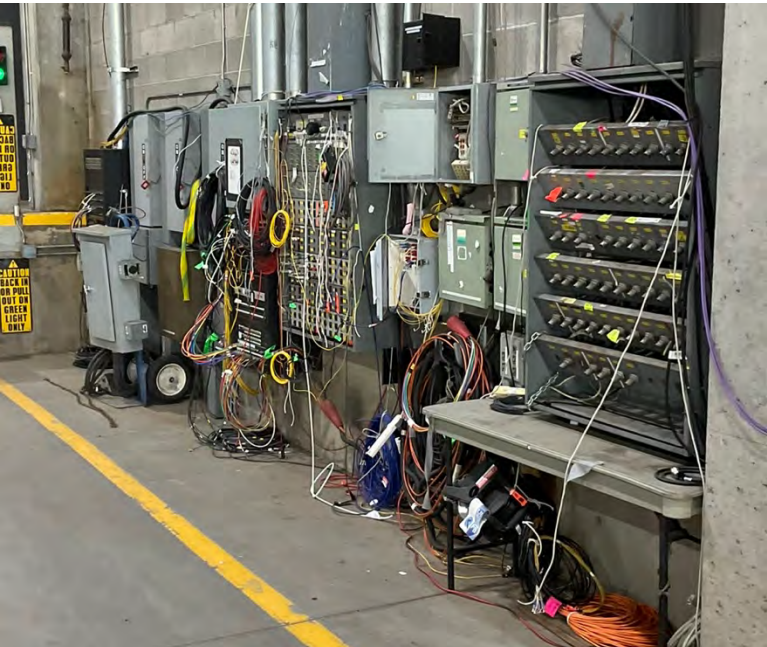
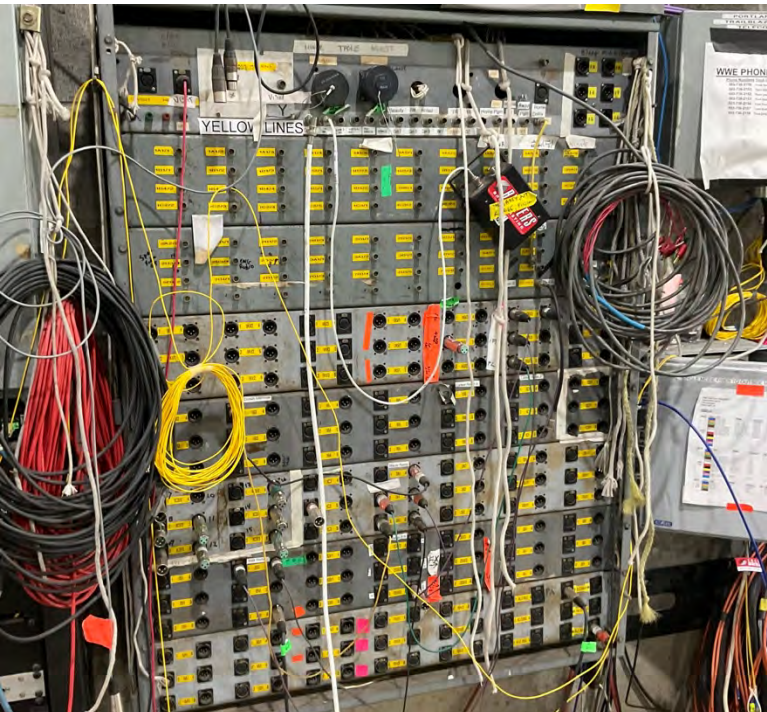
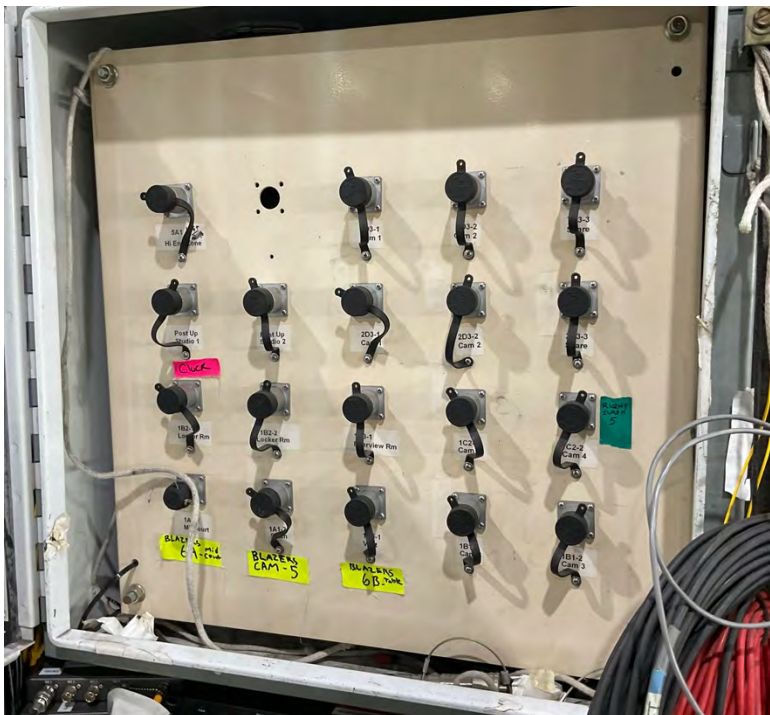
The truck dock location is under cover and provides ample space for multiple production trucks. The cabling connections and infrastructure are aged and in need of replacement. Cabling additions and expansions over years have sprawled out along an entire wall shared with mobile unit power disconnects.

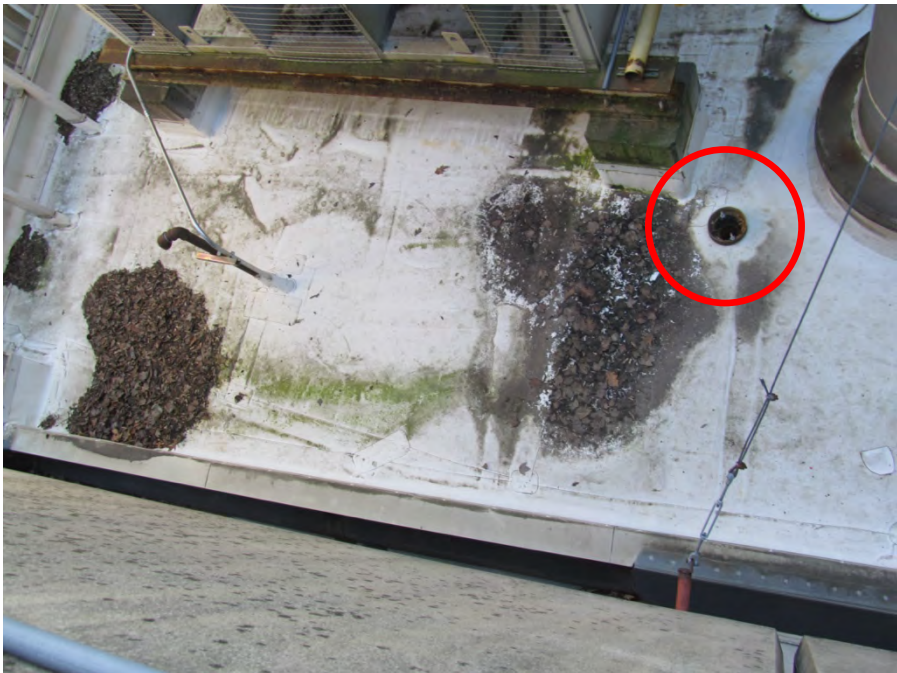
Leaves and debris accumulated on the roof membrane surface (Roof Area 16) and a nearby roof drain (circled) lacks a dome strainer and is susceptible to clogging by debris

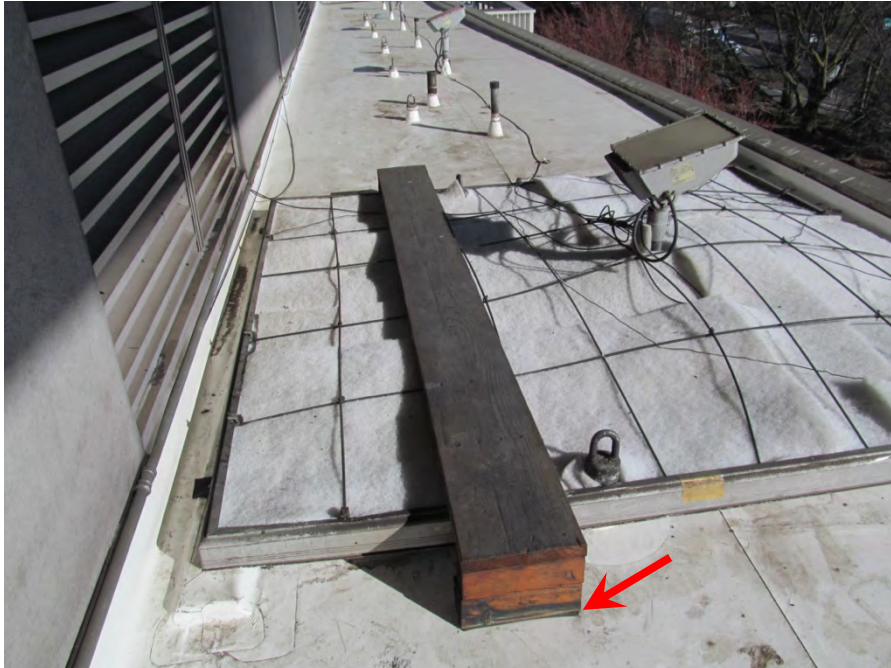
Wood plank, provided for foot traffic across a filter blanket, is installed directly on the (unprotected) roof membrane surface

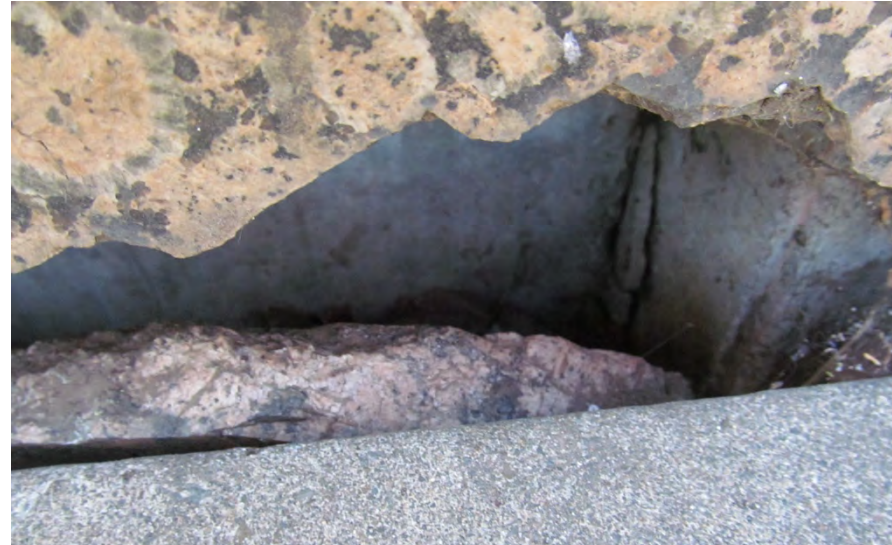
*A piece of stone veneer is broken from a panel at/below grade, leaving an open gap*

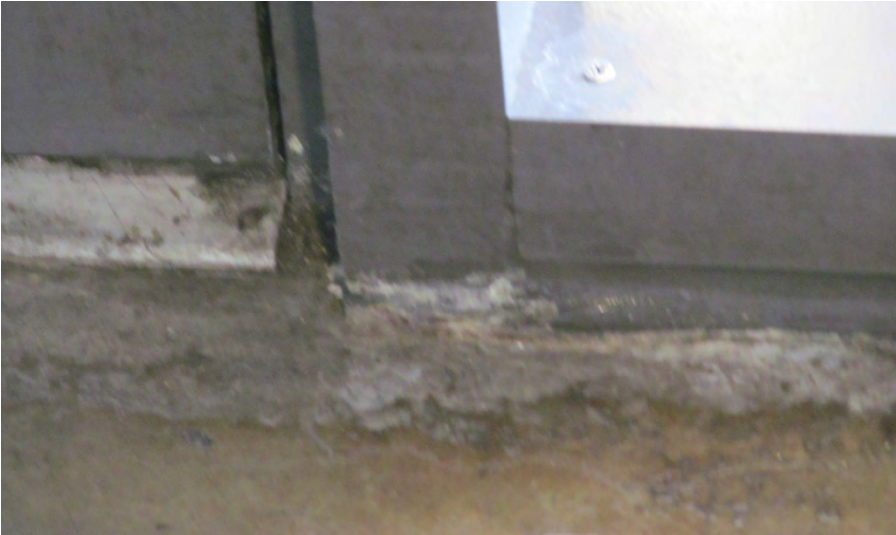
Moisture stains and damage along the base of storefront and entry door near northwest corner of terrace Roof Area 22

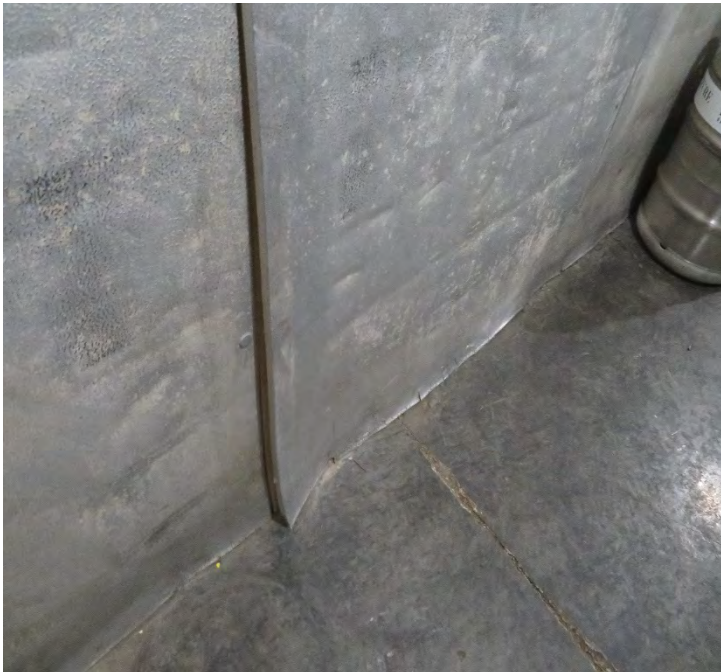
can also begin to rot the insulation due to water and beer leakage.

Damaged walls from beer kegs

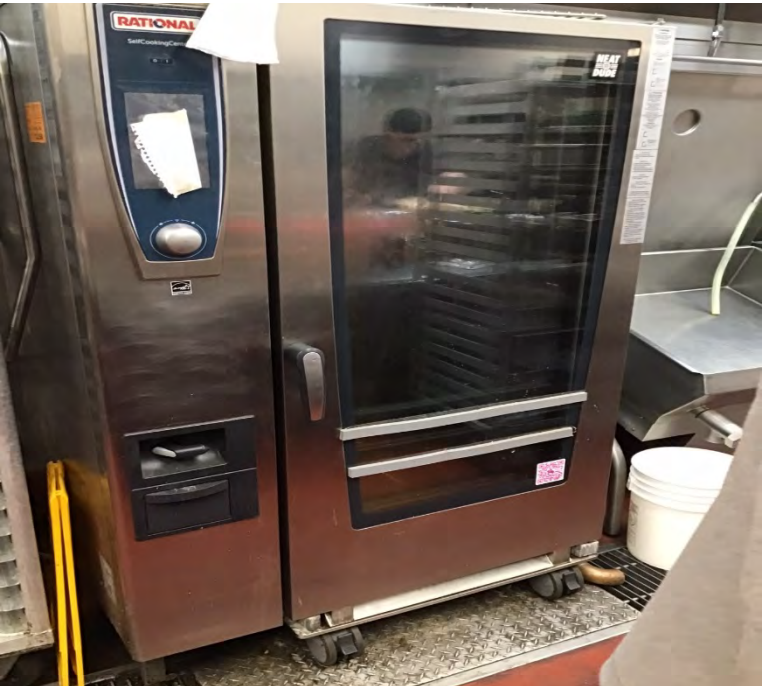
Combi oven not working
