# Facility Condition Assessment

Draft Report

May 14, 2024

# Facility Condition Assessment Moda Center & Garden Garage

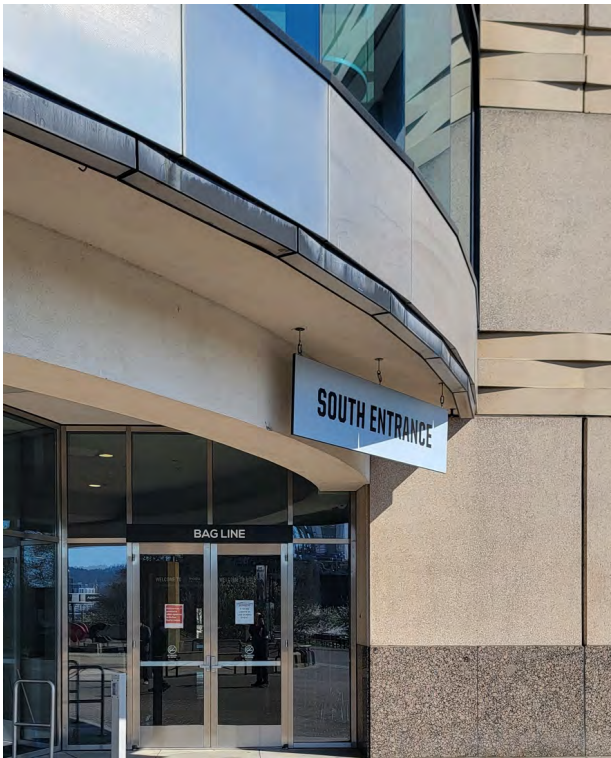
Dirt accumulation on metals and precast panels

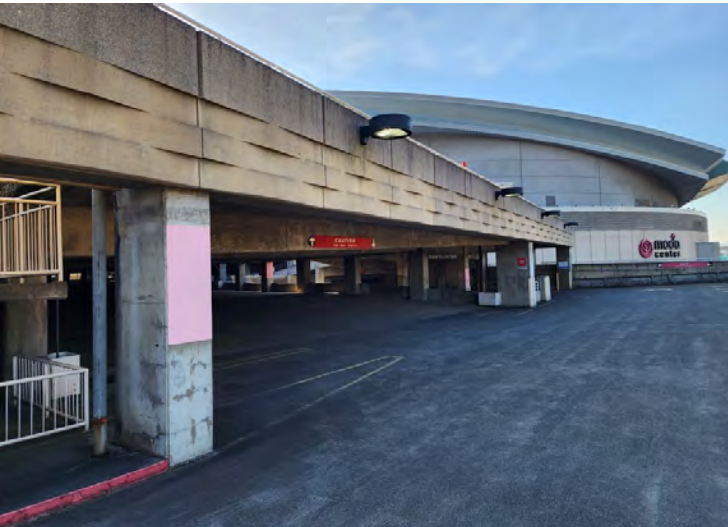
Dirt accumulation on precast panels

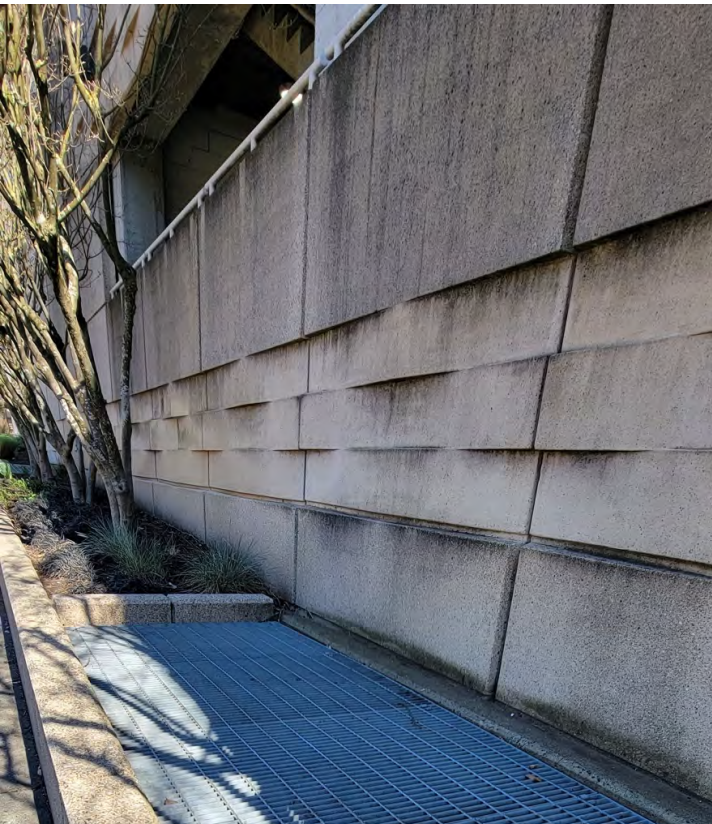
Dirt accumulation on precast panels

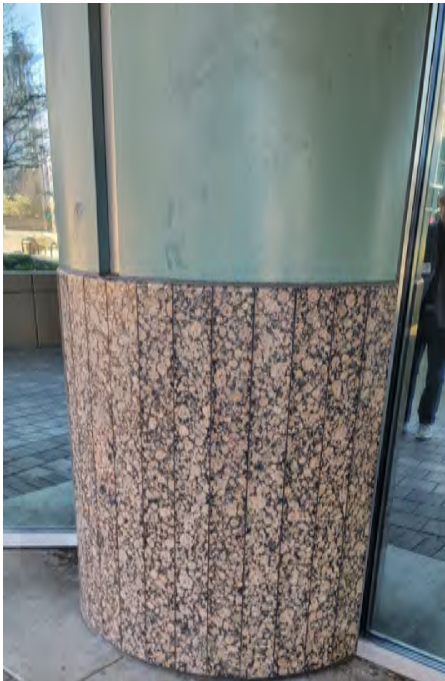
*Metal column wrap baked on finish is oxidizing allowing handprints to easily mark finish appearance*

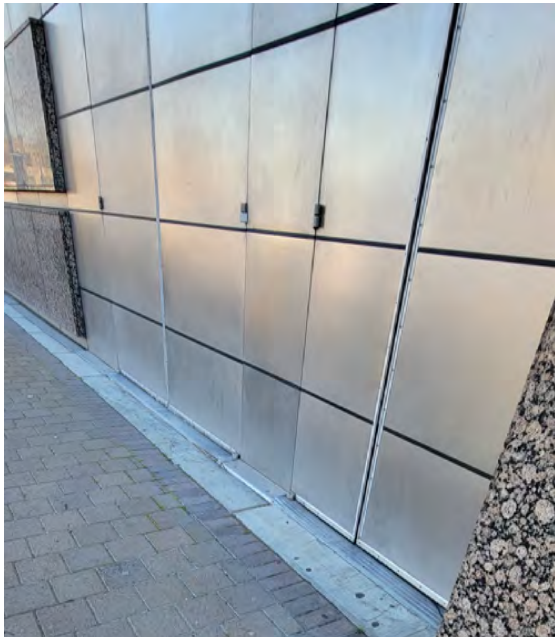
*Stainless steel door skins showing accumulation of dirt*

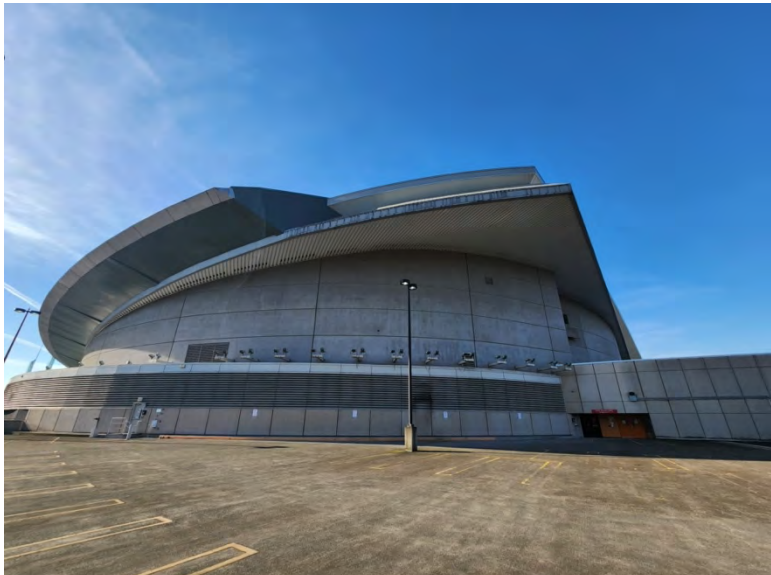
*Dirt accumulation on precast and metal panels*

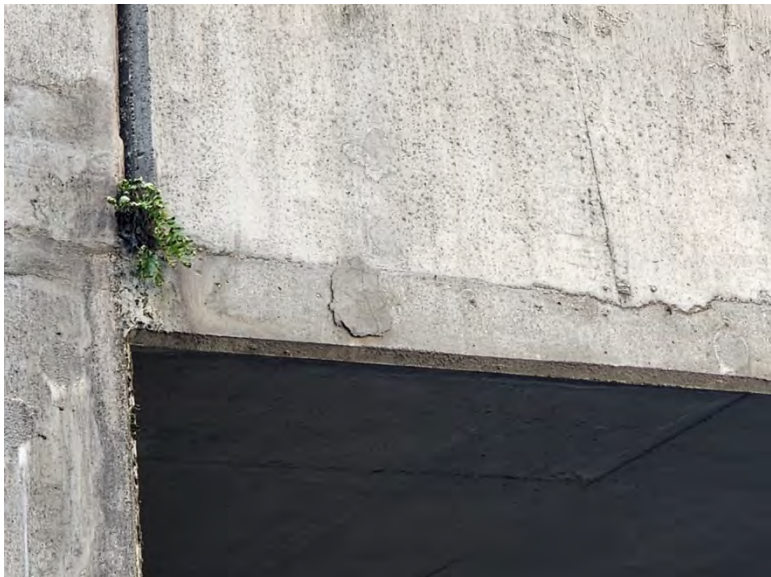
*Organic growth on walls*

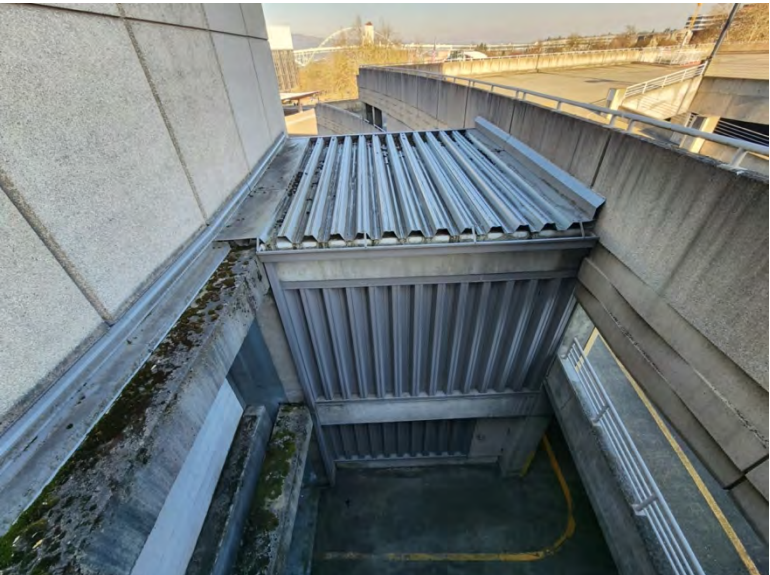
*Expansion joint cover in need of repair or replacement*

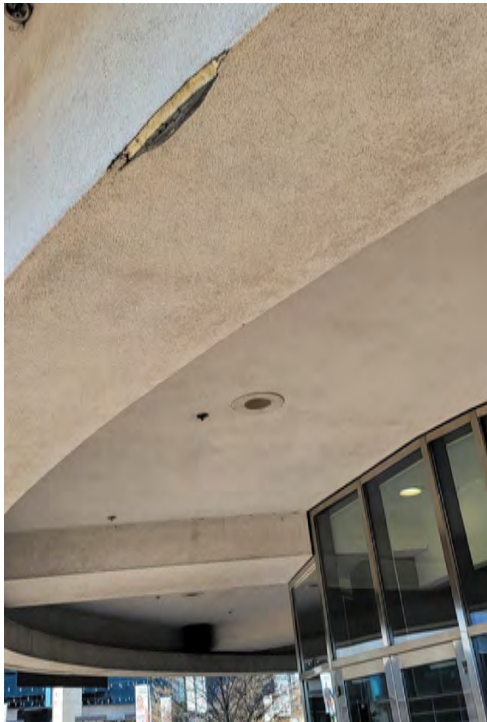
EIFS soffits above 100 level entrances are comprised of flat stucco finished panels. Lining the outer edge of the entrance soffits are boxed linear fluorescent light fixtures. The finish on the linear fixtures is weathered and they are beyond their useful life.

EIFS soffit damage

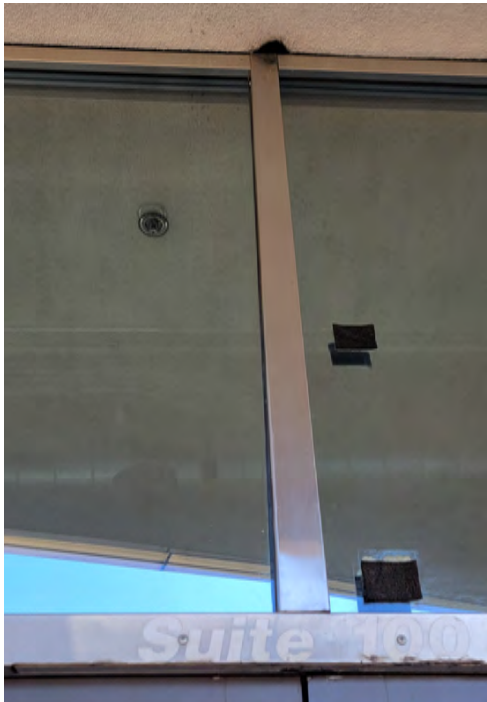
Electrical short damage to exterior soffit

There appears to have been an electrical short that damaged the interior and exterior sides of the interior wall. This area is located just to the North of the circular entrance.

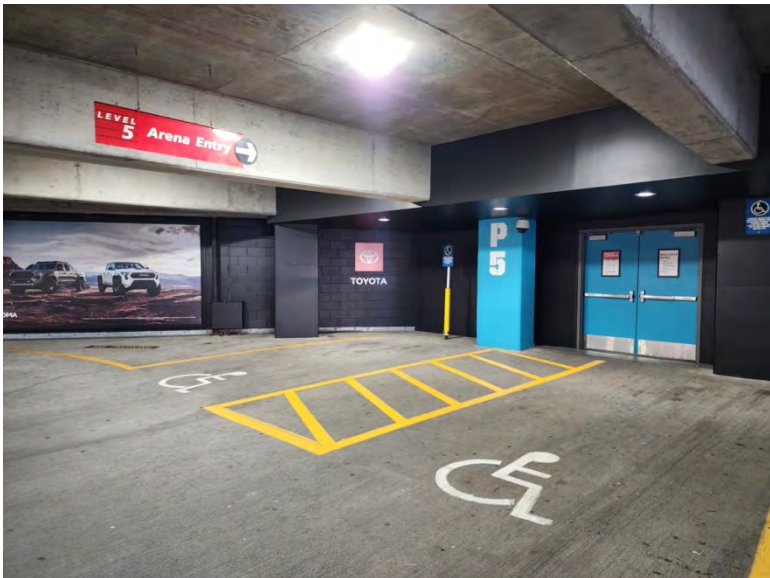
ADA stalls restricting visibility for user entry/exit

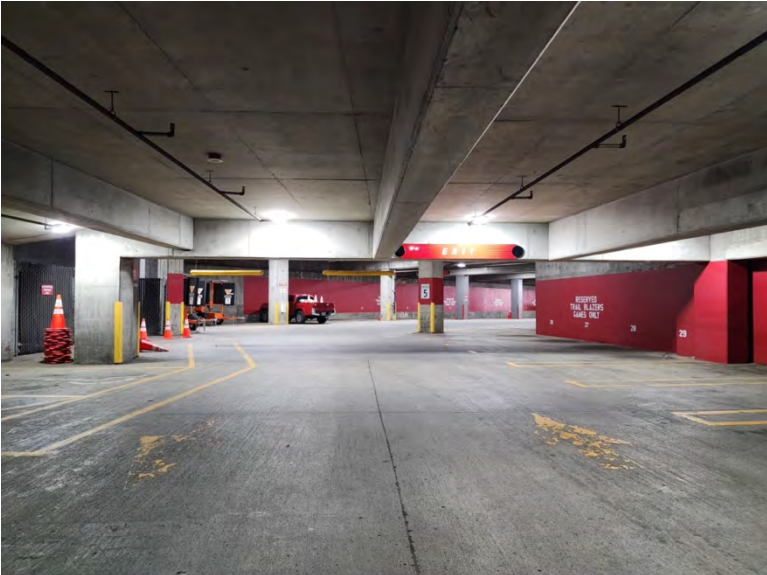
Light fixture imparting glare on wayfinding signage

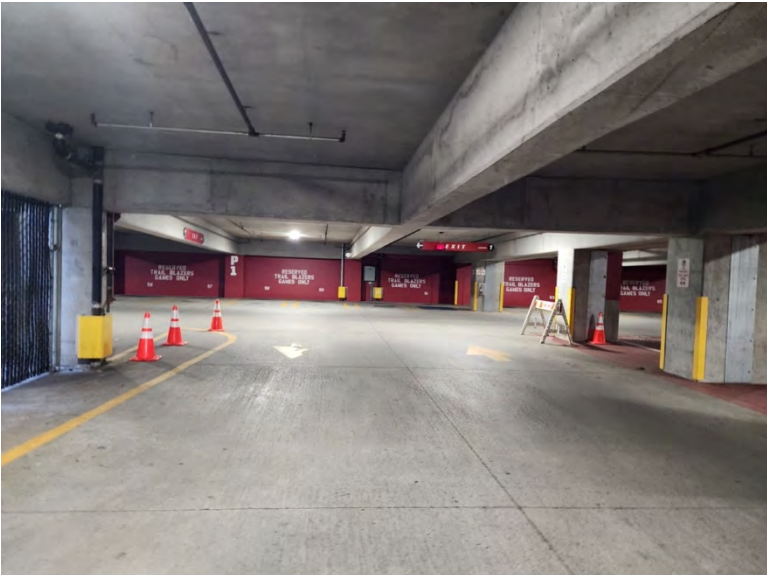
Wayfinding signage hidden with structural members

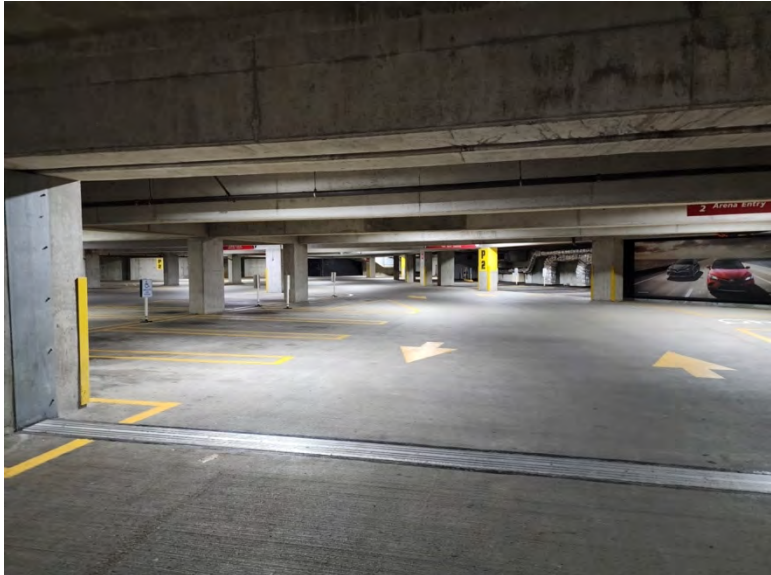
Painting darker areas of garage white would increase perception of safety in garage and improve parking experience

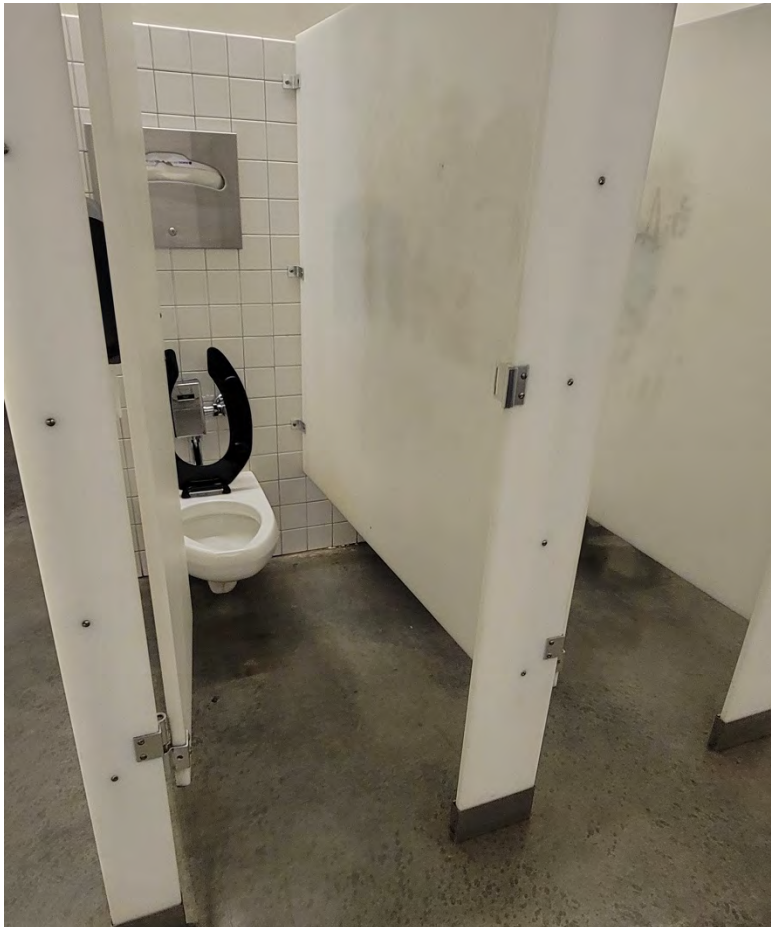
Toilet room partition material showing ghosting of prior graffiti cleaning

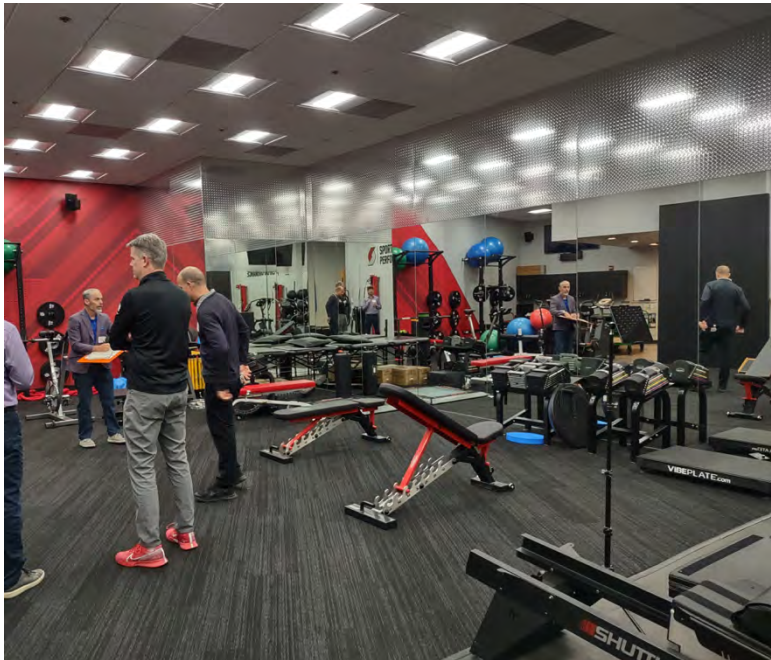
Weight room is in good condition

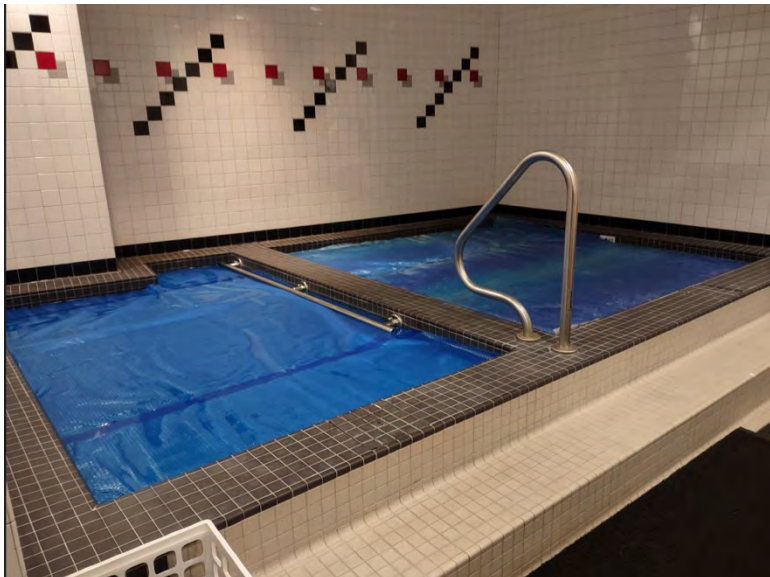
Hydrotherapy area is in fair to good condition

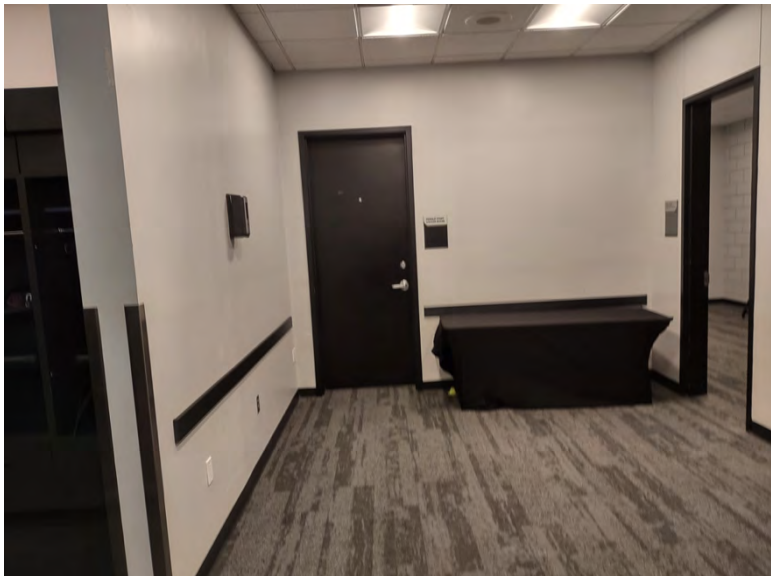
Auxiliary locker room architectural finishes on floor, walls, and ceilings show signs of wear and tear

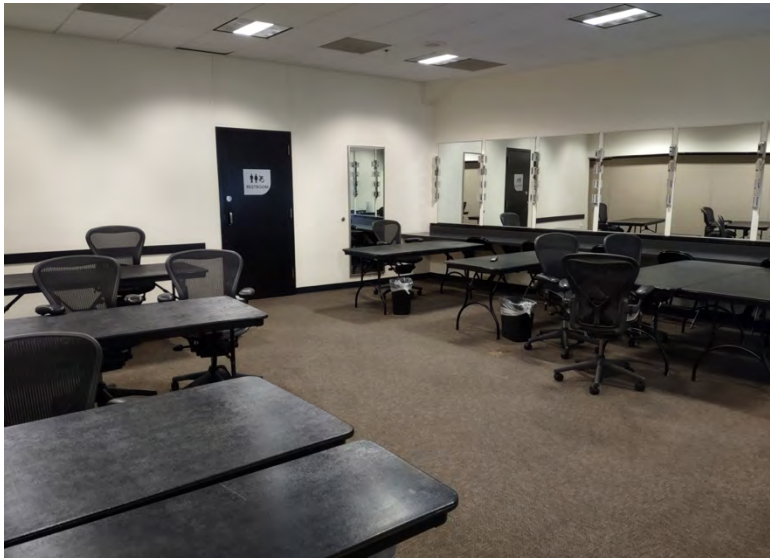
There are six star rooms (dressing rooms); a few rooms have newer finishes, and a few need a finish refresh. Star Room F is in the worst condition and needs more work than the other dressing rooms.

Star dressing rooms have older finishes on floor, walls & ceilings show signs of wear and tear

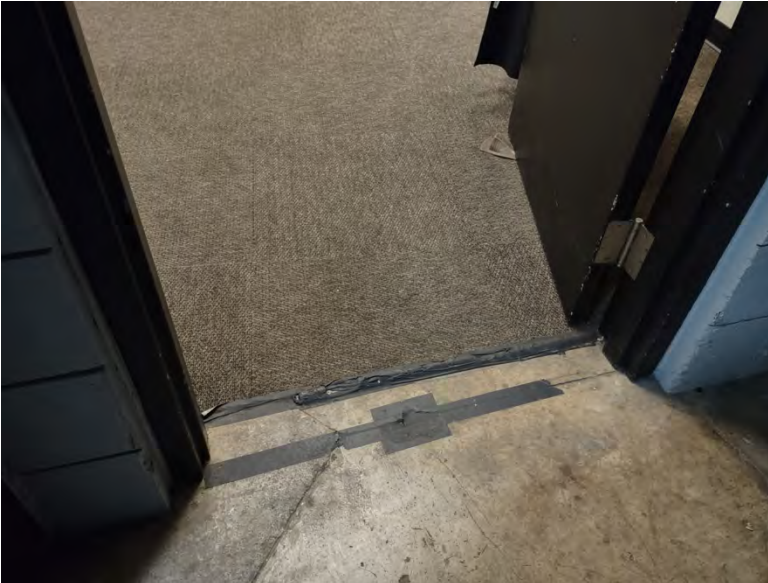
Door threshold at star room is worn out and needs repair/replacement to avoid potential tripping hazards

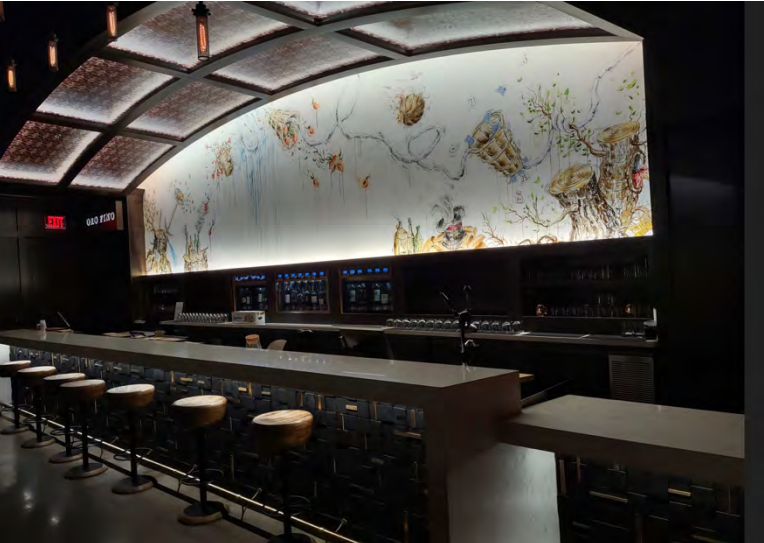
Bar/lounge at Event Level in fair to good condition

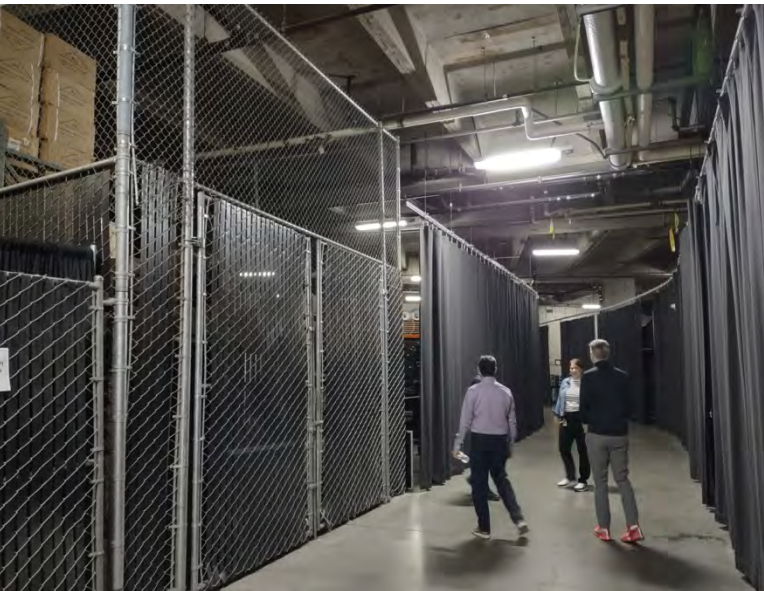
Event storage in fair to good condition

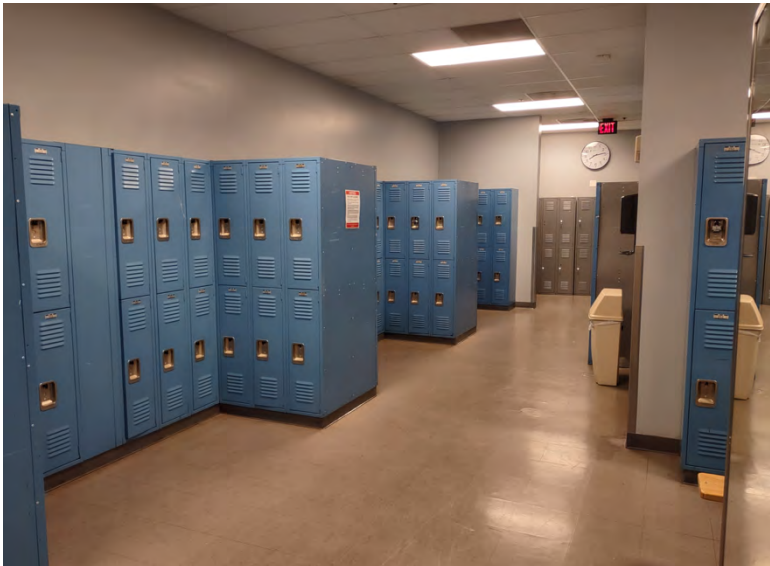
Staff locker room in fair to good condition

The staff locker rooms are large, and the metal lockers are in good condition. The restrooms and showers within the locker rooms are clean but need a refresh of finishes. The ratio of male to female lockers are disproportionate. This should be revisited to see if today’s labor ratios are more balanced. If so, the locker room configuration should be redesigned, perhaps in conjunction with the shared entrance configuration.

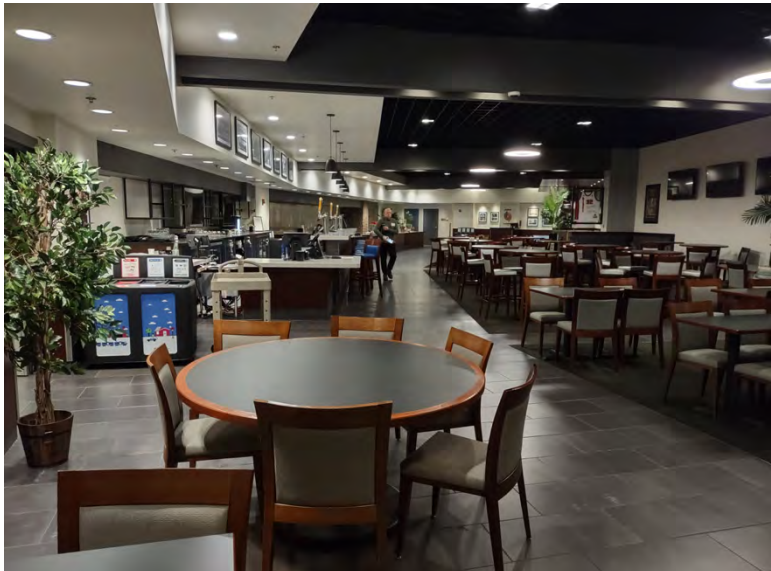
Courtside Club interiors appear in fair to good condition

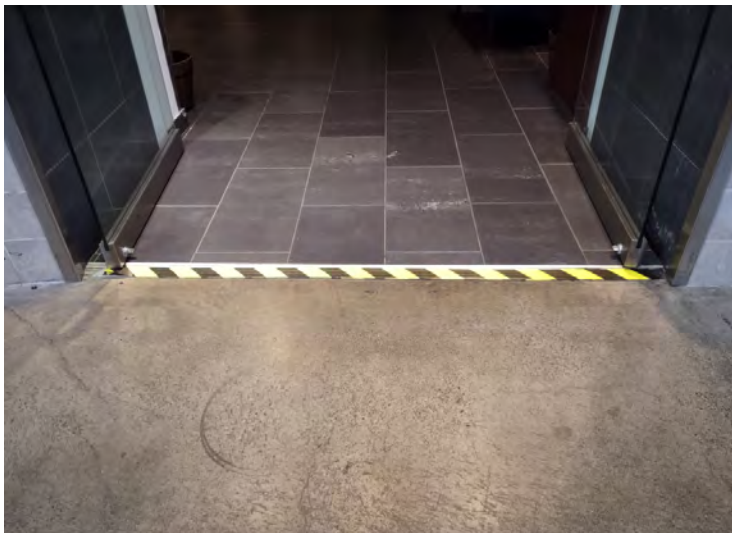
Floor transition at entry to Courtside Club needs repair/replacement to avoid potential tripping hazards or any accessibility issues

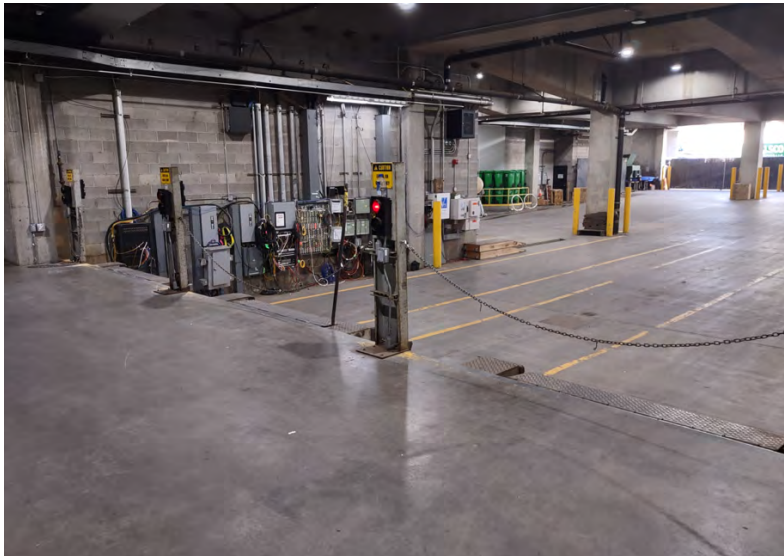
The loading dock has six bays and one ramp to access the event level. There are two dock levelers and four edge of dock levelers. All of the dock equipment, signage, lights, and bumpers should be considered for replacement.

The loading dock is in fair to good condition, showing signs of normal wear and tear

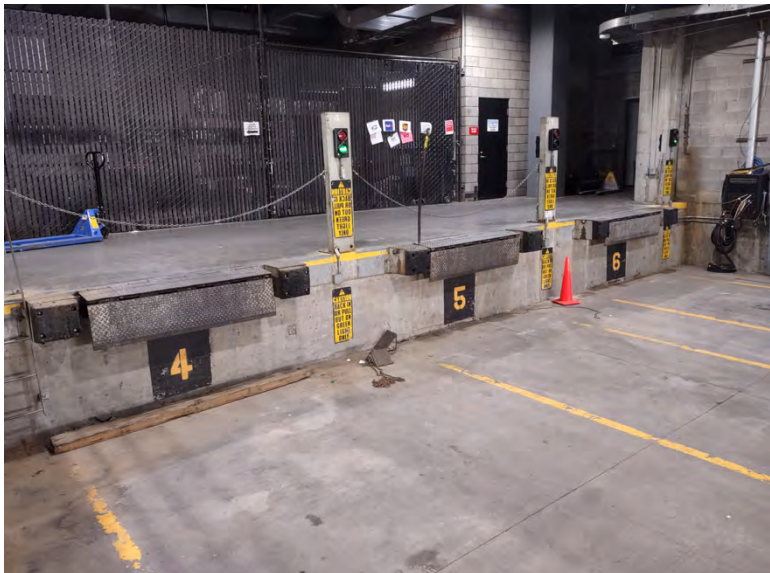
There are no trench drains observed at the base of loading dock apron

Under standard industry design and construction practice, trench drains are typically installed at dock aprons.

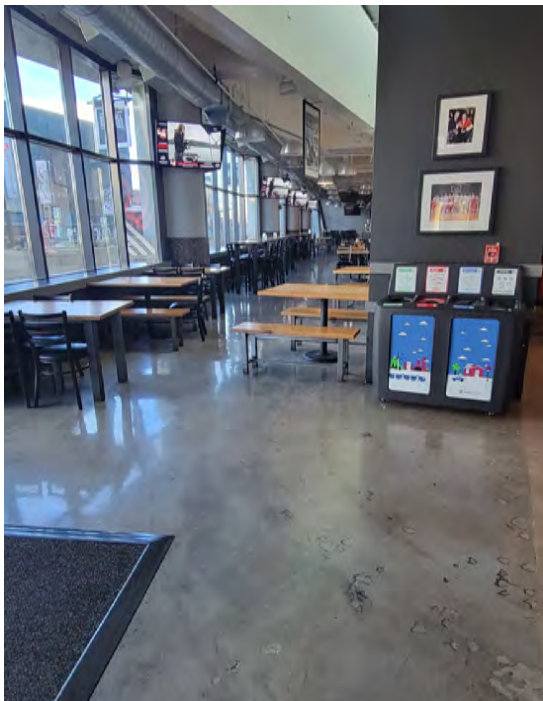
Polished concrete finish with surface chipping/delamination

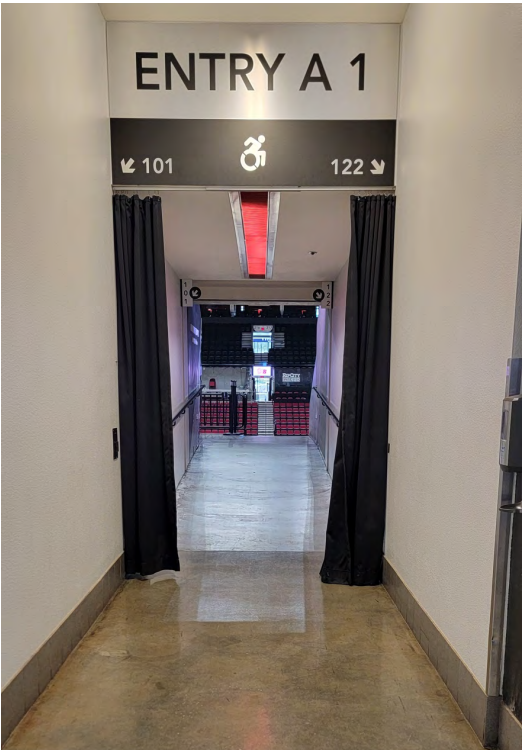
Polished concrete finish staining adjacent to walls

- The cleaning methods used, along with the lack of cove base, is promoting staining along the wall to floor interface.

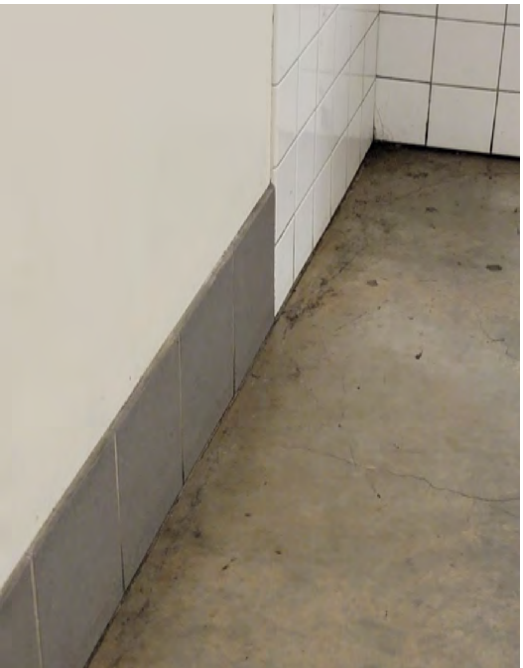
Polished concrete finish staining adjacent to walls

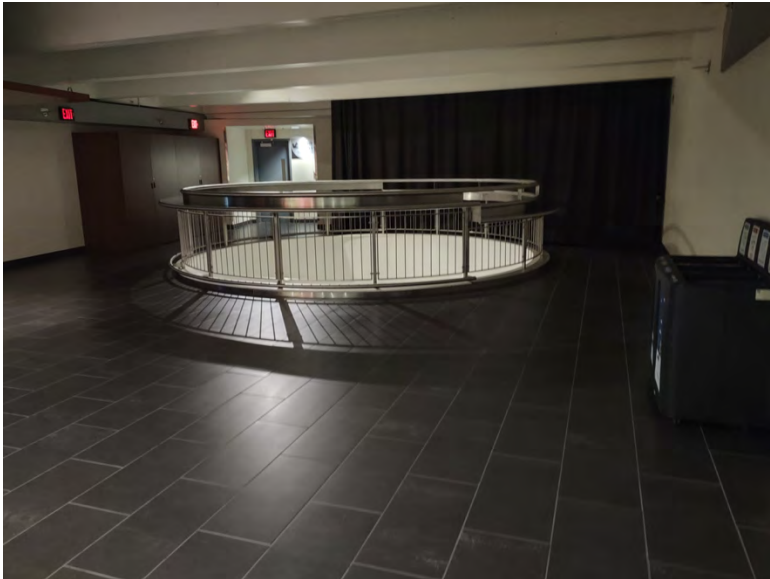
Concourse at Club Level tile flooring in fair condition

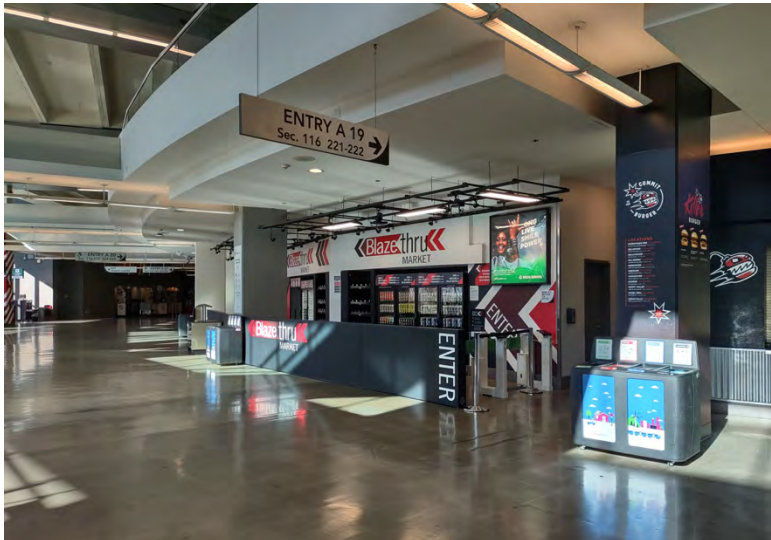
Concourse at 100 Level floor, walls and ceilings are in fair to good condition

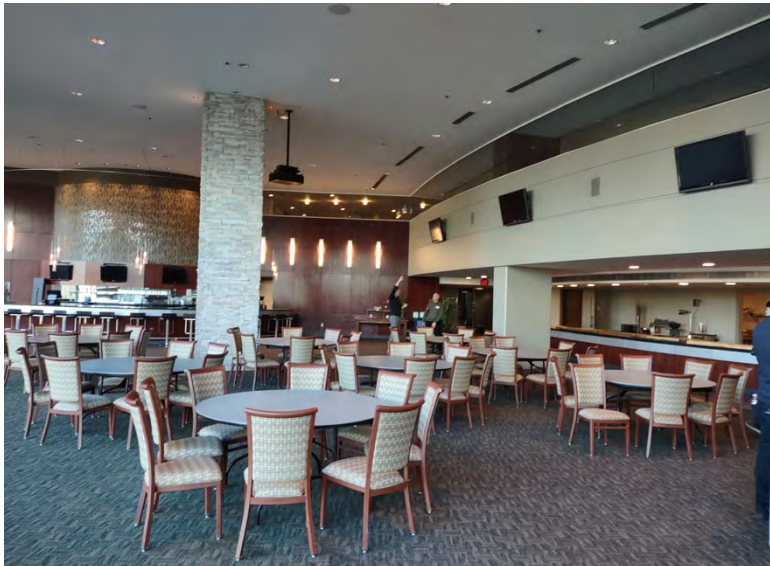
Lounge at club level carpet shows signs of wear and tear

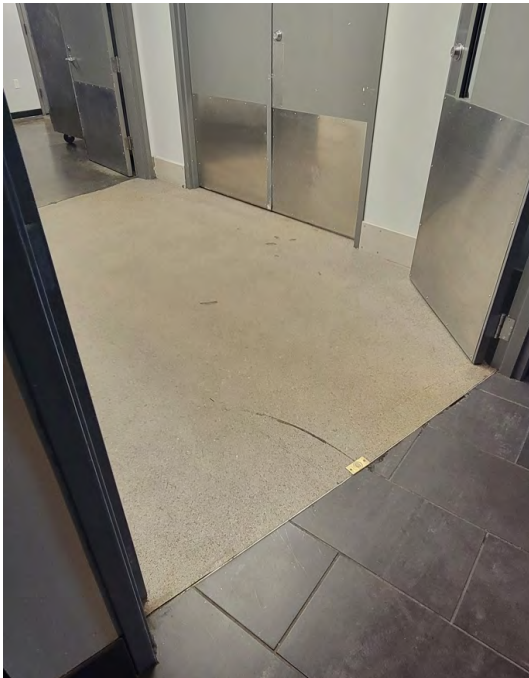
Club Level tile chipping and flooring wear

- Balance of the Club Level flooring will need to be replaced soon.
- Suite doors see a large volume of service carts that in time wear the doors. Doors will need to be replaced once over the next 20 years.

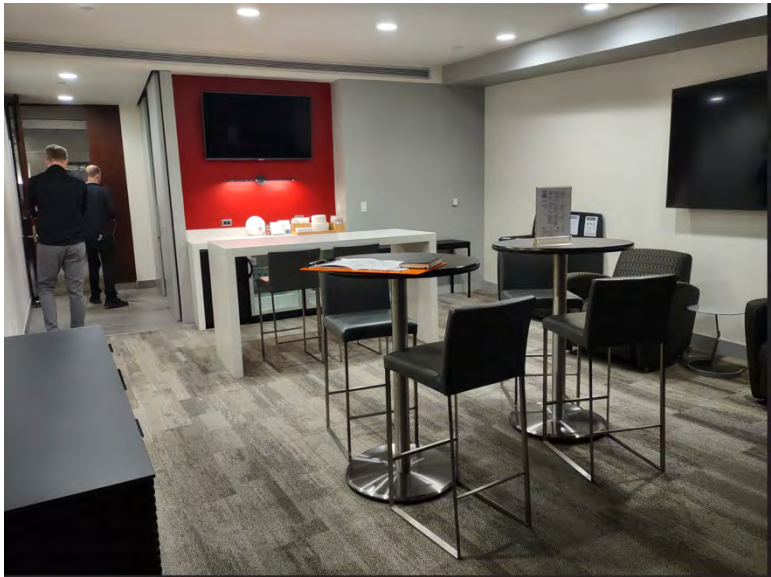
Updated luxury suite finishes in good condition

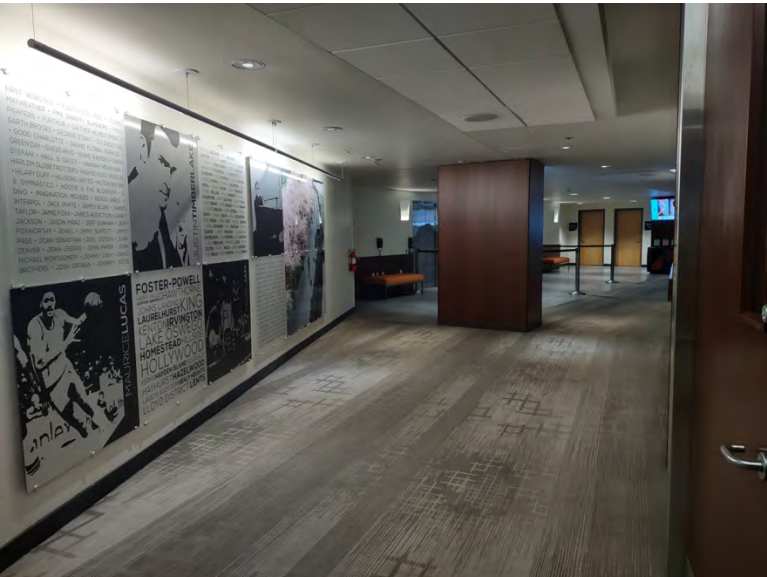
Suite corridor carpet shows sign of wear and tear

- Replace paint and carpet

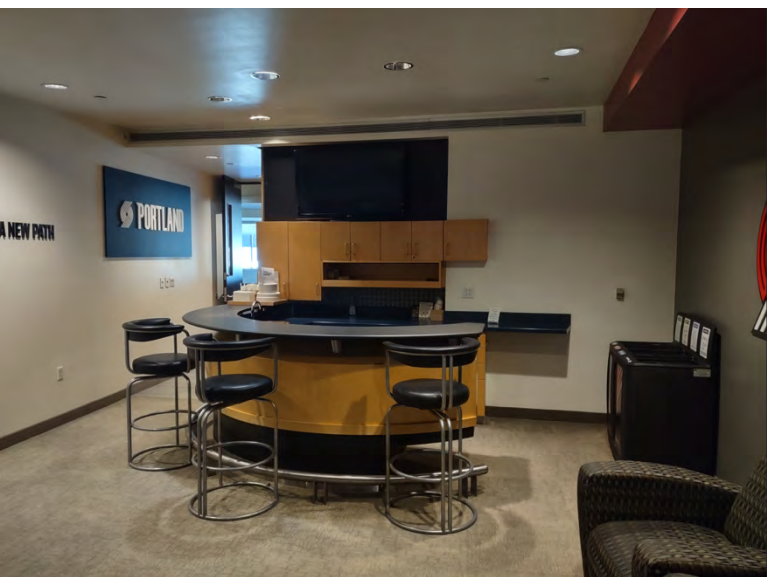
Luxury suite finishes in good condition

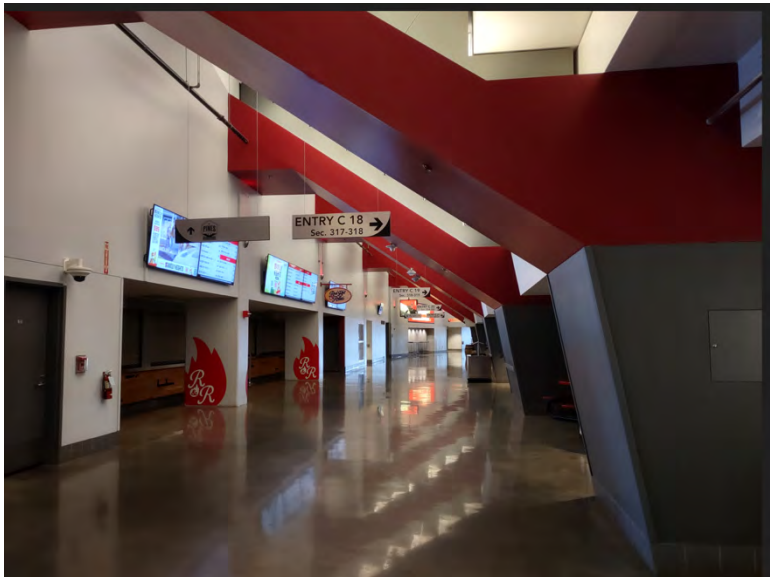
300 Level concourse finishes are in good condition

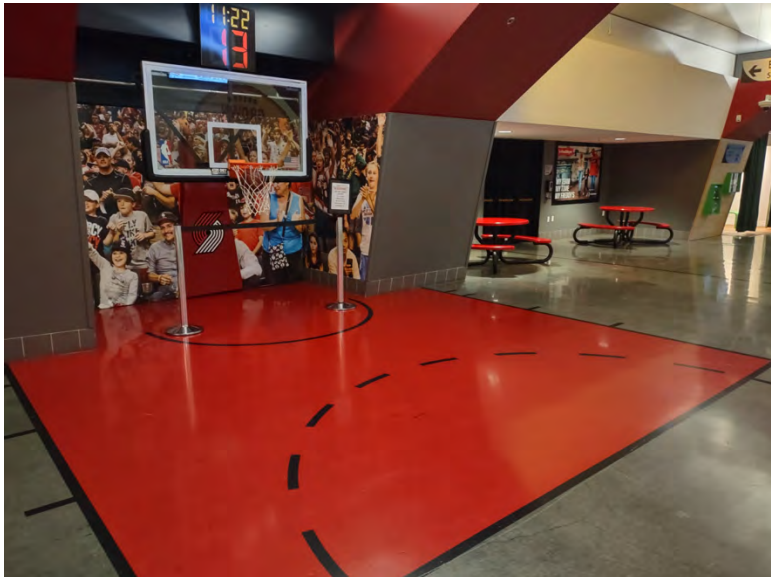
300 Level concourse architectural finishes are in good condition

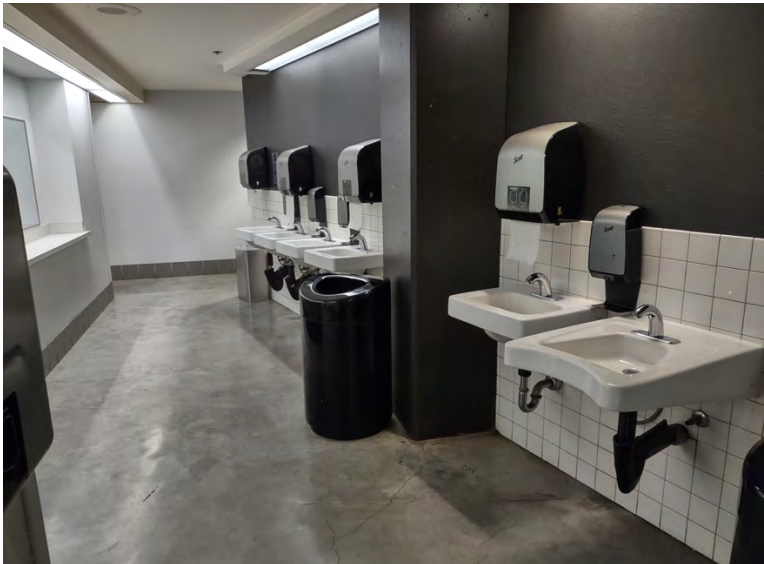
Level 300 restrooms appear to have original finishes

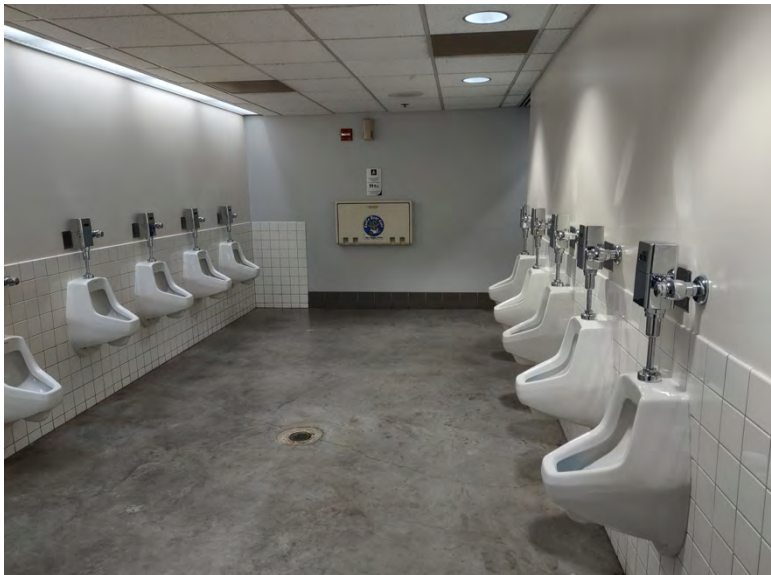
300 Level toilet rooms have original finishes

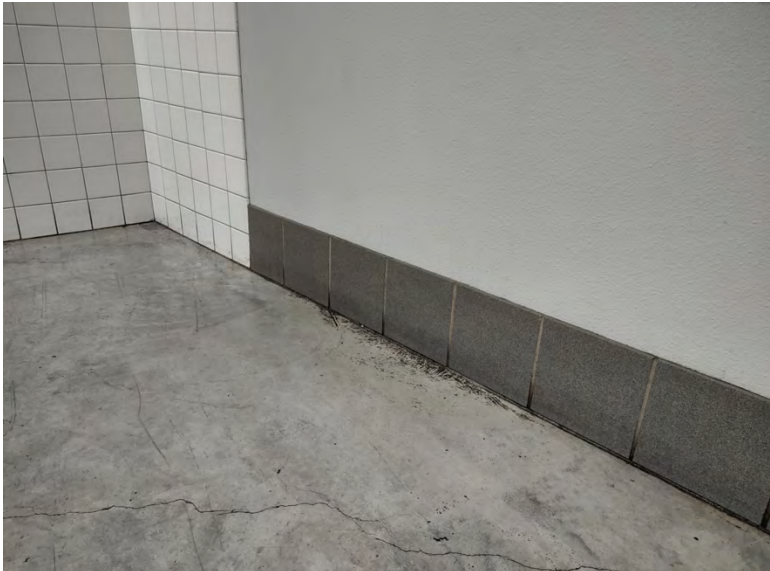
300 Level toilet rooms have original finishes with wall tile and base show signs of wear and tear

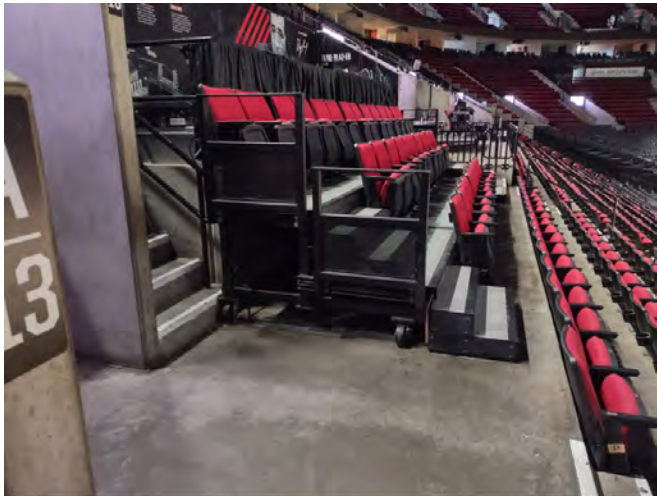
There are accessible seating platforms scattered throughout the bowl at different locations and various levels. We observed several accessible seating platforms that are infilled with fixed seating platforms. We recommend a more thorough review of existing accessible seating to ensure the current configurations meet all requirements, but more specifically horizontal/vertical dispersions and sightlines for wheelchairs in accordance with current applicable building codes and applicable accessibility standards for accessible design.

*Infill seating on accessible platform near*

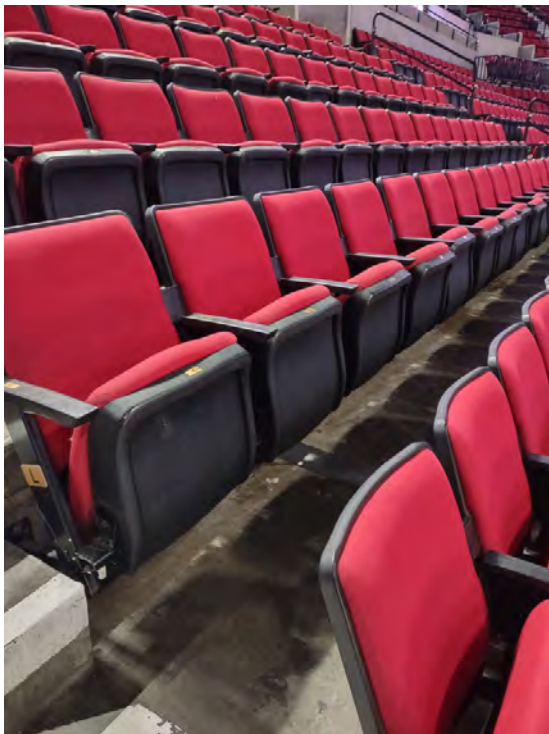
The padded arena fixed seating appears to be the original installation and should be targeted for replacement within the next five years.

*Lower deck padded seats appear to be the original installation and show signs of wear and tear*

- Replace seating within five years
- Prep and paint all leading edges of aisles, steps
- Clean and seal precast
- Replace joint sealants
- Remove and replace metal joint sealant cover plates
- Replace expansion Joints
- Paint and touch up railings
- Complete an accessibility assessment on seating requirements as part of the seating replacement for the bowl.

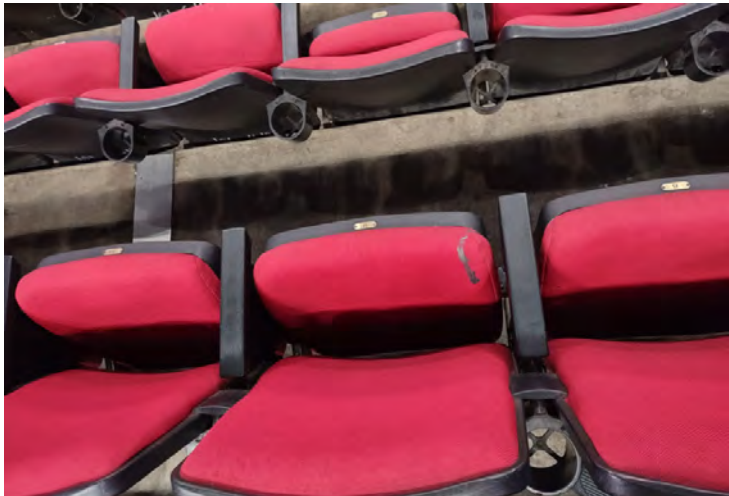
*Stains on padded seating at lower deck*

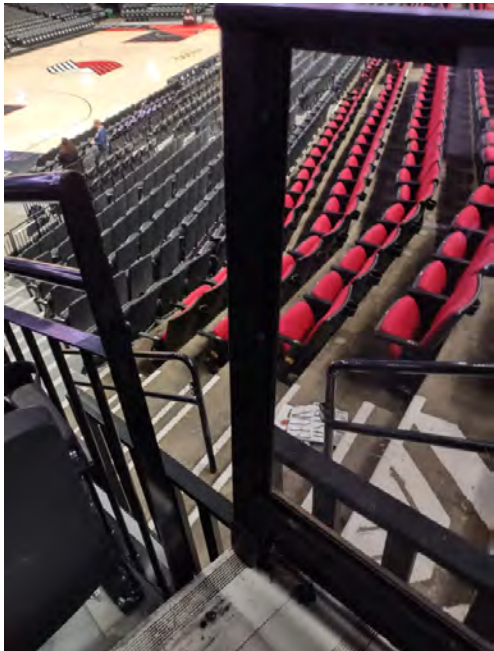
*At Section 116 the gap in guardrail exceeds allowable 4-inch sphere required by code*

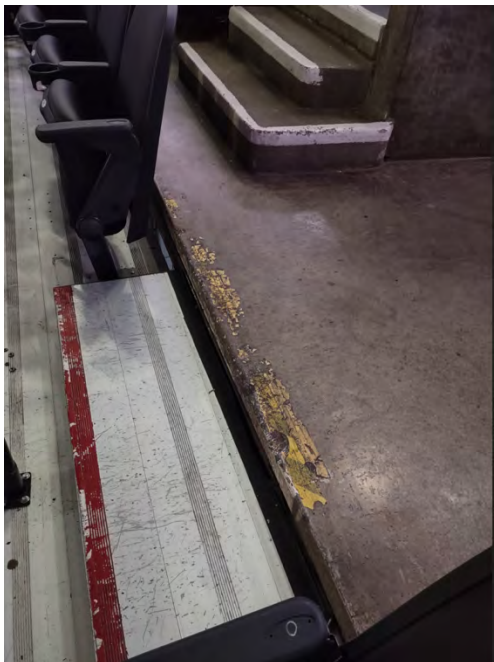
*At Section 116 the gap between concrete and aluminum aisle step; this condition could become potential tripping hazard*

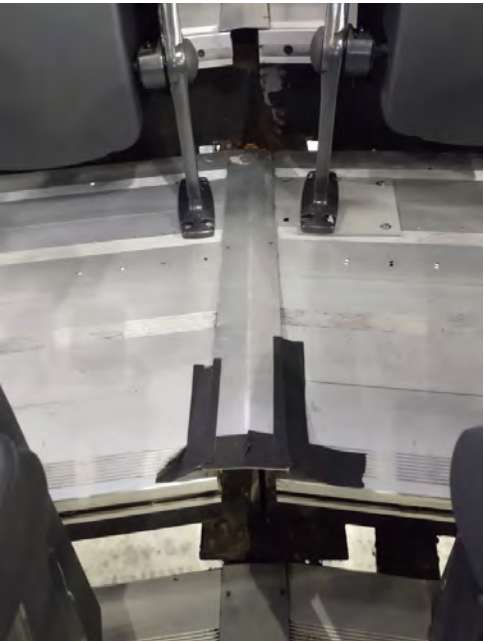
*Aluminum closure plate at seating tread held in place with duct tape; this condition could become potential tripping hazard*

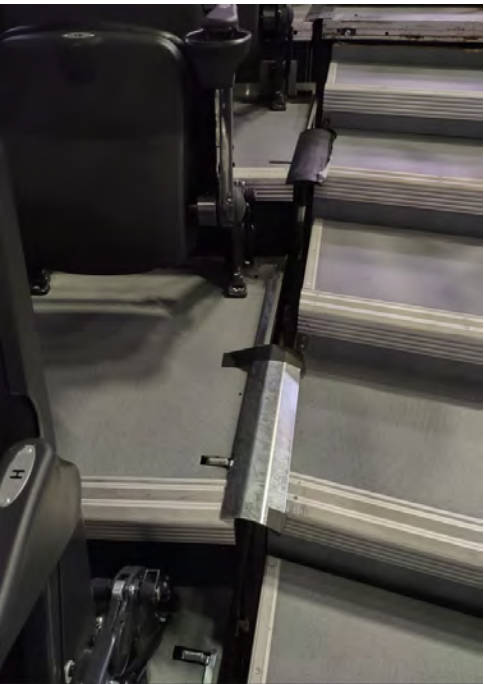
*Aluminum closure plate at seating tread held in place with duct tape; this condition could become potential tripping hazard*

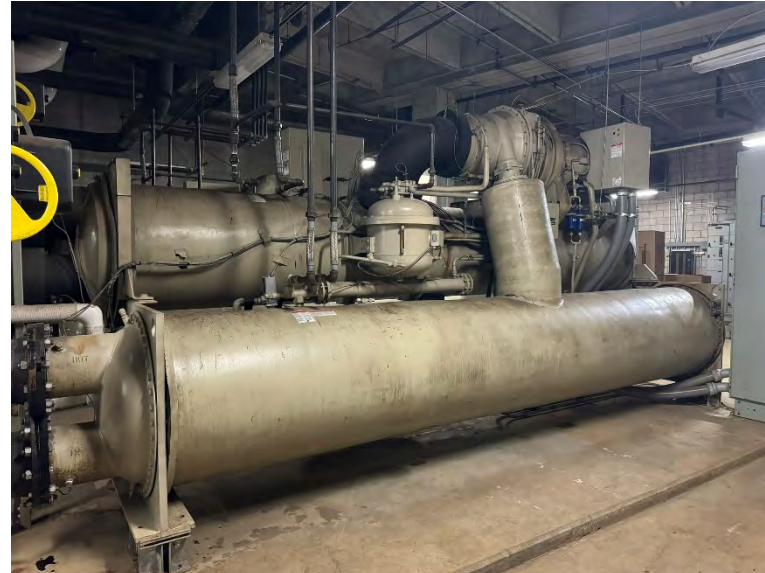
*Chiller 1*

The main chiller plant located within the arena consists of three water-cooled centrifugal chillers. According to maintenance staff, all three chillers are needed to handle a peak building load during the summer months. Two of the chillers (CH-1 and CH-2) are constant speed and sized for 765-Tons each. Both of the large machines are manufactured by McQuay.
