# Facility Condition Assessment

Draft Report

May 14, 2024

# Facility Condition Assessment Moda Center & Garden Garage

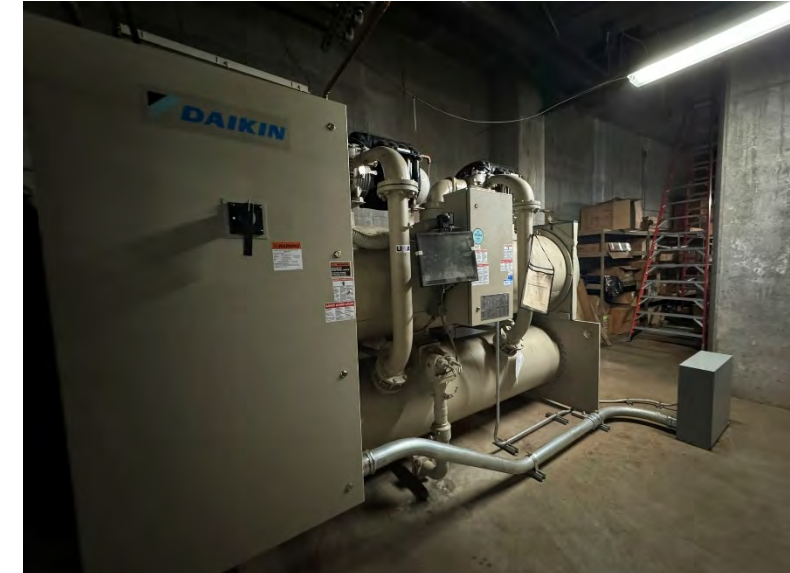
*Chiller 3*

The small chiller, CH-3, is sized for 380 tons and is equipped with a VFD and manufactured by Daikin. All three chillers utilize R-134a as the refrigerant. The small chiller is staged on during periods of low load in the building and can modulate capacity until one of the large machines is staged on. Chillers 1 and 2 appear to be original. Per the facility's capital improvement projects list, there have been several repairs completed on these pieces of equipment. Also, per the facility documentation, Chiller 3 was completely replaced in 2015.

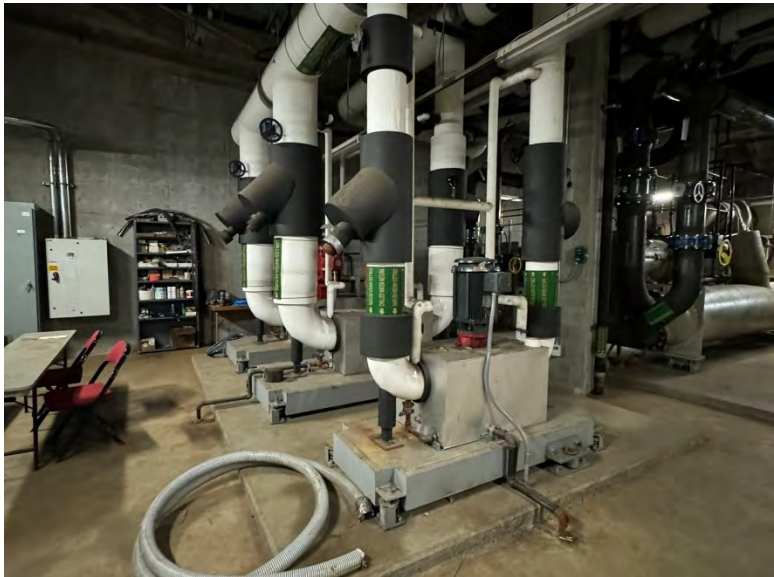
The larger pumps are 50 HP each, and the smaller pump is 30 HP. These pumps are also manufactured by Armstrong.

*Chilled water primary pumps*

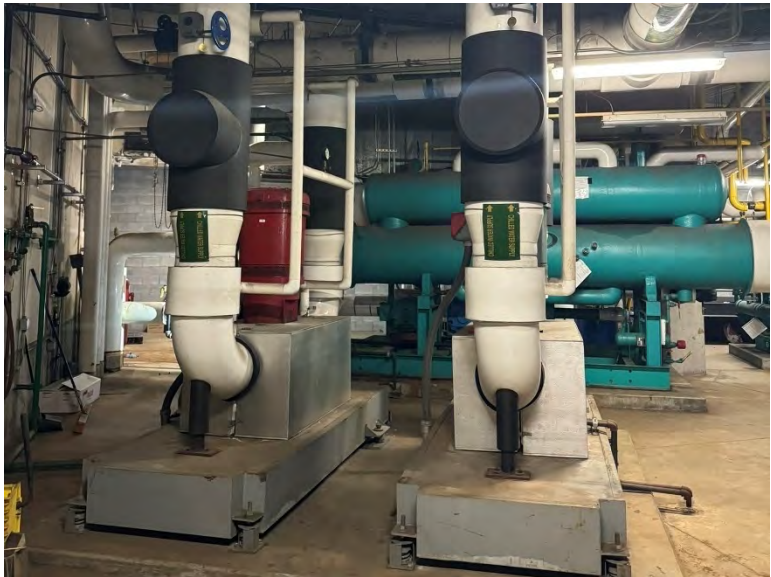
The two secondary chilled water pumps responsible for distributing the chilled water to the facility are vertical in-line pumps sized at 1,910 GPM and 130 ft. of head. These 100 HP pumps are equipped with VFDs and are in relatively good condition considering the amount of time they have been in use.

*Chilled water secondary pumps*

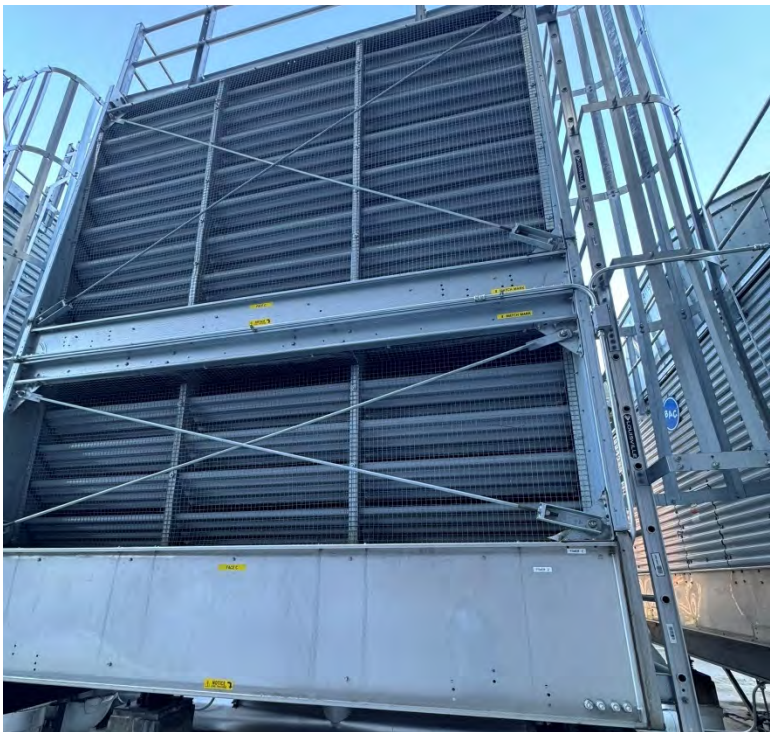
*Chilled water system cooling tower*

Heat rejection for the chillers is through three single-cell, cross flow cooling towers located in an area on the low roof above the boiler plant. Each of the towers are manufactured by BAC. According to the facility's records, all three cooling towers were replaced between 2017 and 2018 and all three appeared to be in great condition. Each of the cooling tower fans are equipped with VFDs.

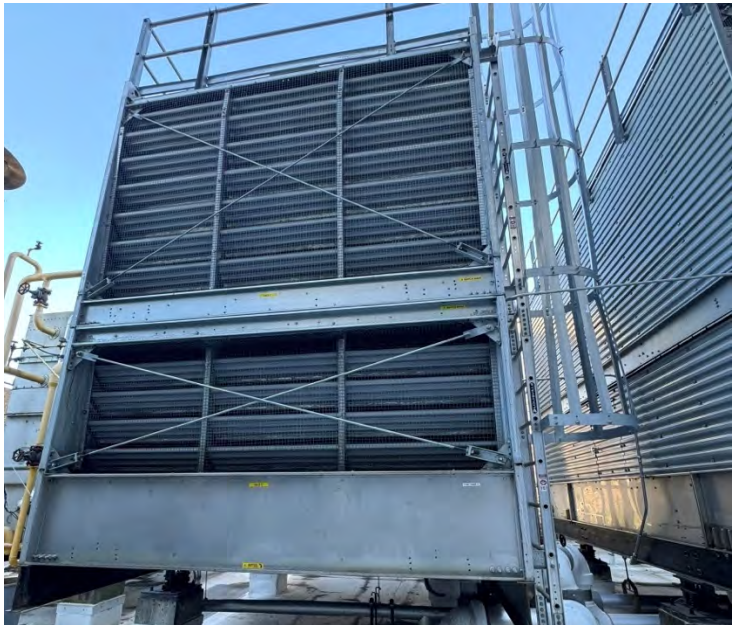
In order to reject waste heat from the heat recovery loop, there is a single cell BAC cooling tower located in the same roof area as the building chilled water towers. This cooling tower is sized for 1,885 GPM of flow and has a 60 HP fan motor. While on site, the cooling tower appeared to be in good condition and of a similar age to the cooling towers serving the chilled water system. The cooling tower fan motor is equipped with a VFD.

Heat recovery cooling tower

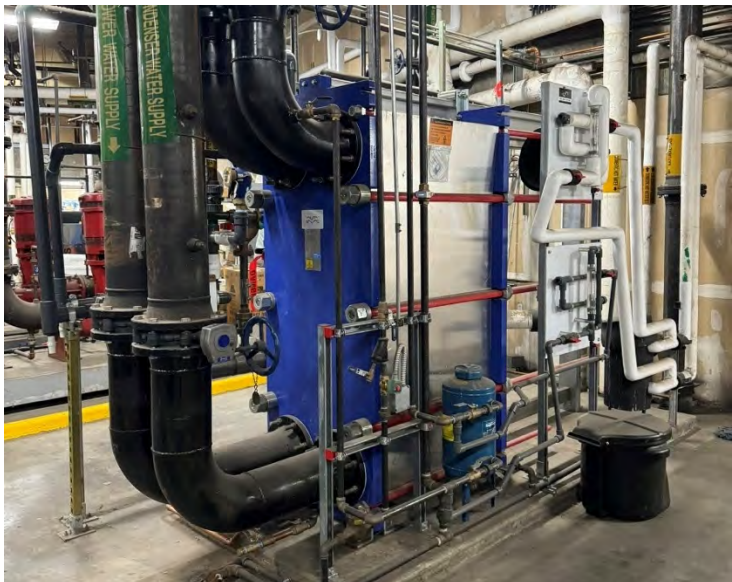
To decouple the open loop system of the cooling tower from the closed heat recovery loop throughout the building, the arena has an 11,266 MBH plate and frame heat exchanger installed. This heat exchanger is manufactured by Alfa Laval and was replaced in 2018. The heat exchanger appeared to be in good condition.

Heat recovery heat exchanger

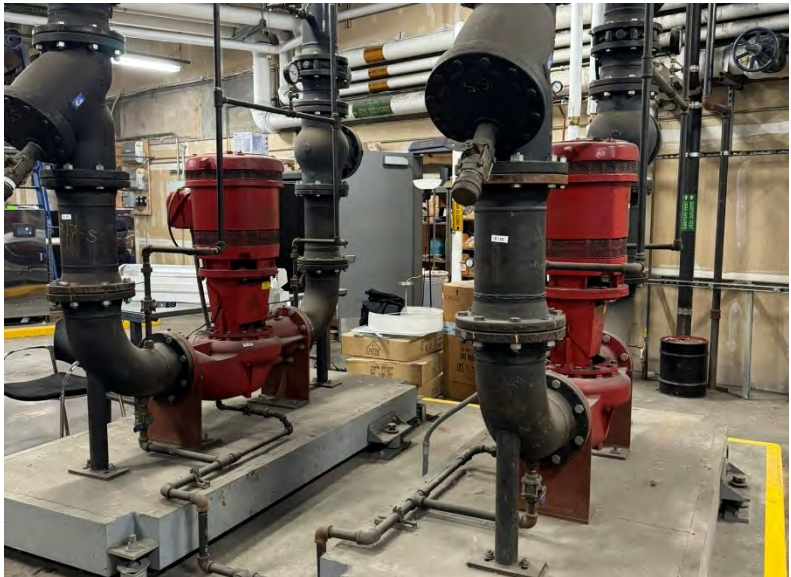
Two additional condenser water pumps between the cooling tower and the heat exchanger are designed such that one pump can handle the total flow, and the second pump is on stand-by. These pumps are vertical in-line pumps sized at 1,500 GPM and 60 ft. of head. These pumps have 40 HP motors which appear to be original, and the primary pump is equipped with a VFD.

Heat recovery condenser water pumps

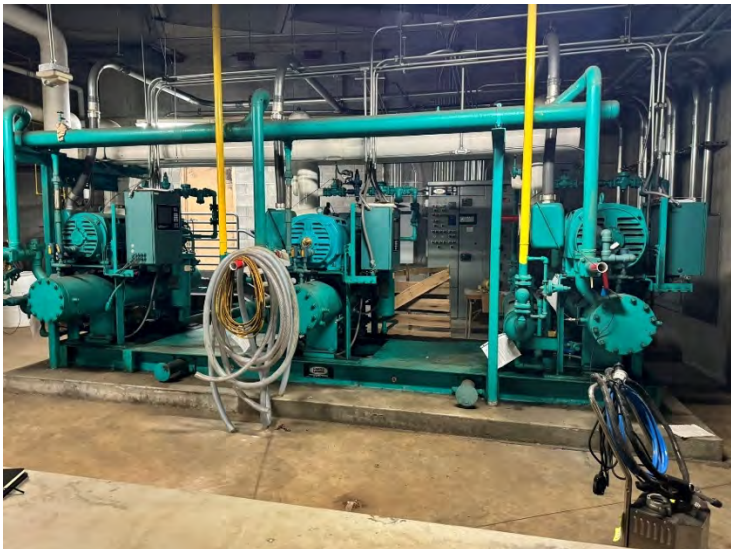
Due to the cost associated with the full demolition and removal of remaining pieces of equipment associated with the ice plant, both the ice plant compressor skid and cooling tower on the roof have been abandoned in place. Replacement of the ice plant and a new ice floor will likely be required to maintain a quality ice sheet.

Abandoned ice chiller

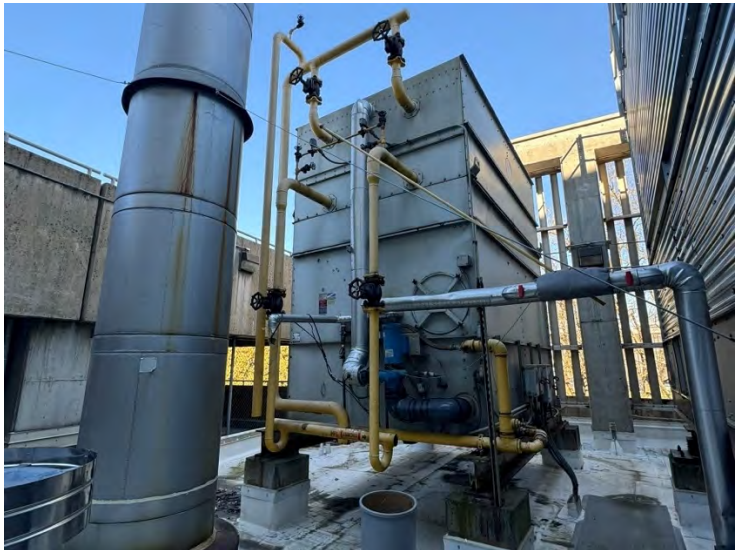
Abandoned ice system cooling tower

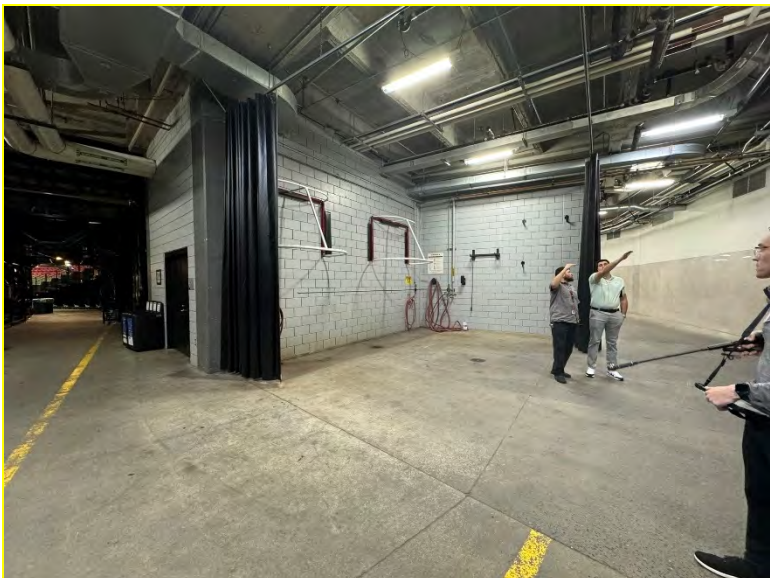
Additionally, down on the service level of the building, other remnants of the ice plant still exist. The overhead pipe routing for the brine fluid that would circulate between the ice chillers and the event floor is still in place. The location where the ice resurfacing machines were stored has been abandoned and now serves as an extension to the service level corridor.

Abandoned ice resurfacing machine area

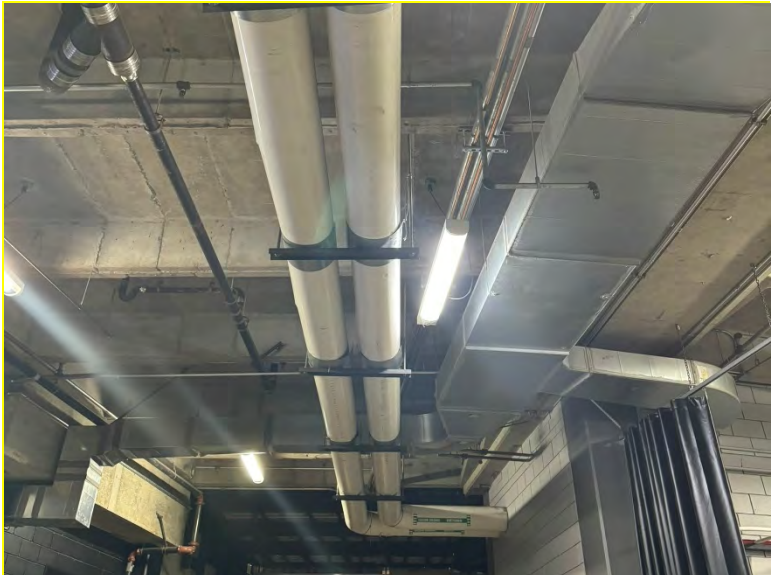
Abandoned ice floor brine piping

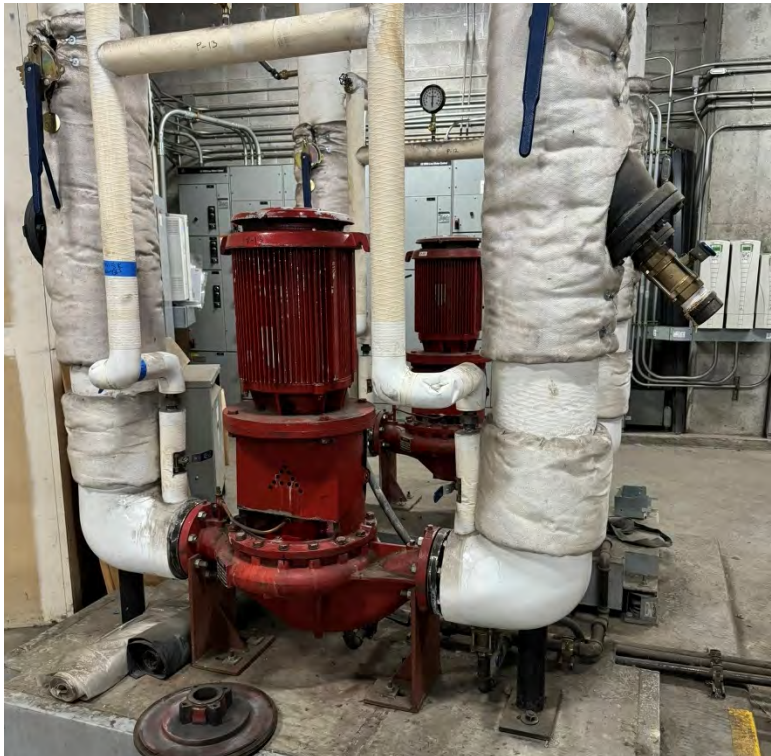
Hot water distribution throughout the facility is handled by two vertical in-line pumps sized at 550 GPM and 130 ft. of head. These 30 HP pumps are in relatively good condition considering the amount of time they have been in use and are equipped with modern VFDs. The pumps are manifolded together and piped in a parallel configuration, therefore if one pump fails, the hot water system can still operate.

Heating hot water secondary pumps

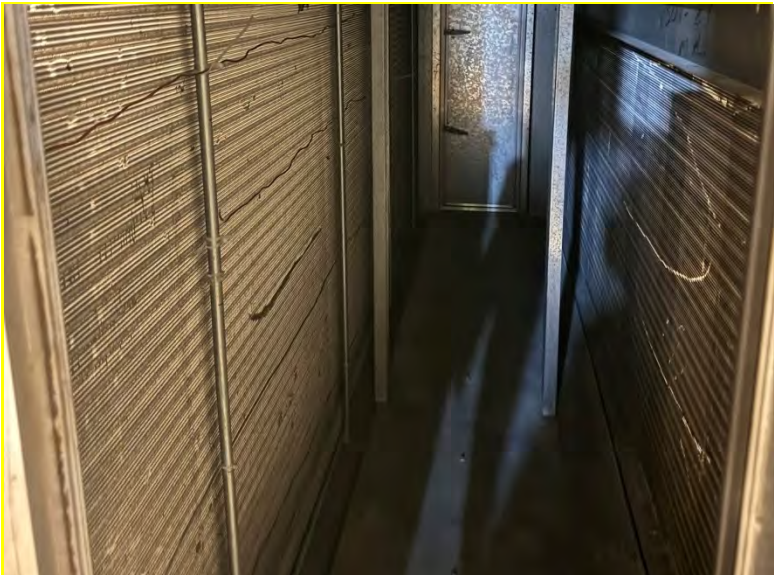
The bowl units, all manufactured by Carrier, are original and in good condition considering their age. According to the facility staff, the filters are changed on a regular basis based on equipment run time. Upon inspection of the units, the coil sections were clean with little damage, and the drain pans were free of any build up or rusting. There were no known issues reported at the time of the assessment.

*Bowl AHU coil section*

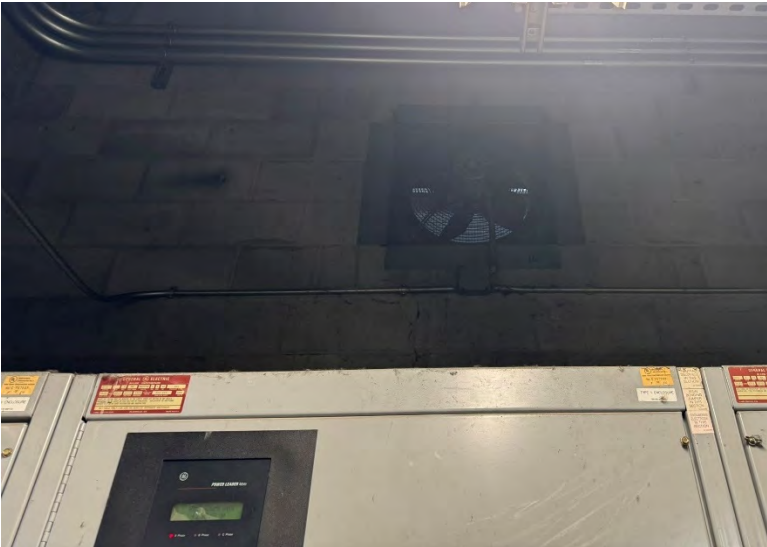
There are ventilation fans throughout the building located in electrical rooms, as many of the electrical rooms are not conditioned. Some of the electrical rooms were noticeable warmer than adjacent spaces even with the ventilation fans pulling the air from the room. Most of the ventilation fans are original with a portion of them being replaced as they have failed.

Ventilation fans in main electrical room

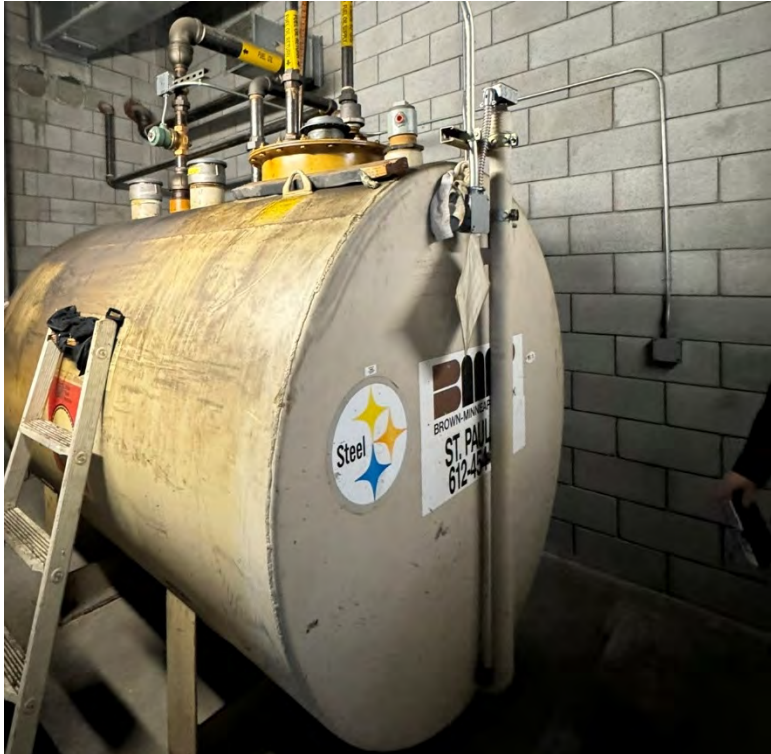
Within the room there is a 5 ft diameter by 7 ft long storage tank that is original. The tank is equipped with a single pump to flow the fluid out of the tank to supply to the generator. The facility staff reported no known issues with the system.

Fuel storage tank

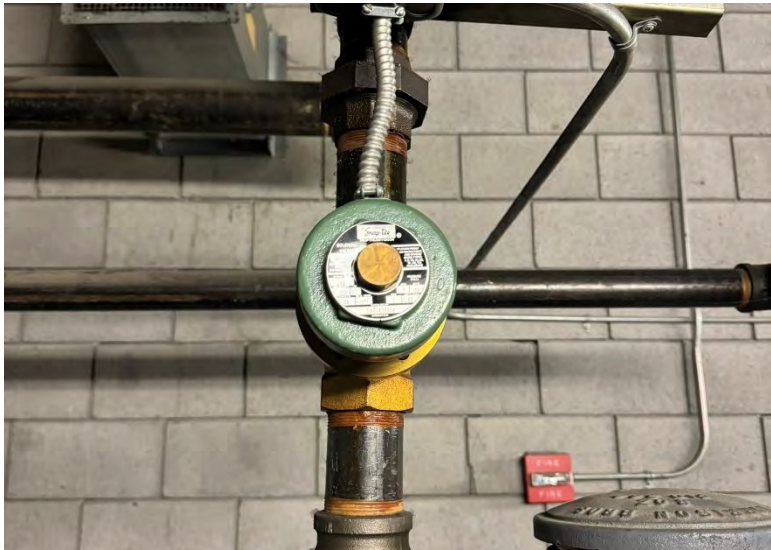
Pump in fuel storage room

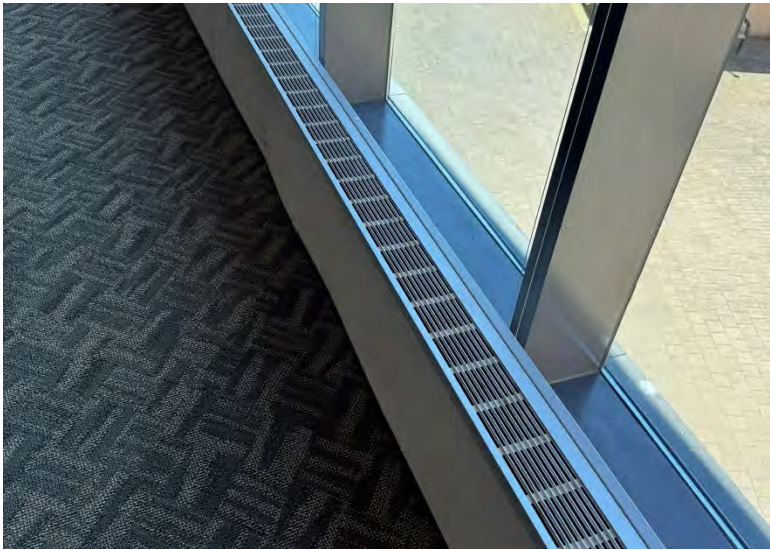
There are small sections of fin tube radiant heaters installed in two of the club spaces and in the Annex. These devices are connected to the heating hot water loop of the building.

Fin tubed heater

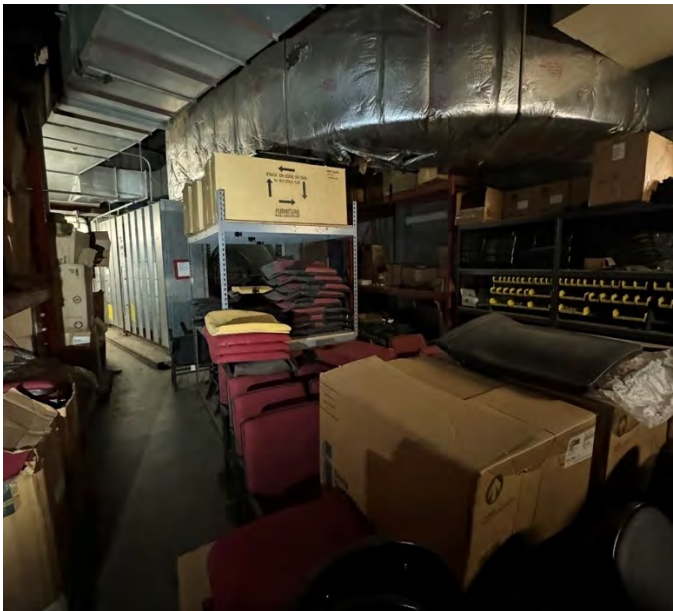
Overall, mechanical rooms were clean, but some were being used for additional storage. This can cause clearance issues, as well as maintenance issues if there were to ever be an emergency, and the unit was not able to be reached.

Obstructed air handling unit

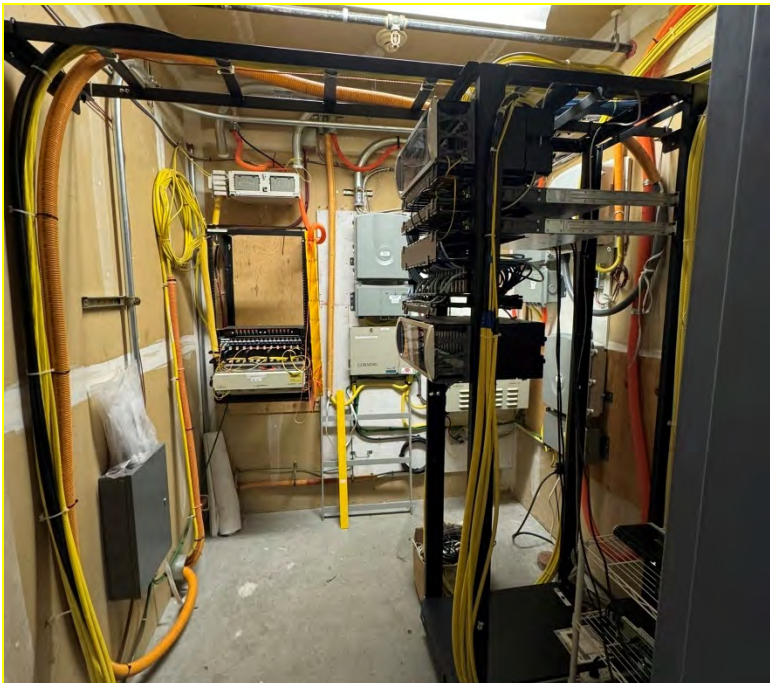
Currently, some of these rooms have ventilation fans that appear to be near the end of their life cycle. Hydronic or DX fan coil units can be added in order to offset the heating load presented by the electrical equipment, especially in the main electrical room. While on site the warmest spaces were the IT and electrical rooms accessed from the catwalk.

Catwalk level IT closet

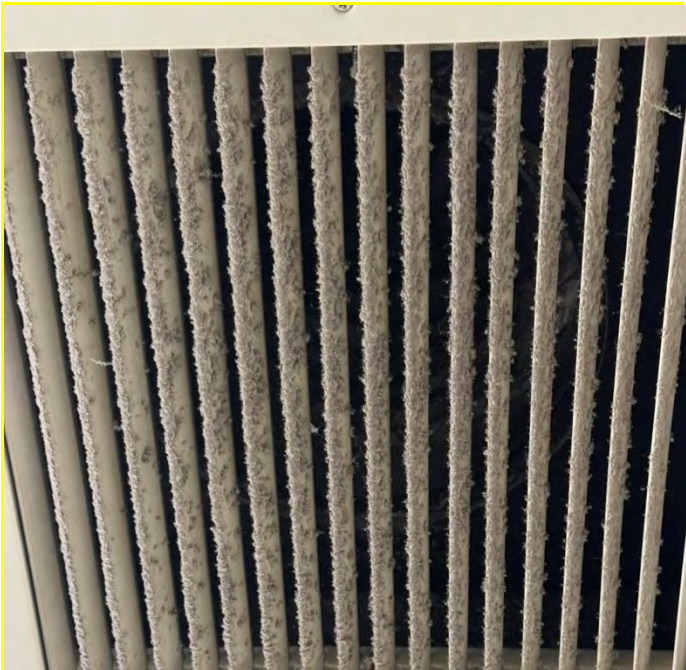
It was observed that the arena’s diffusers and grilles are likely original, and many diffusers have noticeable paint peeling, grease, and dirt build up, and should be cleaned and replaced if necessary.

Dirty exhaust grille

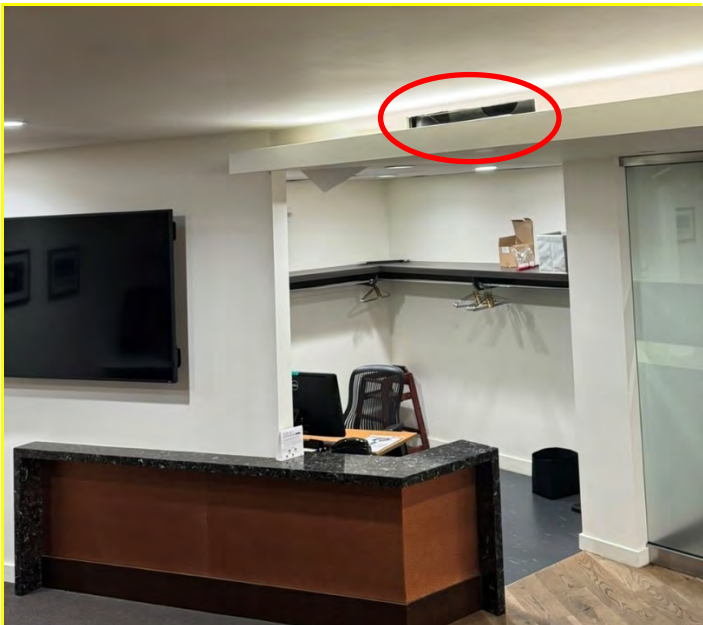
In one of the larger premium areas on suite level, there was a missing diffuser.

Missing diffuser

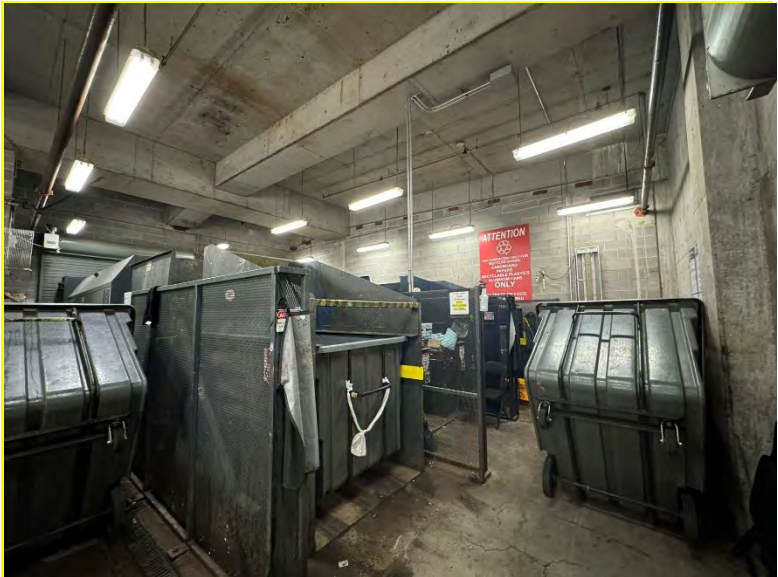
The main trash/recycling room on the service level is not currently conditioned. In similar sports facilities it is typical for these spaces to be provided with a dedicated fan coil to condition the space during the summer months and to help reduce the negative impact of harsh odors.

Unconditioned trash/recycling room

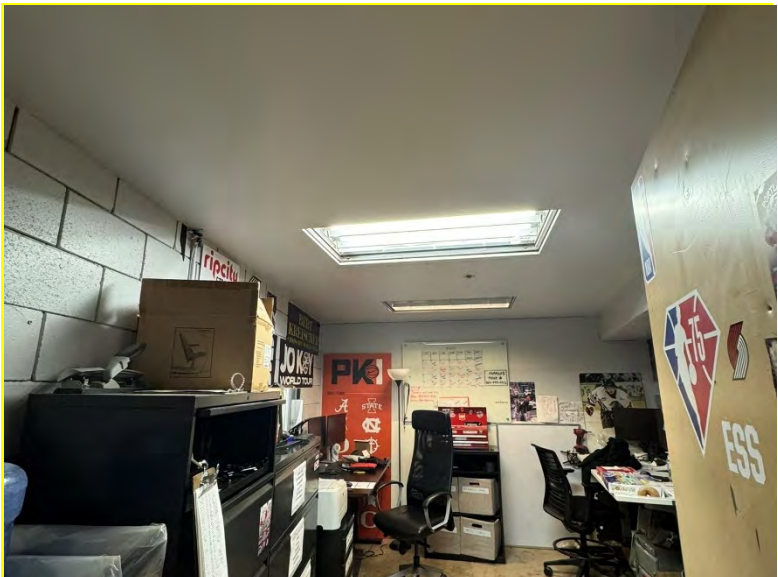
While on site, we observed an office space that appears to originally have been a storage space. This office was set up with two workstations and there was no form of space conditioning or ventilation air supply being delivered to the room.

Unconditioned office

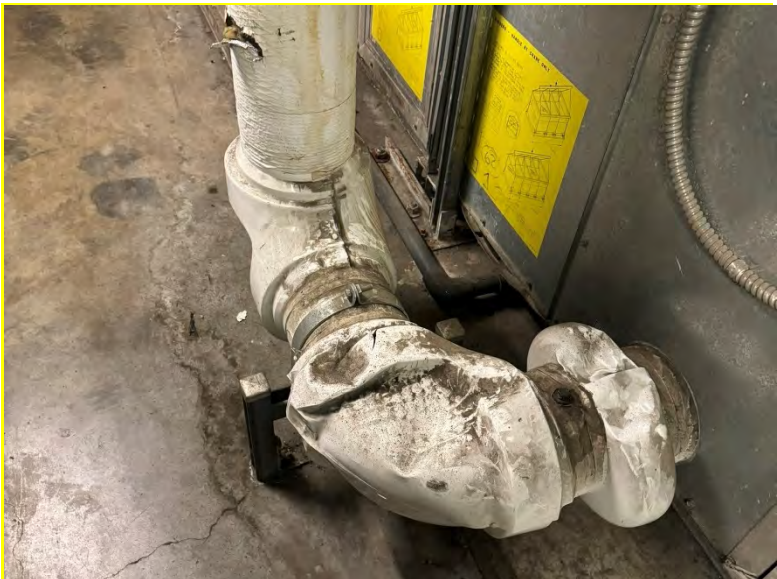
We observed several locations of damaged insulation on both piping and ductwork.

Crushed pipe insulation

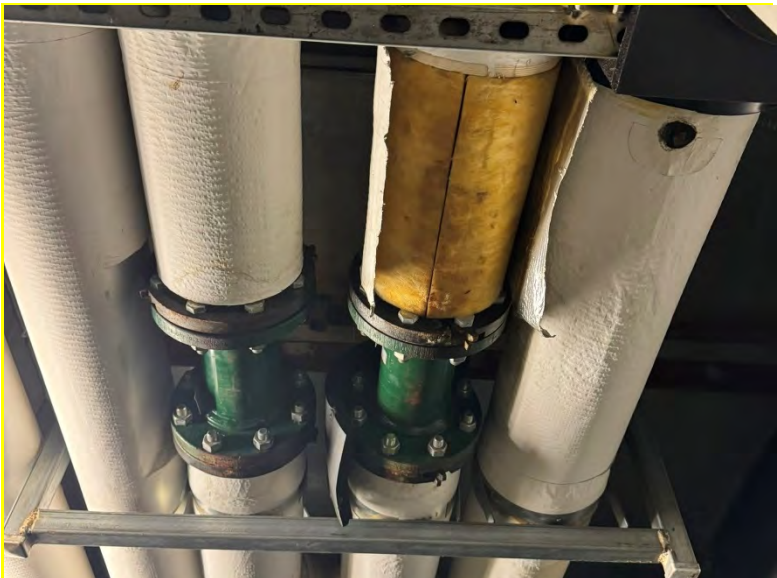
Damaged pipe insulation

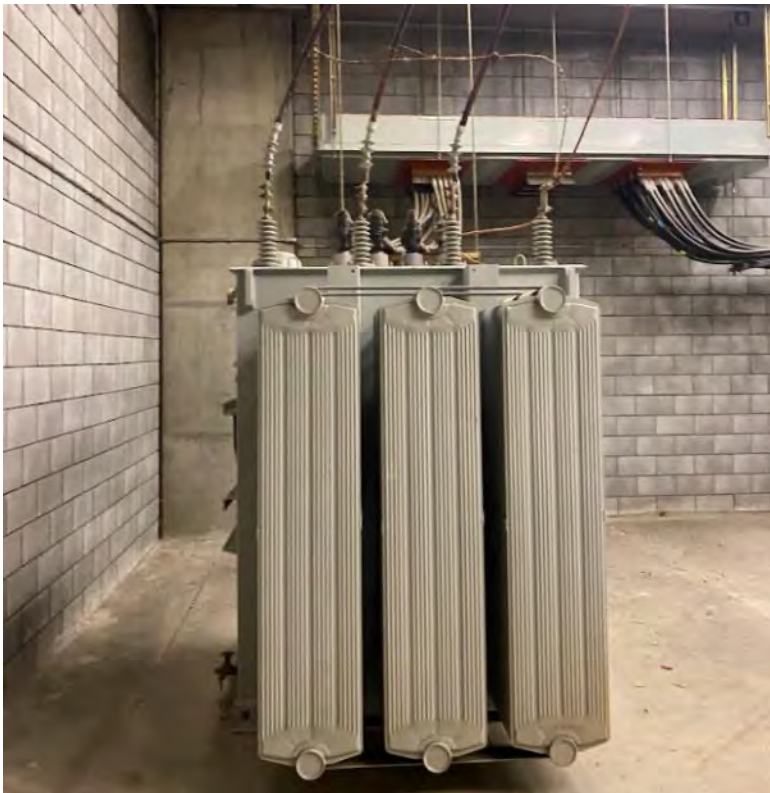
The electrical utility distribution, manufactured by G&W Electric, has a dedicated vault with two 2,500kW, 12470/480V, 3ph utility transformers that feed into the main electrical room via a collector bus. This equipment was observed to be in good condition and is original to the construction of the arena. Utility power is fed from one 12.47kV, 3ph feed from Pacific Power without the capability to transfer to a secondary utility feed in the event of the main utility failure.

Utility transformer

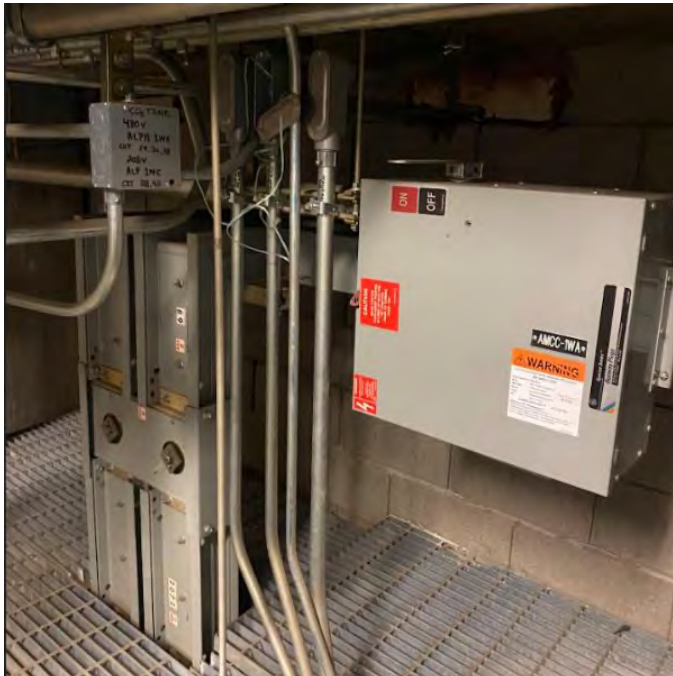
Bus duct is utilized in all four north, south, east, and west riser electrical rooms for concessions, general power, and emergency power. No issues were noted during the walkthrough, but debris and water intrusion over the years, along with new penetrations made in existing electrical rooms, could eventually cause the bus duct to fail and result in a loss of power to a large portion of the arena if not corrected.

Bus duct riser

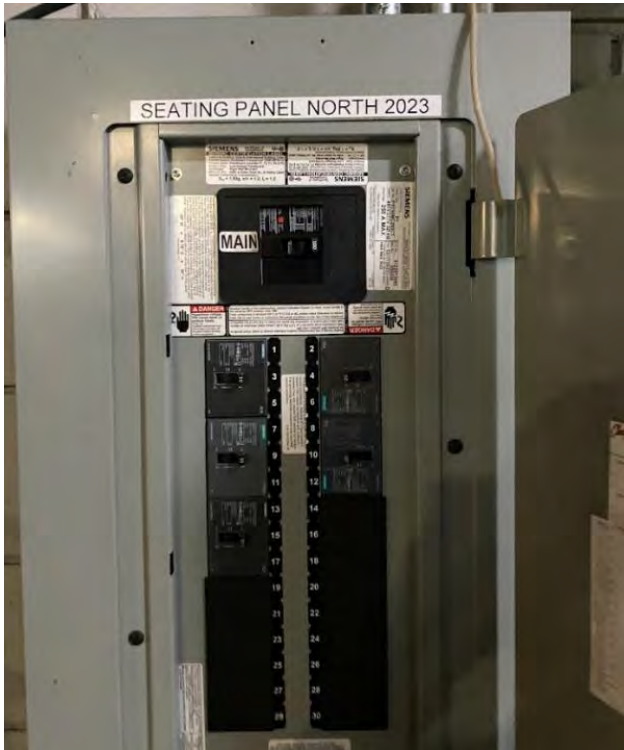
New electrical equipment for retractable bowl seating was installed in 2023 and includes a 250A, 480/277V, 3ph panel in each quadrant of the arena. While this equipment is in good working condition, it has been reported that the motors have bent the metal seat framing causing damage to the seating structure.

Typical retractable seating panel

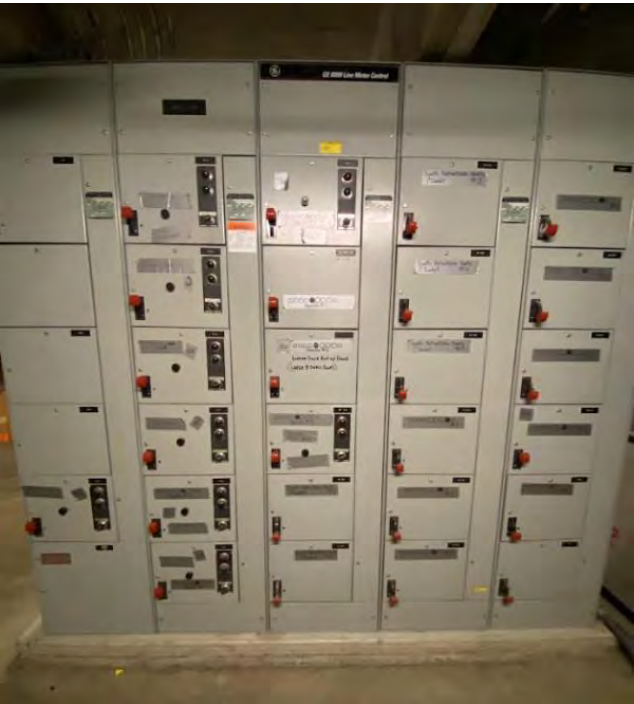
The motor control centers (MCC's) are original and are in fair condition. As equipment continues to be replaced these boards will be replaced by standalone starters VFDs.

Typical motor control center

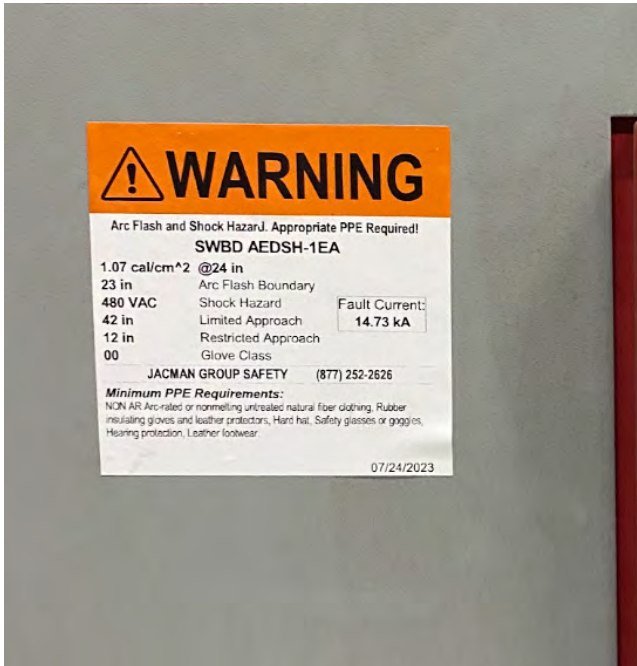
Typical arc flash label

Facility staff stated the maintenance contract for the majority of electrical equipment to be through Christianson Electric but is now mostly through GE. There was no record of infrared scanning at the time of the assessment. We recommend performing infrared scanning every three years on all major equipment in order to identify any damaged or failing electrical devices. Arc flash labels were located on all equipment and were last performed in July of 2023. An updated study should be performed again after any major renovation is complete to ensure accurate safety labels on all electrical equipment.

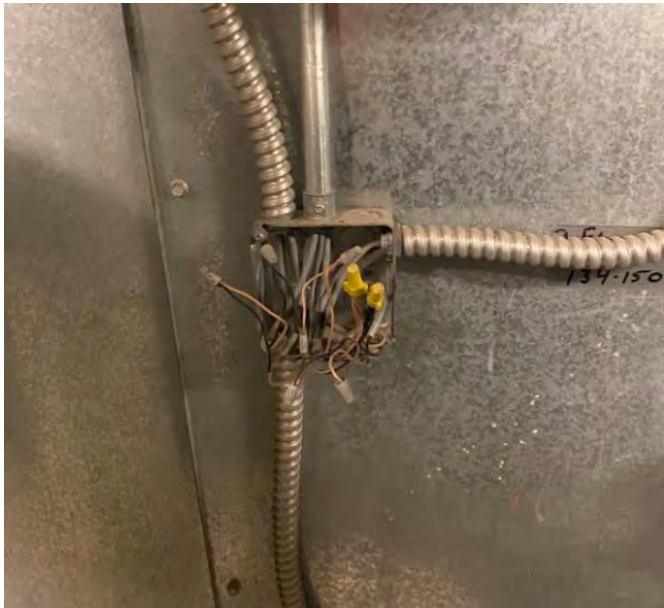
It was observed in several locations junction boxes or pull box covers were missing, exposing live conductors, which creates a safety hazard for anyone working on or near this equipment. Missing covers should be replaced to contain conductors after any work is performed in that area.

Example of exposed junction box

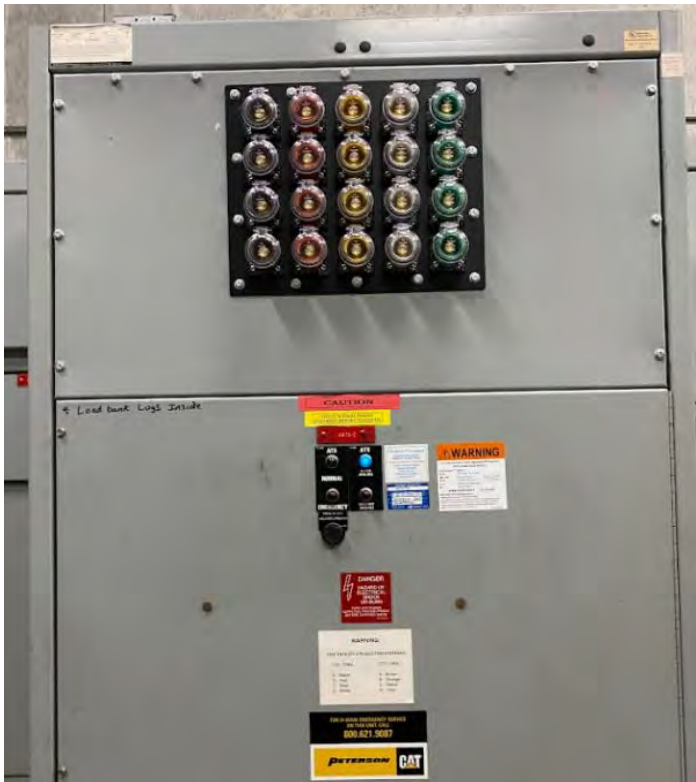
AATS-1, 2, and 3 are located within the same room as the emergency generator while AATS-4 is located in the fire pump room at the south side of the arena. The generator maintenance contract is through Peterson CAT and is scheduled for monthly visits. It appears that load bank provisions have been added to the largest ATS (AATS-2, 2,500A) which is beneficial for testing the true performance of the generator. Recent tests include load bank testing, a full diesel fuel replacement, and battery testing. It should be verified that the load bank testing is taking place with records provided to staff for record tracking.

AATS-2 with load bank connections

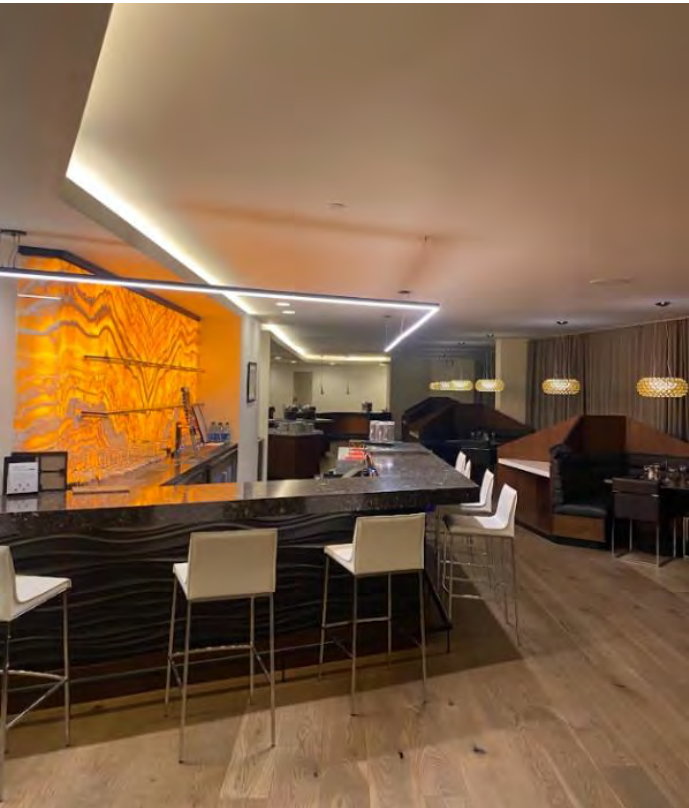
The clubs and renovated suites contain unique LED decorative fixtures that are difficult to replace due to long lead times and the various manufacturers. It is likely that the fixture drivers are the main point of failure for these types of fixtures.

Club light fixtures

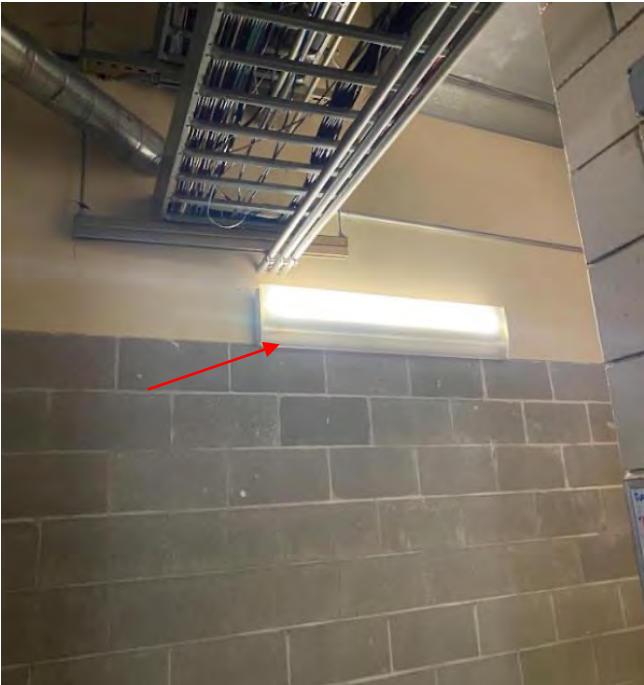
Original lighting in the arena consists of non-LED fluorescent, incandescent, or halogen fixtures. However, the electrical staff have systematically changed fluorescent lamps to LED in certain high use areas such as concourses, vomitories, and player/coaches areas. Most fluorescent tube fixtures have been replaced with LED tubes as the original fixtures burn out. The fixtures in the parking garage have also been recently replaced with high output LED fixtures with field selectable color temperatures. Issues with the existing interior lighting include broken lenses, non-operational ballasts, and aging fixtures that have irregular color temperatures.

Burned out wall mounted fixture

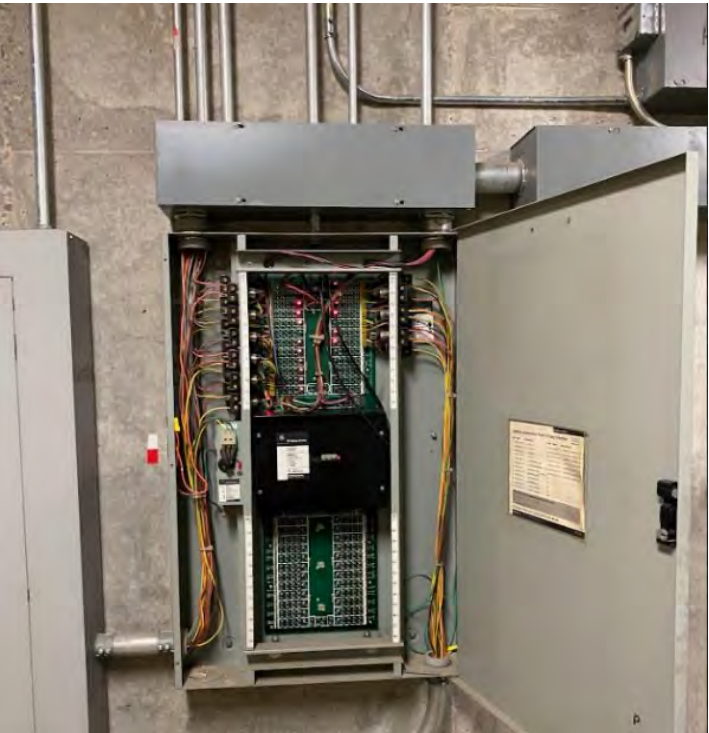
The lighting control system is mostly original and in need of replacement. The controls are very limited and only include GE contactors to sweep lighting on/off. All dimming is localized 0-10V Lutron wall dimmers, with the exception of the club level where there were ETC UNIOSN dimmer racks installed to control a select portion of the general lighting on club level. Local dimming is very limited to locations such as suites, clubs, player areas, and broadcast areas. SAMJIN Smart LED control touchpads have been added to select player areas with the ability to adjust brightness, color temperature, sensor settings, and on/off control.

Typical lighting contactor cabinet

While no issues were noted, the entire system has become out of date and obsolete making it difficult to find replacement parts as components begin to fail. The arena does have a networked lighting control platform, WinControl, that is accessed on the 7<sup>th</sup> floor in the production studio and is original. This system can remotely open and close contactors for specific areas of the arena but lacks the capabilities of a more modern networked lighting control system. Occupancy sensors are installed on service level fixtures and most exterior fixtures are controlled via a photocell, but additional occupancy, timeclock, daylighting, and site controls will be required for any major renovation to meet new energy code requirements for ASHRAE 90.1 or IECC.

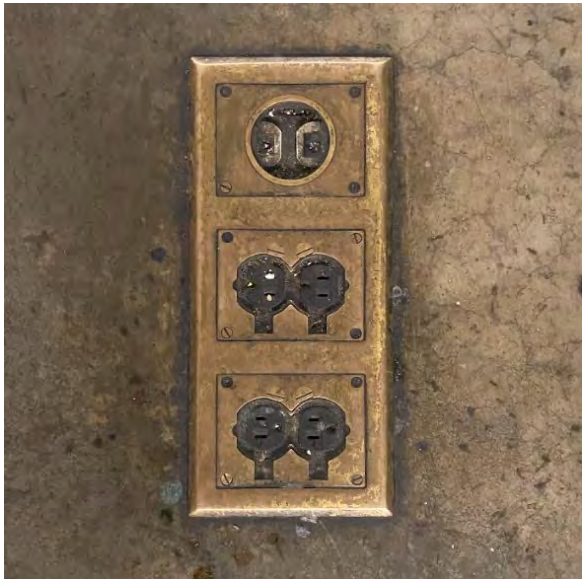
The main and upper concourse levels have power distributed throughout for food service. Dedicated panels and receptacles have been added over the years to accommodate the increased number of portable concessions, including the 2023 addition of several Blaze Thru Grab-N-Go markets. Facility staff noted that there is adequate power throughout for concessions, but many of the poke-thru devices are original and damaged.

Damaged poke-thru receptacle on concourse

- Replace the floor power devices on interior concourses that can provide reliable temporary power when needed during event days.
- Replace outdoor covers and devices as needed to ensure they maintain the weatherproof rating and avoid nuisance tripping.

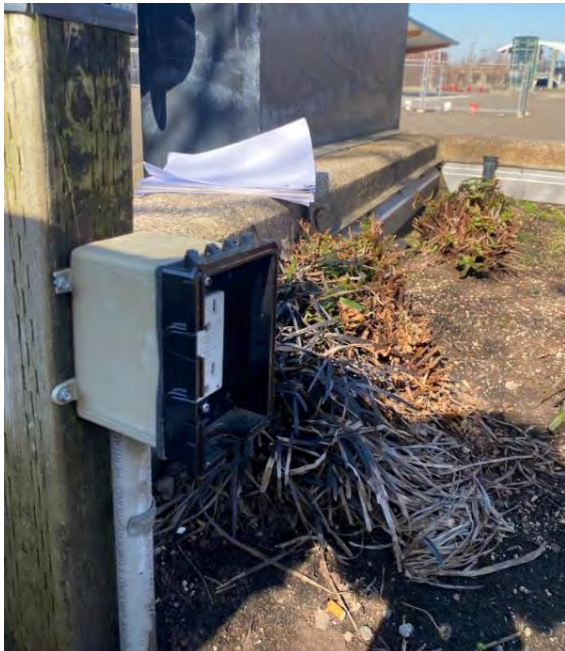
While there is adequate power for temporary connections throughout the exterior plaza and garden areas, many of the weatherproof devices have been damaged or are missing their protective covers.

Missing weatherproof receptacle cover

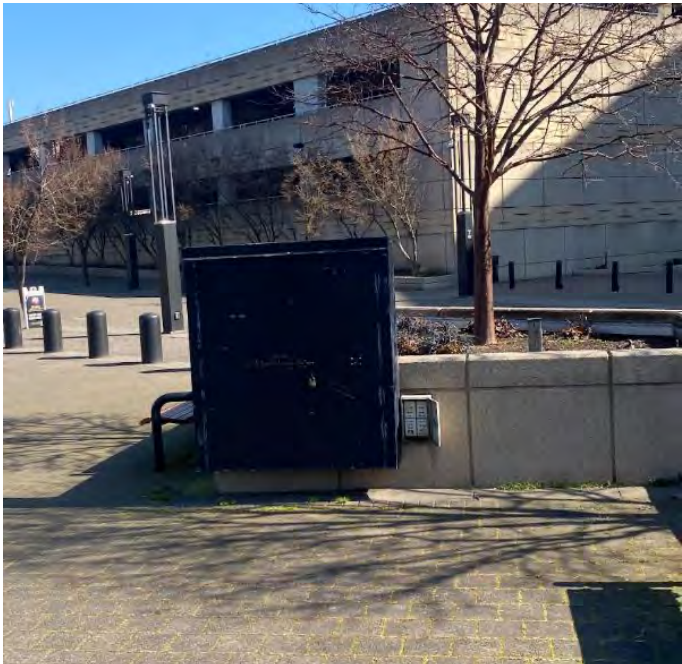
The plaza contains an outdoor performance space along with a NEMA 3R rating cabinet containing temporary points of connection. While there was no access to the inside of this cabinet, facility staff has not needed additional power.

Exterior show power NEMA 3R cabinet

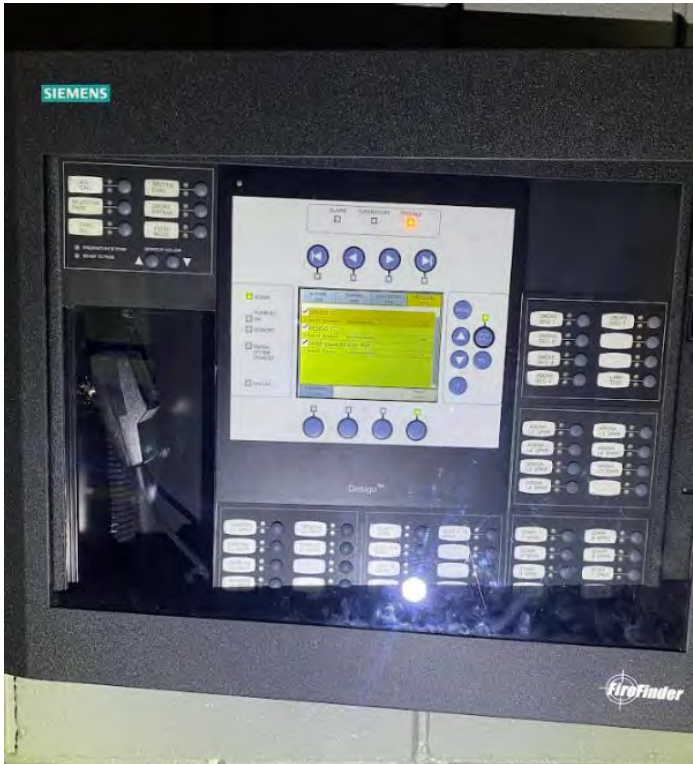
The fire alarm system was upgraded within the past two years to a Desigo system manufactured by Siemens. The fire alarm devices throughout the arena are mostly original. The new Siemens cabinet is located in the fire command area on the event level and is in great condition. The Desigo building management system (BMS) is also located in the fire command room and had three trouble messages during the time of the assessment. Facility staff noted that frequent false trouble messages occur due to the systems sensitivity to utility power surges.

Siemens fire alarm cabinet with trouble message

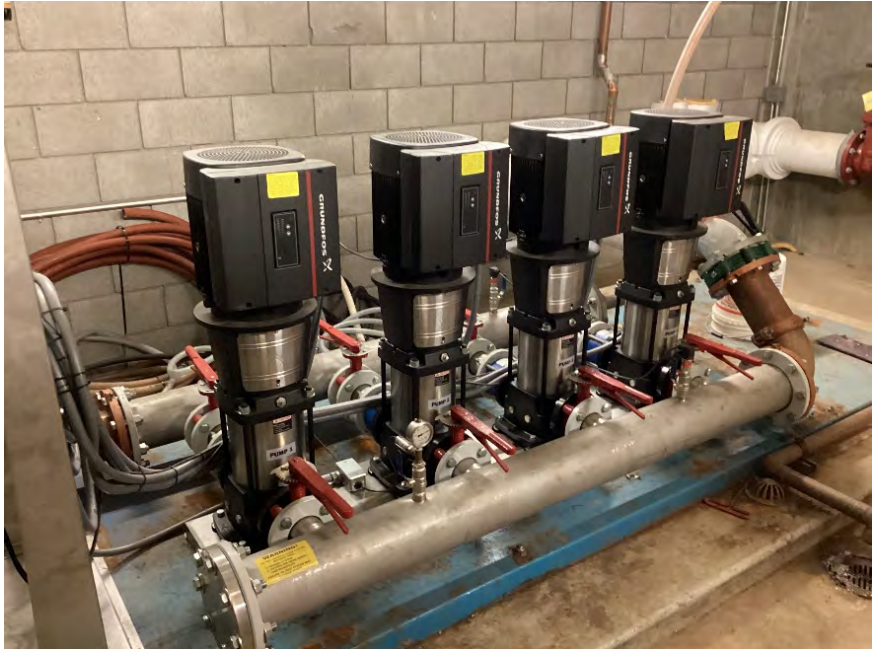
Quadraplex domestic water booster pump skid

The arena's domestic cold water is served by a Grundfos Hydro MPC-E 4 CRE 32-2 variable speed packaged booster pump skid. Each of the four pumps are 10 HP, sized for 180 ft. of head and a flow rate of 158.5 gpm. The entire skid has a maximum flow rate of 845 gpm. Variable speed motors allow for more efficient distribution during low flow periods.
