# Facility Condition Assessment

Draft Report

May 14, 2024

# Facility Condition Assessment Moda Center & Garden Garage

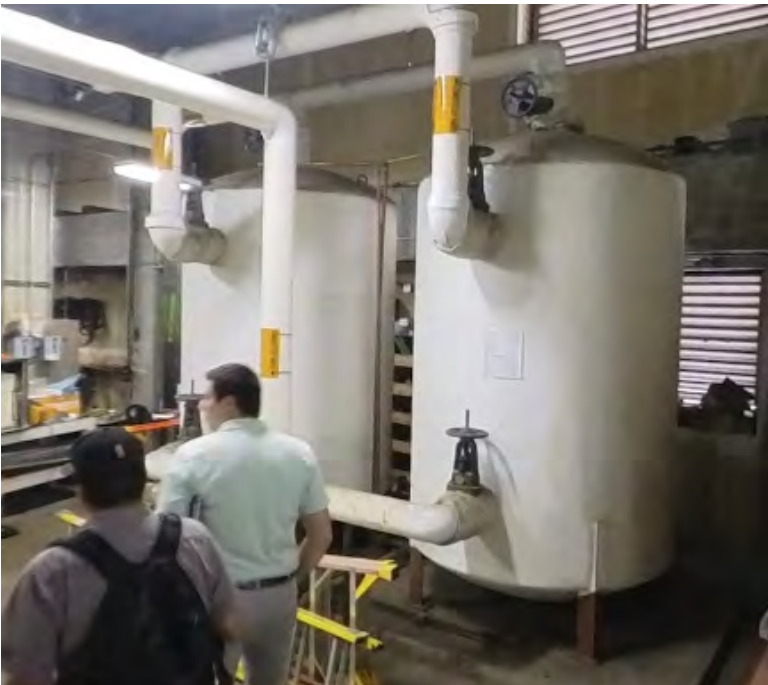
Domestic hot water storage tanks on club level

Two Hanson Mfg. 1,500-gallon vertical hot water storage tanks provide a buffer for periods of high hot water demand. The storage tanks are original.

- Continue to perform regular maintenance on major plumbing equipment.
- The hot water storage tanks do not currently pose any issues to facility maintenance staff, but they have outlived the typical useful life. It is recommended to clean and inspect the interior of the storage tanks to further assess their condition.

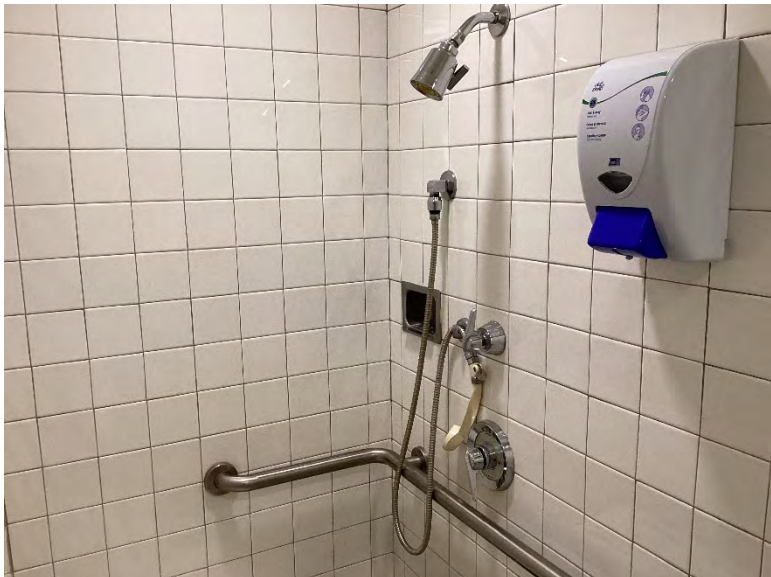
Typical shower at star rooms on the event level

Most of the showers, both individual and communal, are beginning to show their age. Several fixtures in star rooms had audible water hammer when we operated the shower valves.

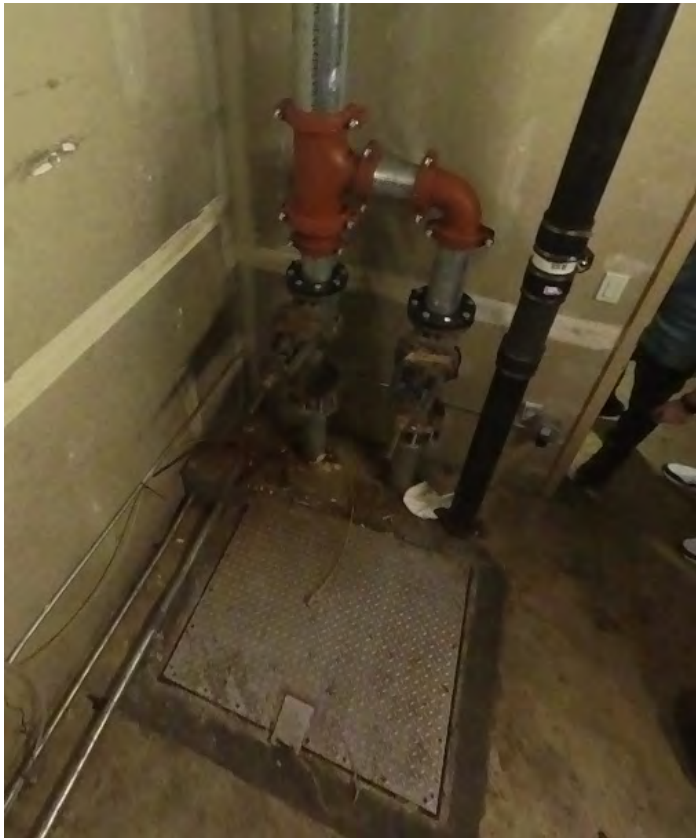
Ejector pit 1 on event level

Piping has recently been replaced. The original duplex ejector pumps have also been replaced within the last 10 years.

The pit in the SE portion of the arena had a very noticeable sewer smell.

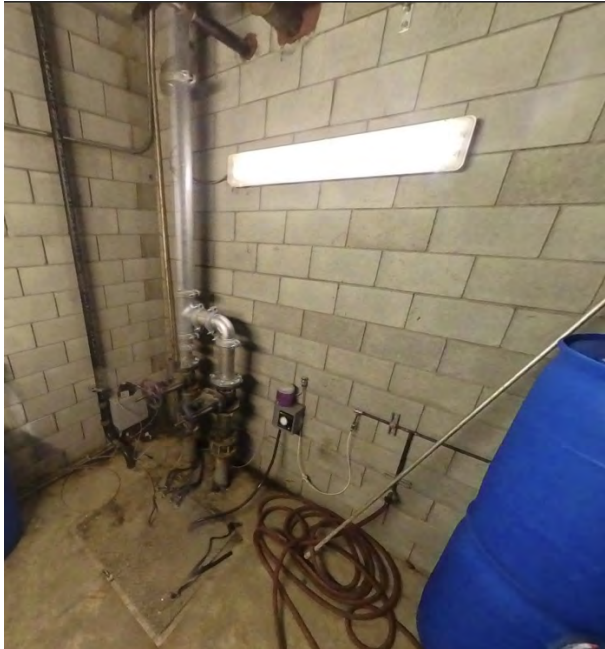
Ejector pit 2 on event level

This pit in the SW portion of the arena did not have a noticeable sewer smell.

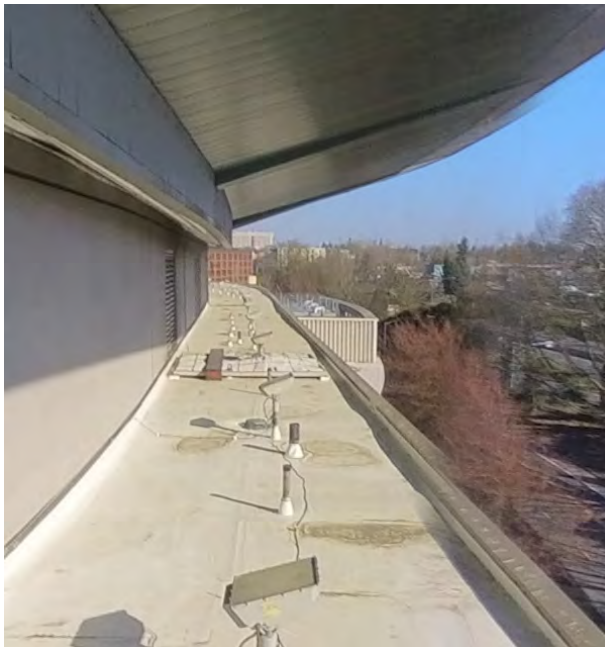
Vents and roof drains on level 7 intermediate roof

Roof drains appeared clean and functional on the intermediate roof. The main roof was not easily accessible at the time of assessment.

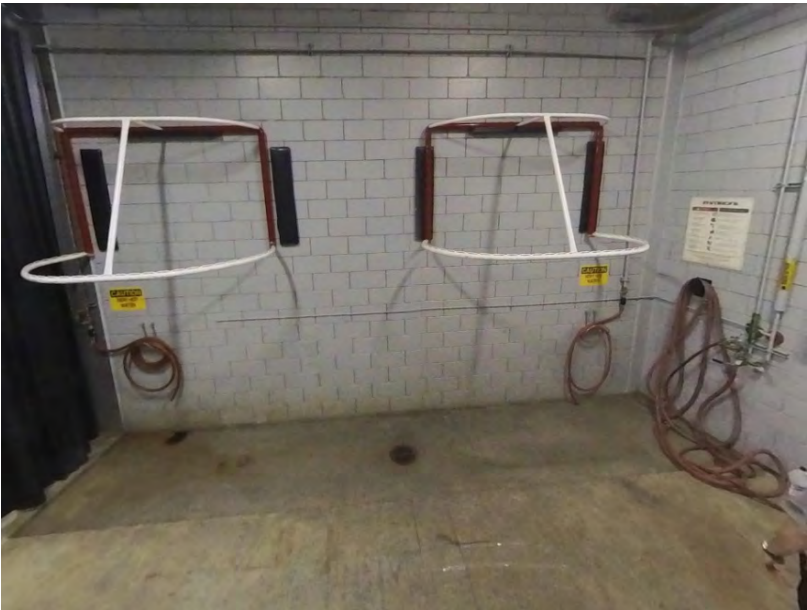
Abandoned ice melt area on event level

Facility maintenance staff mentioned that the ice melt area is no longer used. The water hookups have been used for star laundry during concerts.

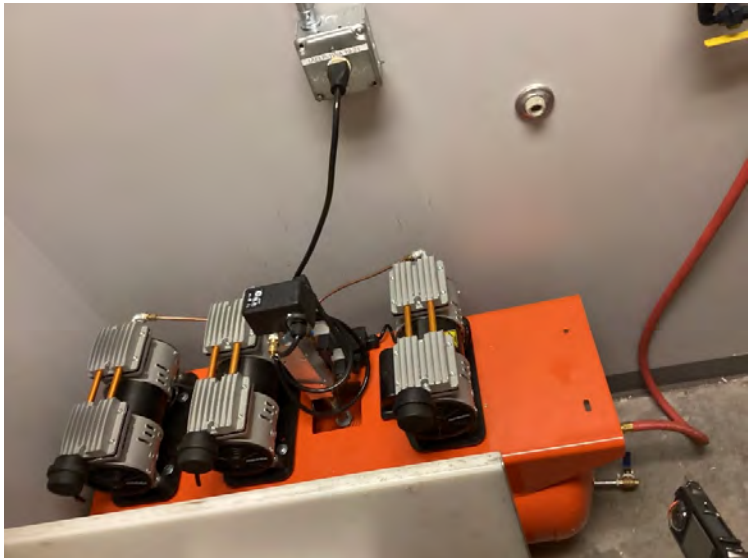
Air compressor serving dry sprinkler valve recently replaced

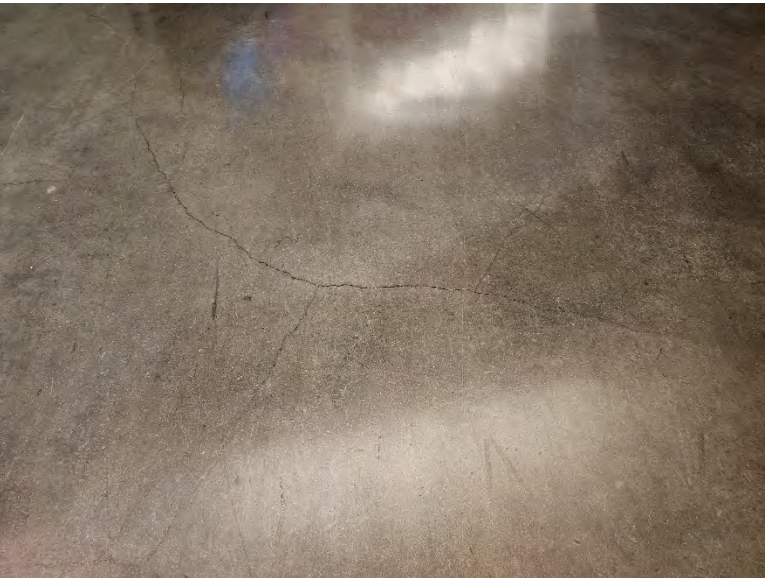
The concrete topping slab was typically coated in what appeared to be an epoxy finish coating, which was not original construction, and which coated over previously formed cracks in the topping slab.

Upper concourse (Section 311) topping slab with a clear finish coating over existing cracking

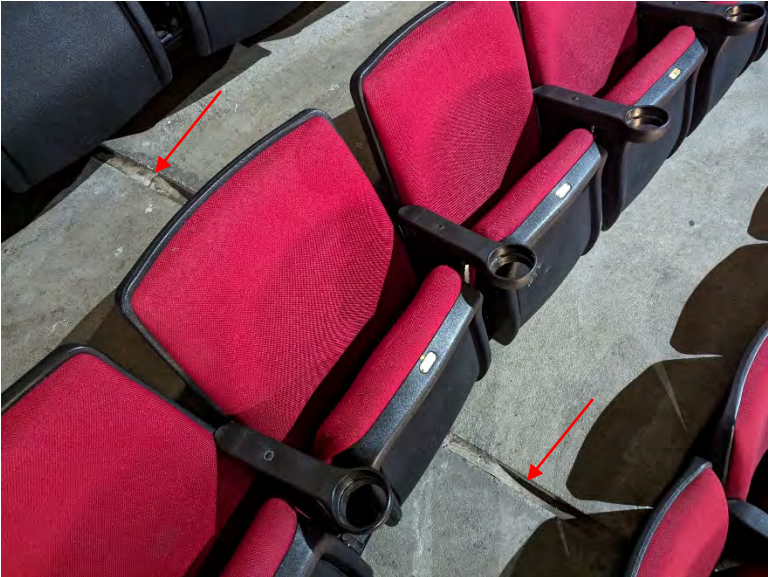
The lower, middle, and upper seating bowl areas are coated with a pedestrian grade coating. Throughout the seating bowl, joint sealants and cove sealants have generally failed at horizontal and vertical substrates. Some of the joint sealants appeared to be urethane joint sealants with a width of greater than 1” wide. This is typically wider than the maximum allowable joint width for urethane joint sealants, so silicone joint sealants should be considered during replacement. However, silicone sealants are not compatible with urethane sealants, and that would have to be considered during the design phase. We recommend replacing sealants at seating bowl in in the next three years.

Seating bowl (Section 322) with locally failed joint sealant at seating row

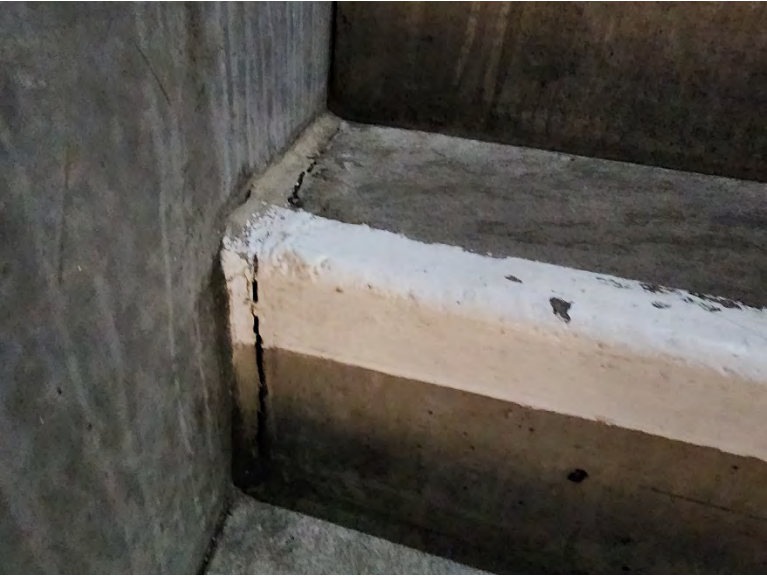
Seating bowl (Section 326) with locally failed cove joint sealant at stairs

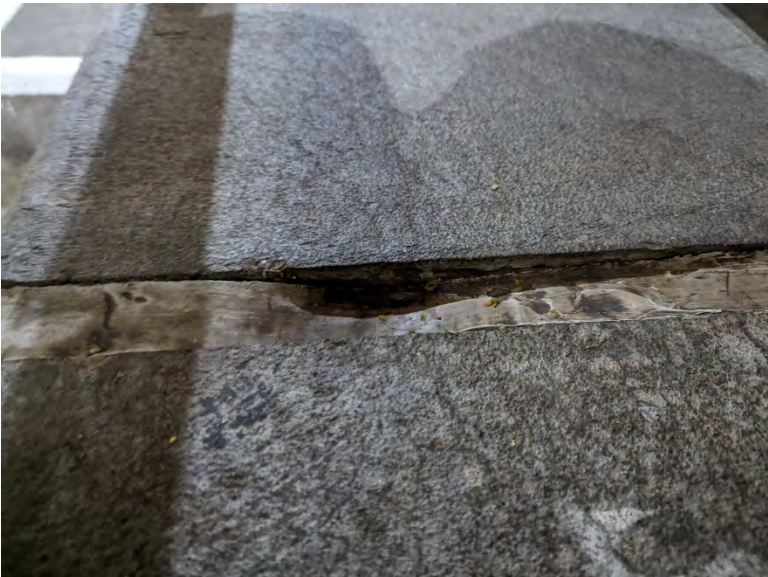
Seating bowl (Section 320) with locally failed joint sealant at seating row

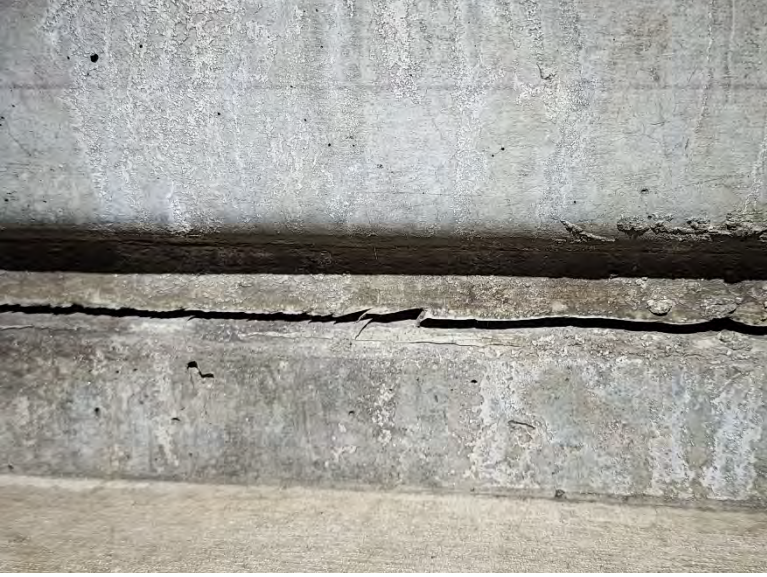
Seating bowl (Section 314) with locally failed joint sealant at stair riser

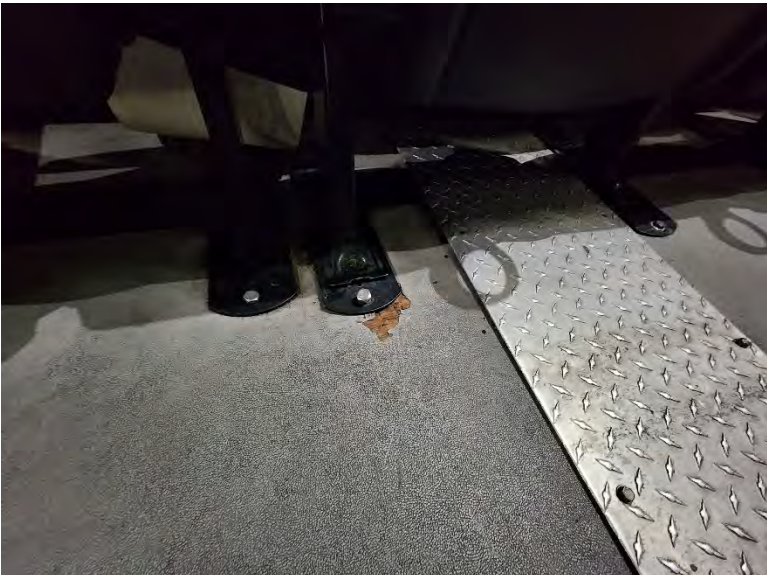
Typically, treads on area seating (i.e., Sections 110 to 114) had metal protection plates installed over trafficable sections of joint sealants and the condition of the joint sealant could not be verified. We recommend installing metal protection plates over exposed trafficable joint sealants to provide protection to sealants.

Seating bowl (Section 326) with installed metal protection plate over joint sealant

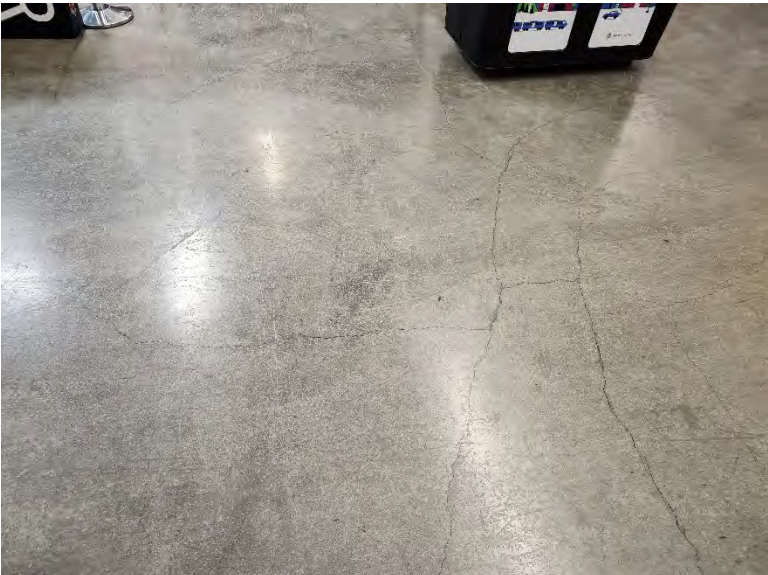
Multiple locations throughout the arena concourse levels exhibited cracking of the concrete topping slab. It appears that a sealer-type product had been applied over the slab and cracks. Some of these cracks appeared to be through-thickness cracks that reflected on the slab soffit. However, no evidence of water intrusion through the cracks was observed. No repair is required at this time.

Preferred level (Section 209) concrete topping slab cracking

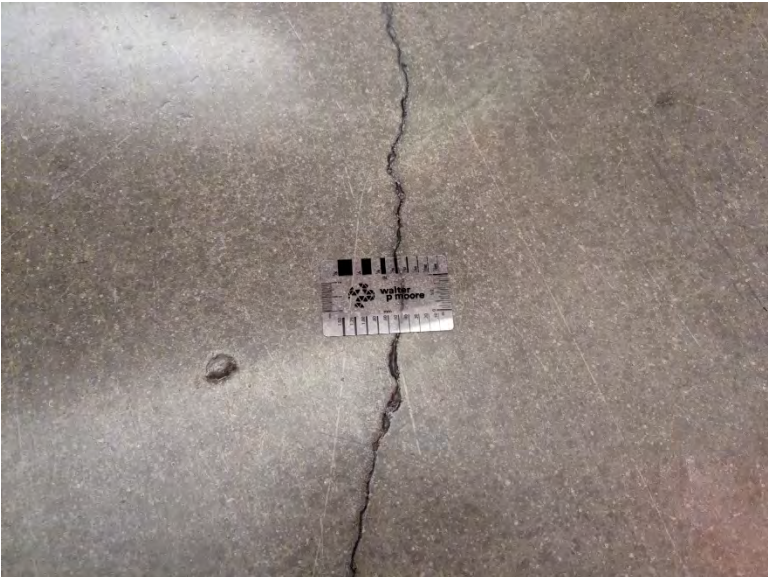
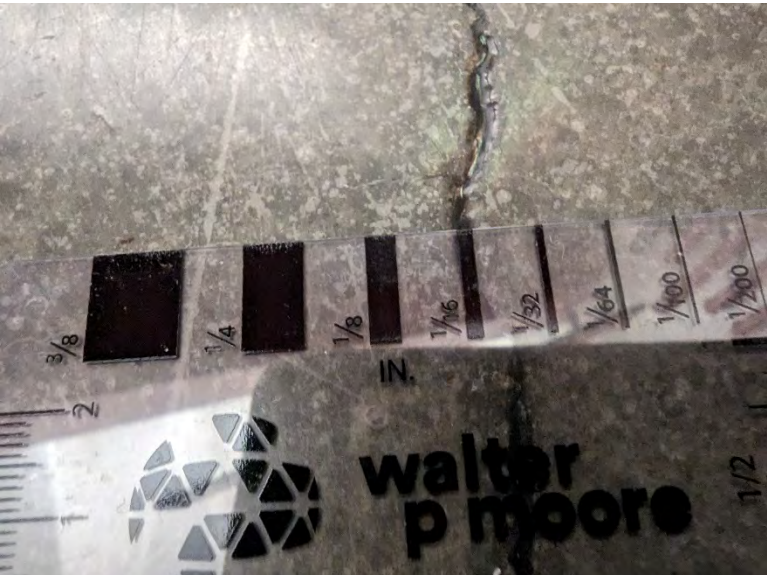
Upper concourse (Section 310) concrete topping slab cracking measured to be 1/16" wide

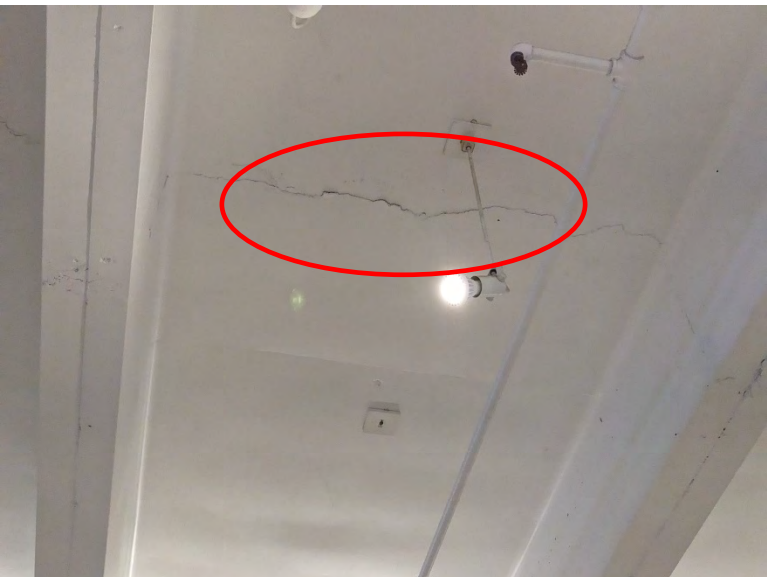
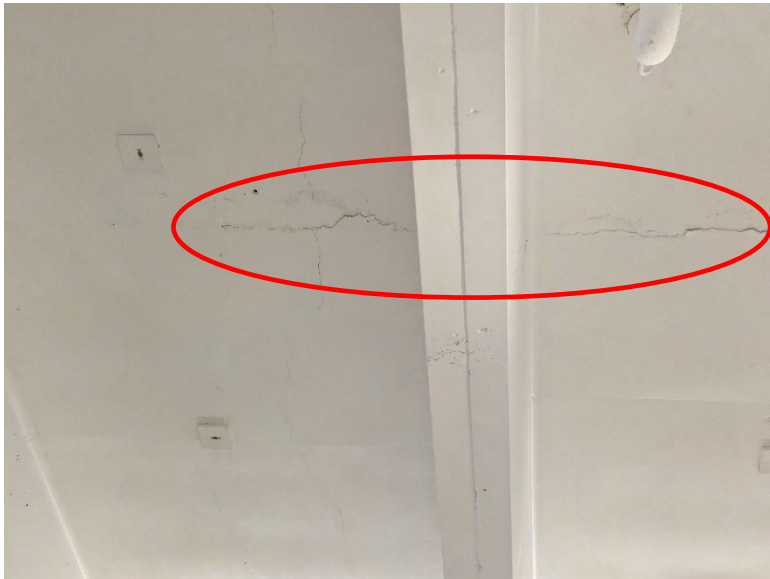
Main concourse (Section 121) concrete pan joist soffit cracking

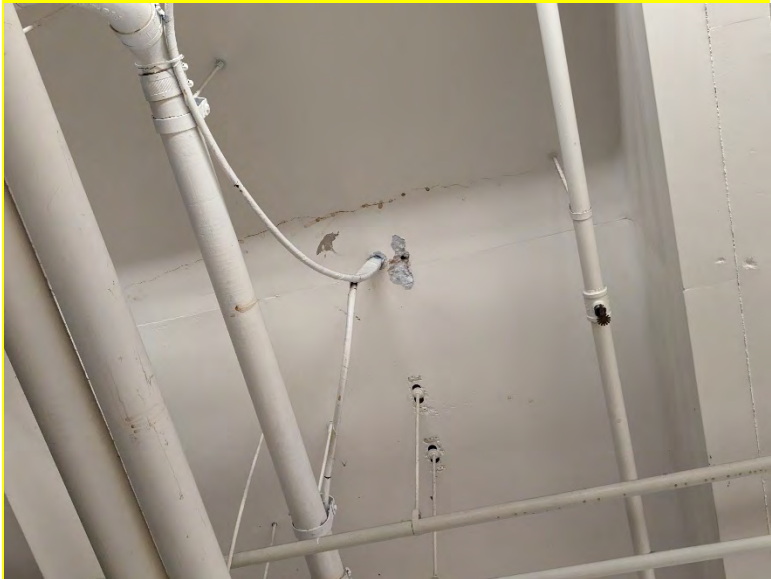
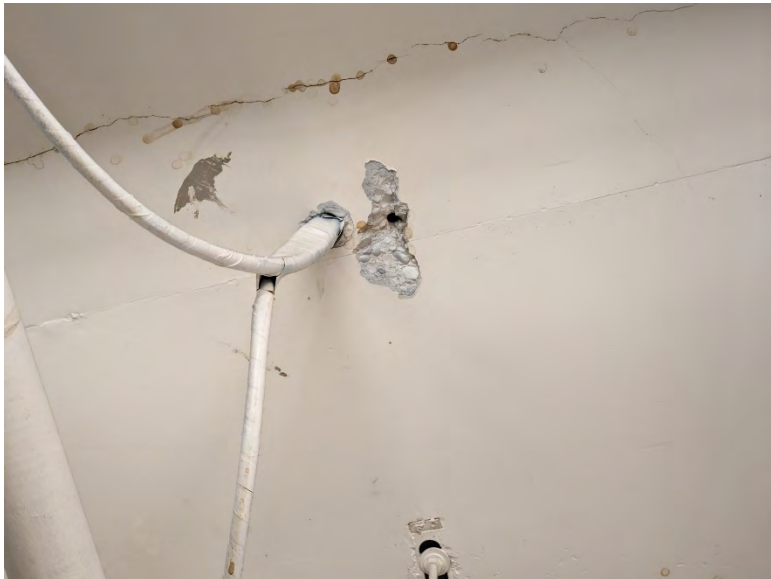
Main concourse (Section 114) concrete pan joist soffit spalls at previous anchor locations

Isolated instances of soffit spalling were observed at locations that appeared to be where anchors were previously removed. We recommend cleaning soffit staining throughout the arena concourse and repair and paint over concrete spalls.

Main Concourse (Section 114) concrete pan joist soffit spalls at previous anchor locations

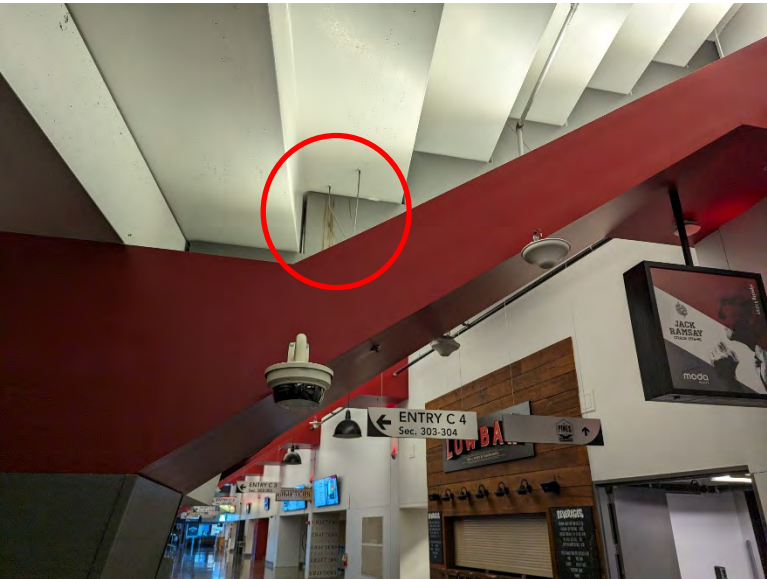
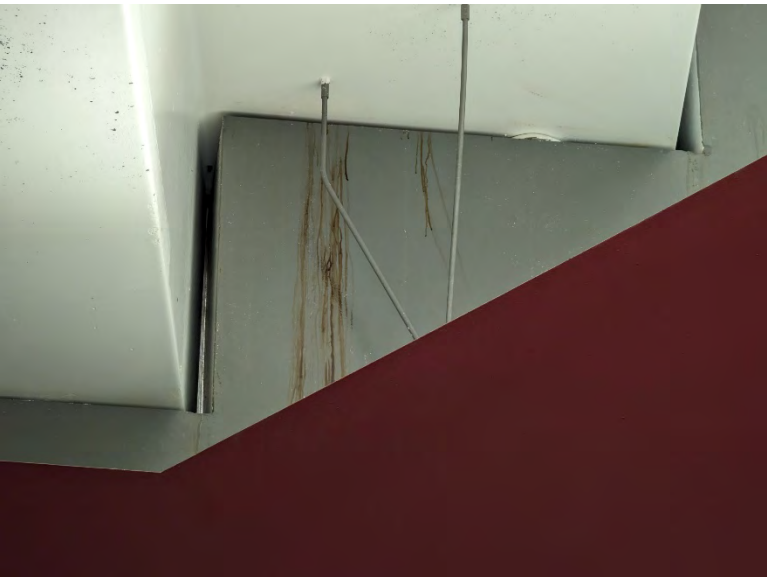
Upper concourse (Section 303) staining at cast-in-place raker

Staining was observed at isolated locations at some concrete rakers. Staining appeared to be a result of leaks from the seating bowl through failed sealants. Replacing sealants in seating bowl should prevent this from occurring.

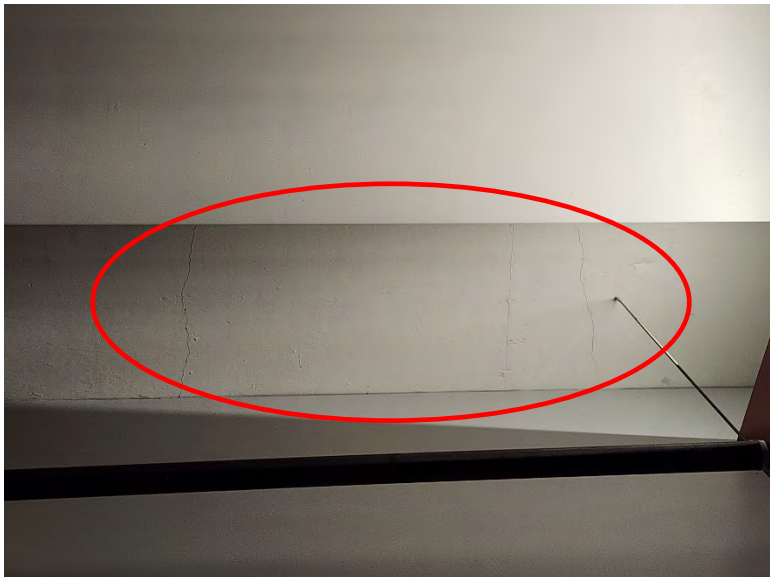
Upper concourse (Section 314) cast-in-place concrete soffit cracking

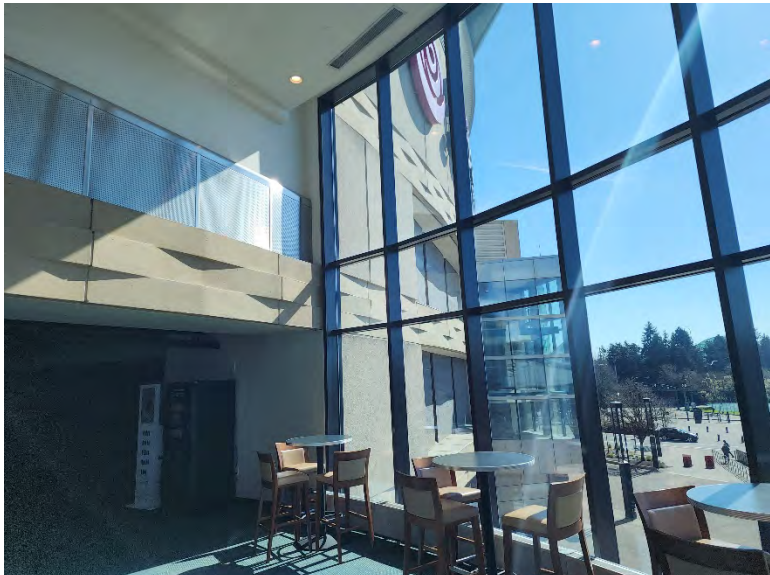
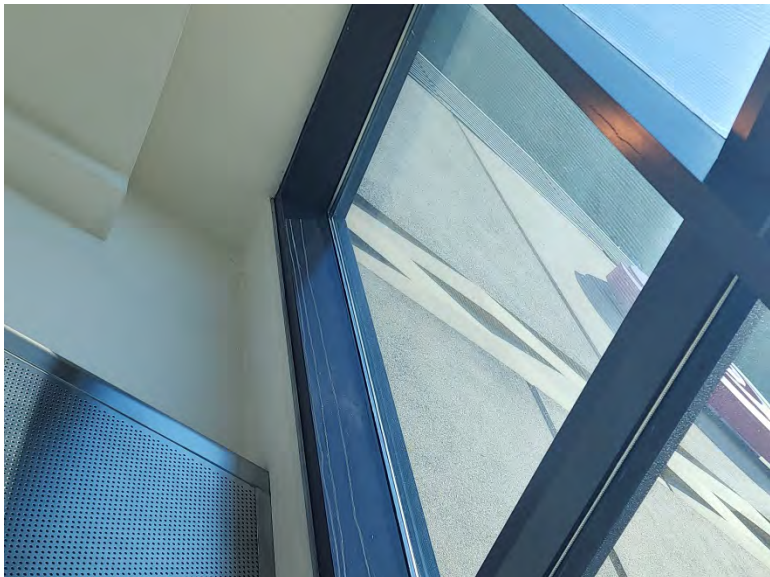
Evidence of water intrusion was observed at a fenestration at the Club Level near section 229. Further assessment is required to determine whether or not water intrusion has occurred at other fenestrations and to determine the cause of the observed water intrusion at the fenestration.

Club Level (Section 229) water Intrusion at fenestration

Club Level (Section 229) water intrusion at fenestration

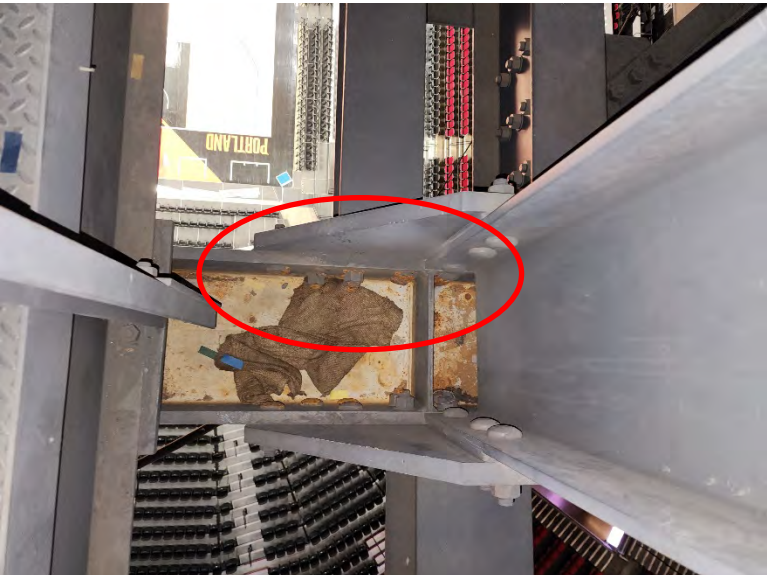
an isolated instance of corrosion at a framing connection located along the inner catwalk and gridline R7. We recommend cleaning and coating the corroded steel framing connection and perform periodic recoating as necessary at isolated locations.

Catwalk level (Gridline R7) corroded steel framing bolt connection

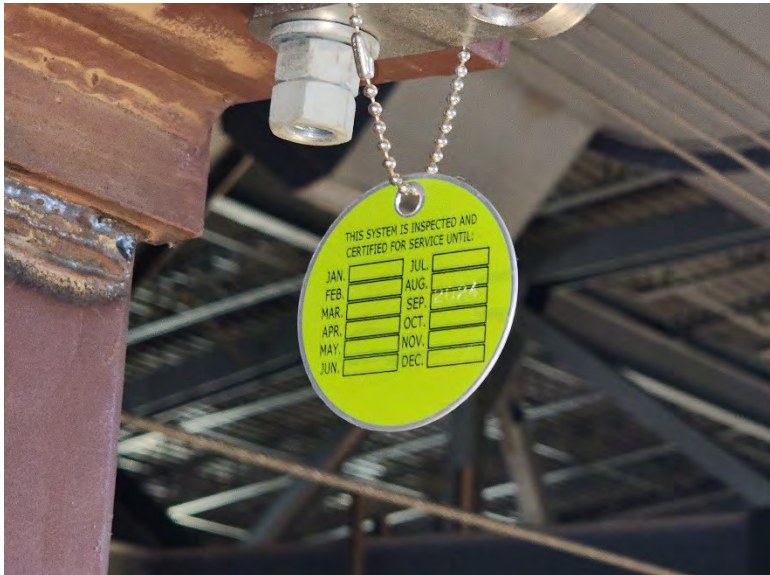
A post-installed fall protection system was observed throughout the catwalk level and is due for inspection in September 2024.

Catwalk level post installed fall protection system due for inspection in September 2024

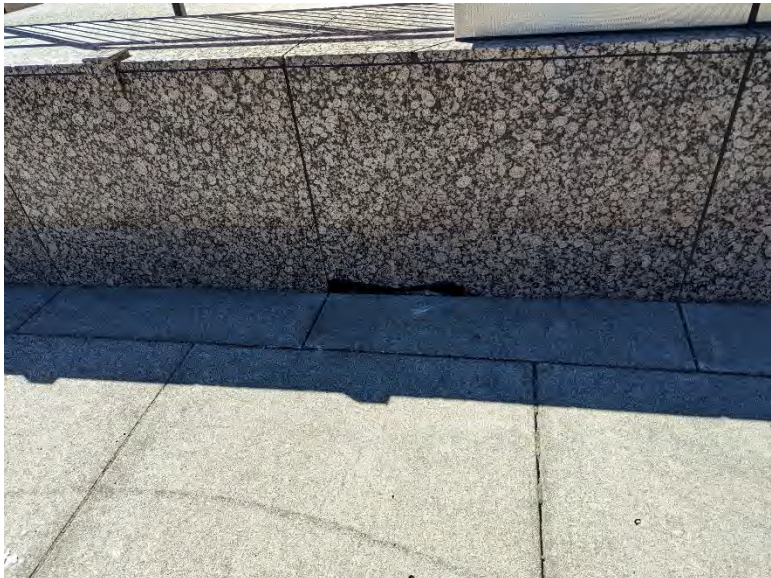
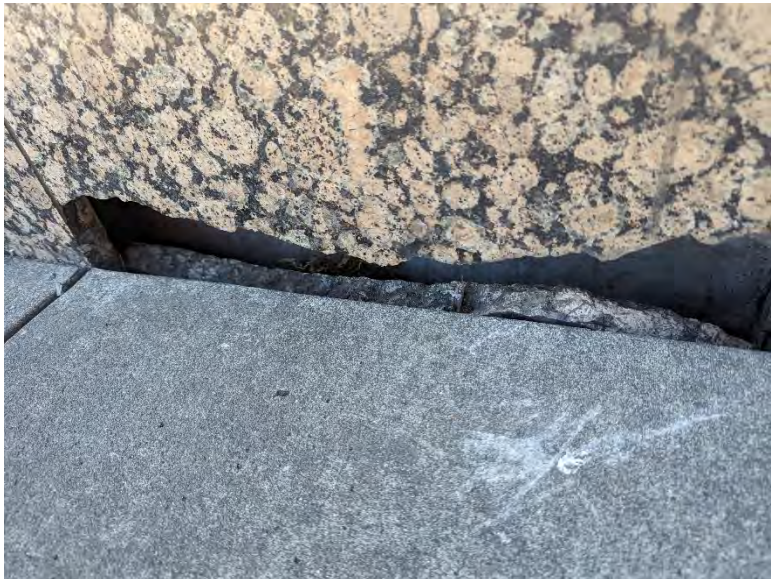
A street level granite façade panel at the East elevation was observed to be spalled. We recommend replacing or repairing the spalled granite panel.

Façade (East façade) with spalled granite façade panel

Façade (East Façade) spalled granite façade panel

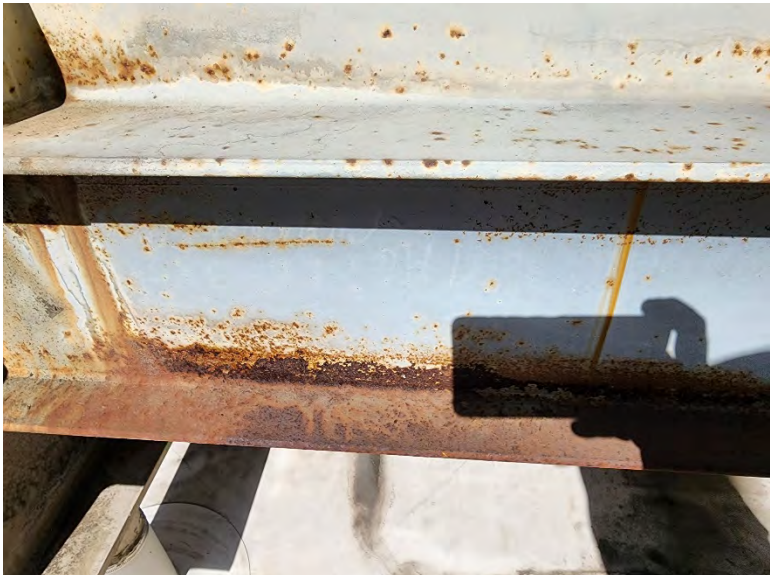
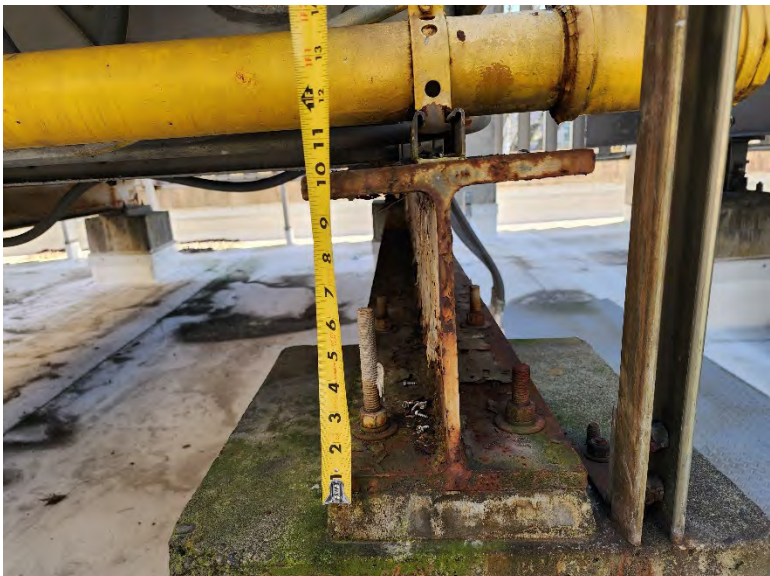
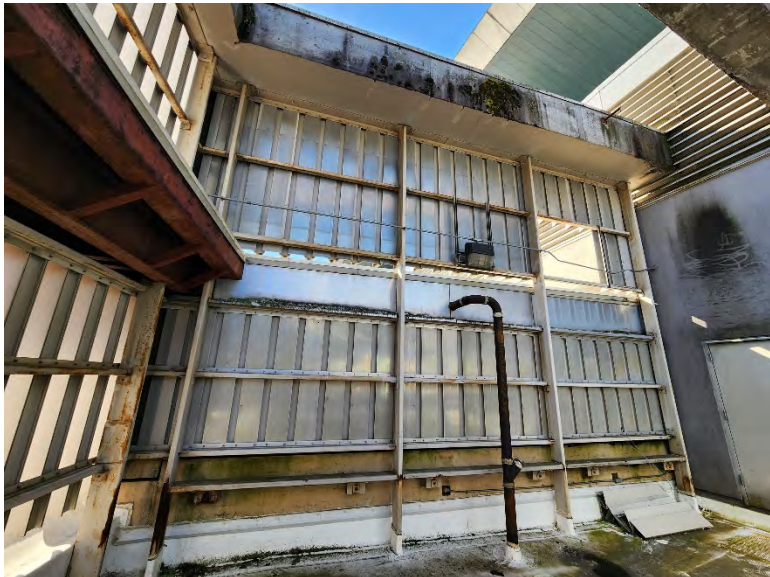
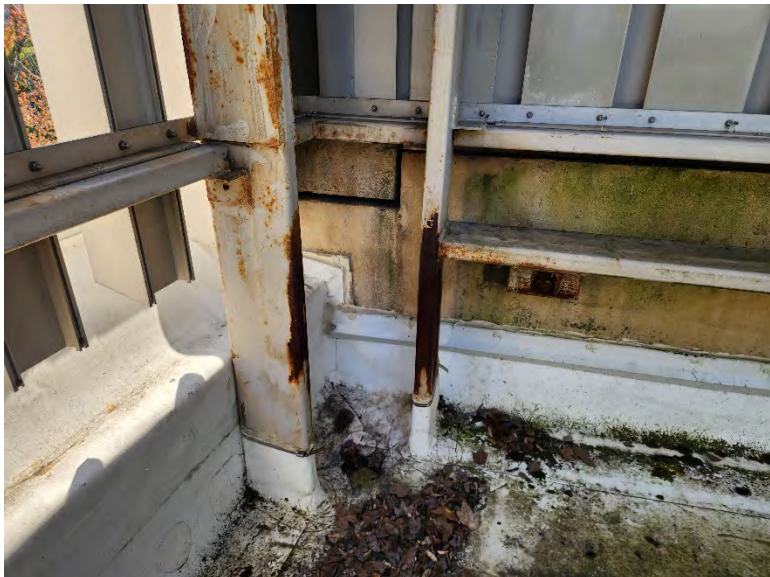
Steel panels and steel framing elements at a roof mechanical area near gridlines R82-FF were observed to be corroded.

Mechanical level (Gridline R82-FF) corroded steel MEP framing beam

Mechanical level (Gridline R82-FF) corroded steel panels

We recommend cleaning and coating corroded steel elements. Steel framing that is found to be exhibiting 10% section loss or greater should be replaced.

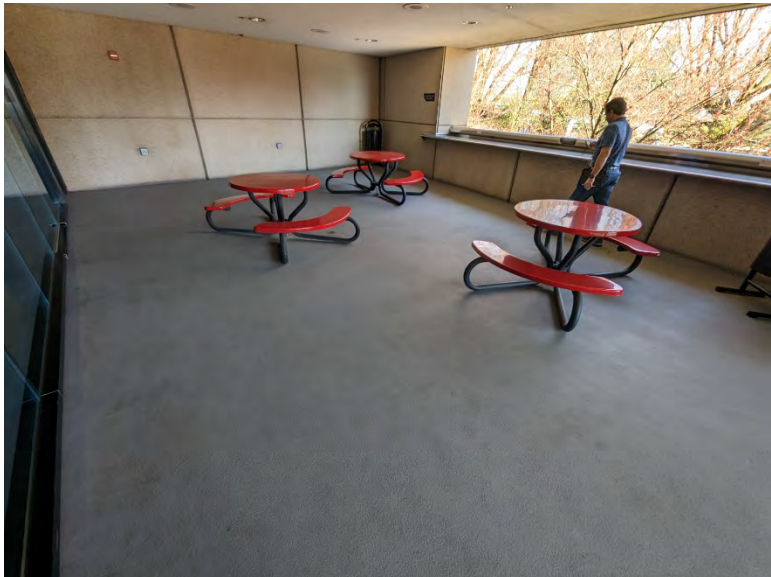
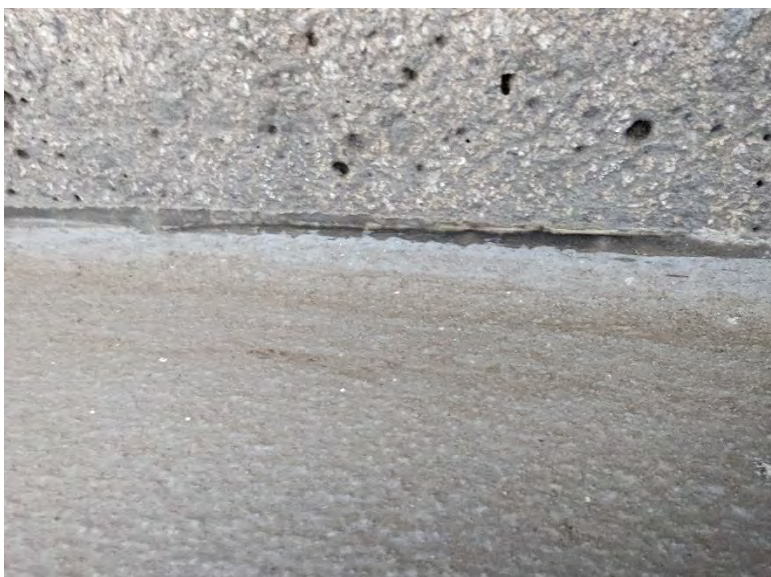
Suite level (Suite 41) plaza annex traffic coating

Plaza annex areas throughout were coated with a pedestrian grade traffic coating that was typically in fair condition. We recommend recoat traffic coating within five years.

Suite level (Suite 41) plaza annex traffic coating upturn termination

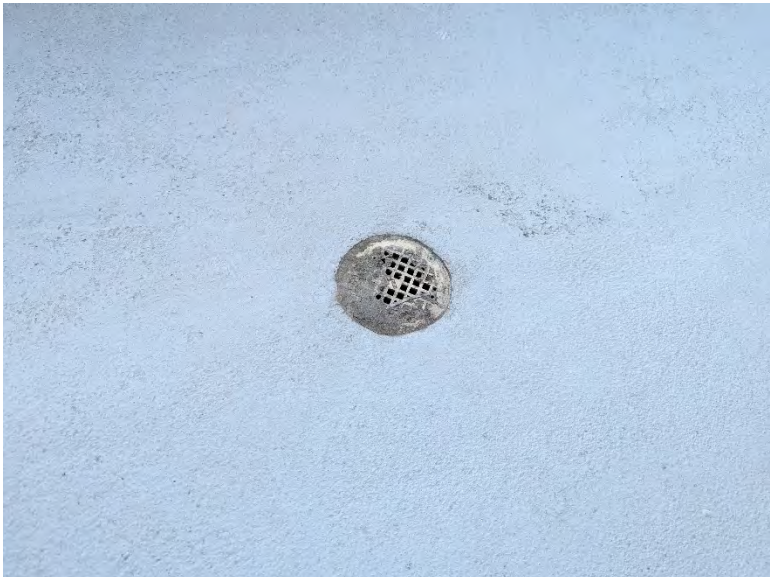
Club Level (Section 225) obstructed plaza annex floor drain

Floor drains at these plaza annex areas were typically obstructed by dirt or debris.

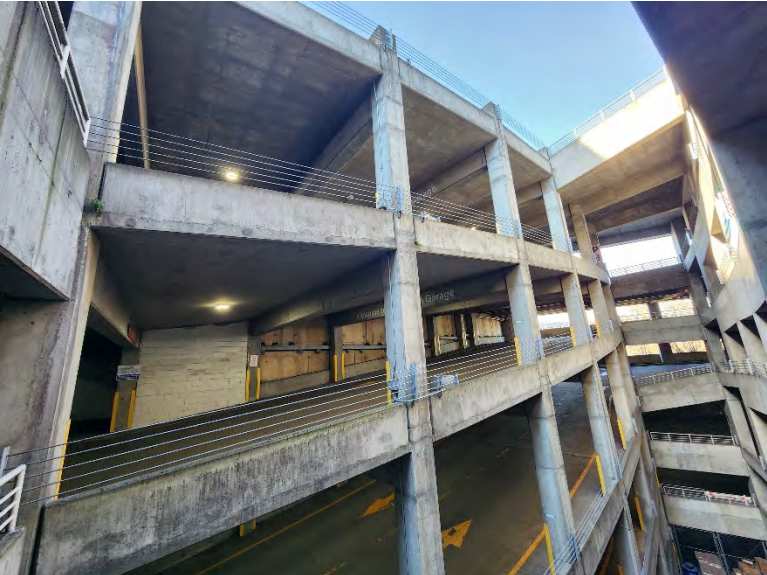
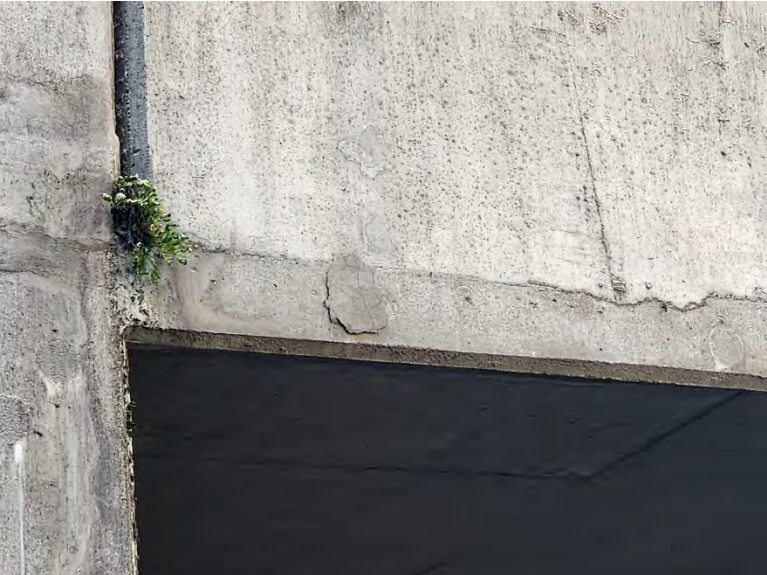
Isolated grout pockets that protect the post-tensioned tendon anchors at the slab edge were observed to be delaminating. The orientation of the grout pockets suggested that they were protecting temperature and shrinkage tendons. Grout pockets for the primary steel tendons could not be observed due to existing façade finishes. We recommend replacing delaminated or damaged grout pockets in the next year and review condition of the anchors.

Level P5 post-tensioned tendon grout pocket delamination at the slab edge

Level P6 post-tensioned tendon grout pocket delamination at the slab edge

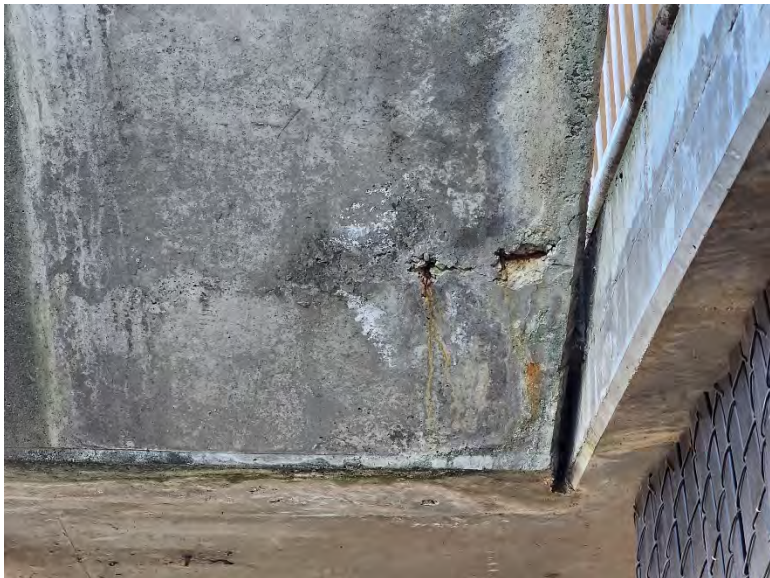
Overhead concrete spalling was observed at a ground level stair soffit. We recommend repairing overhead concrete spalling in the next year. If steel reinforcing bars are found to have experienced 10% section loss or greater, they may need to be replaced.

Level P4 overhead concrete spalling

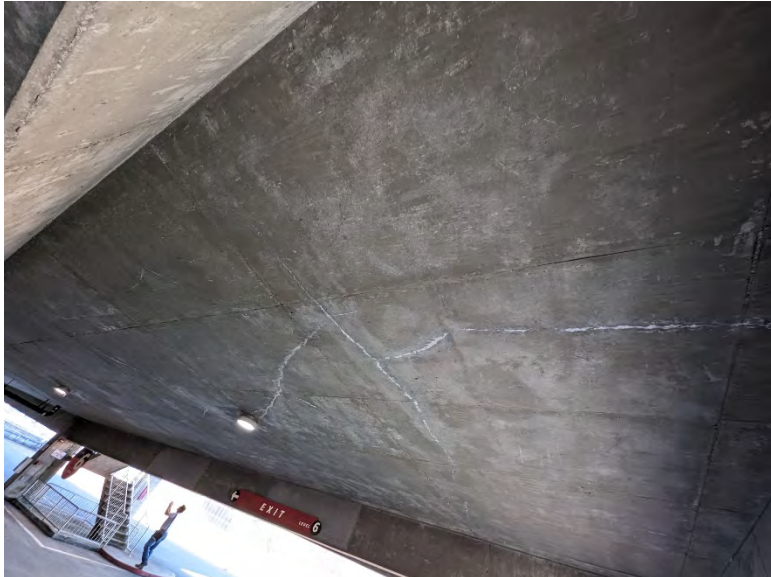
Cracking and efflorescence were observed at post-tensioned concrete slab soffits throughout the parking structure. Cracking of this nature in a post-tensioned slab is unusual and may indicate an issue with the post-tensioning system. The efflorescence indicates water intrusion through these cracks. Continued water intrusion through a post-tensioned concrete slab may eventually develop into a structural concern if allowed to continue. We recommend routing and sealing cracking from the top side of the slab. Monitor slab cracks for increase in width, which could indicate failure of post tension tendons.

Level P6 soffit cracking and efflorescence

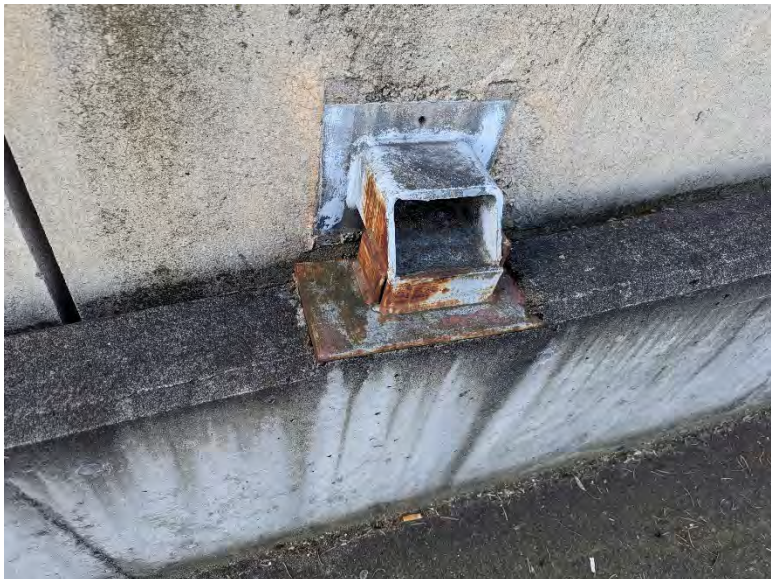
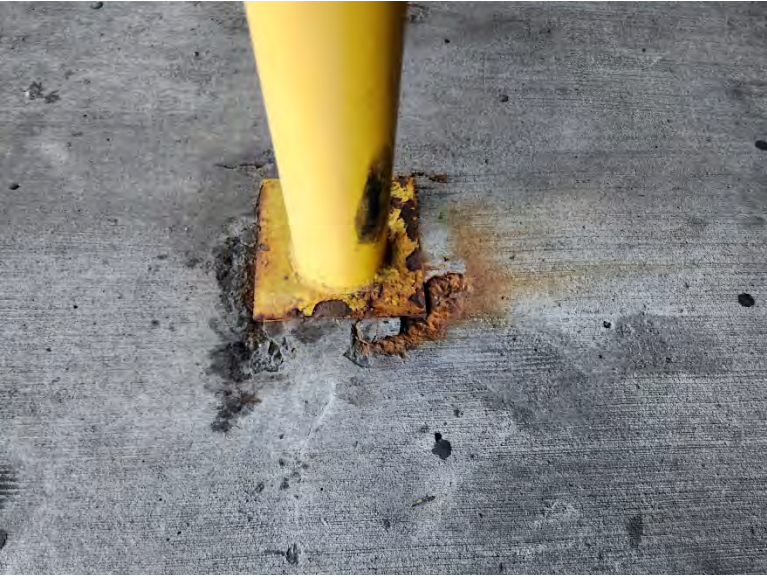
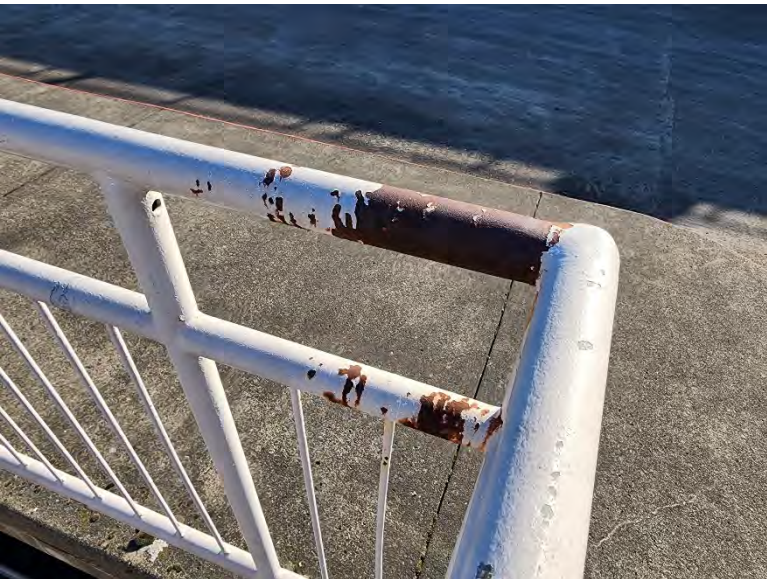
Corrosion was observed at steel elements throughout the parking structure including the precast façade panel connections, bollards, and stair handrails. We recommend cleaning and coating corroded steel elements within the next three years. If steel elements are found to have experienced 10% section loss or greater, they may need to be replaced.

Level P7 corrosion at precast concrete façade panel connection

Level P4 corrosion at steel bollard base

Level P6 corrosion at steel stair handrail

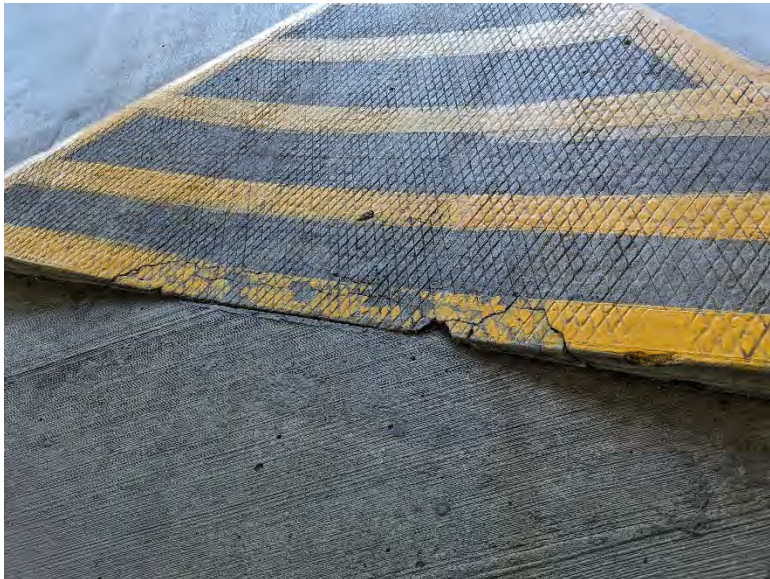
The curbs and floor slab were observed to be cracked, spalled, or delaminated at isolated locations throughout the parking structure. These are typically not structural concerns, but rather potential tripping hazards for pedestrians. We recommend repairing cracked, spalled, or delaminated concrete locations that represent tripping hazards to pedestrians.

Level P4 cracked curb near the stairwell

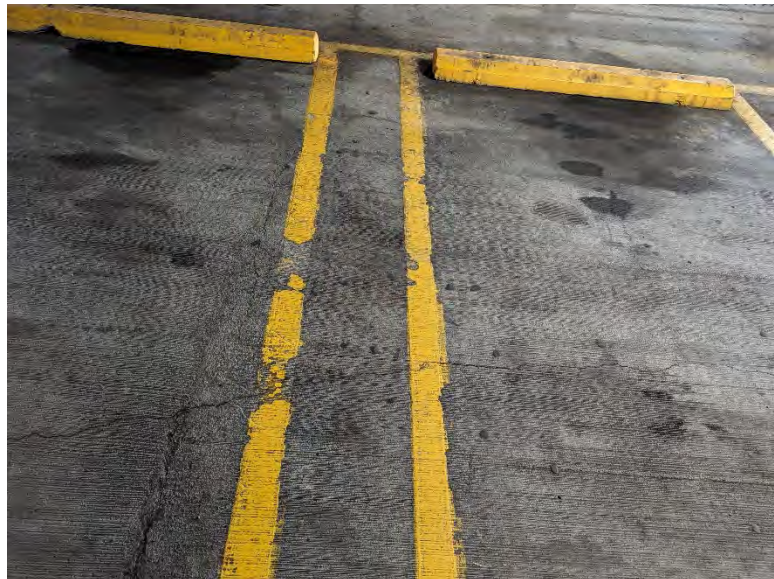
Level P4 ground level floor cracking
