# Facility Condition Assessment

Draft Report

May 14, 2024

# Facility Condition Assessment Moda Center & Garden Garage

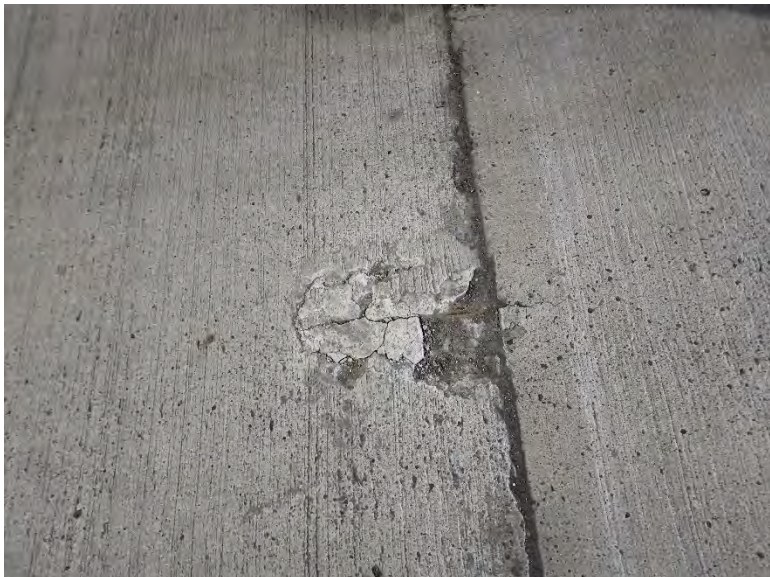
The curbs and floor slab were observed to be cracked, spalled, or delaminated at isolated locations throughout the parking structure. These are typically not structural concerns, but rather potential tripping hazards for pedestrians. We recommend repairing cracked, spalled, or delaminated concrete locations that represent tripping hazards to pedestrians.

Level P1 spalled floor slab

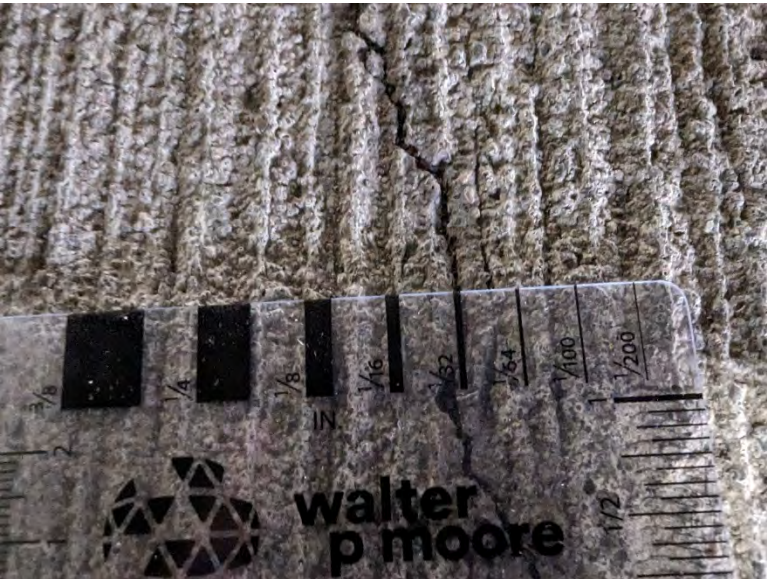
Floor slab cracking was observed throughout the parking structure, primarily at ground level and below grade levels of the parking structure. There was generally no immediately evident cause for the cracking, but the locations where the cracking was observed suggested that it may be due to differential movement coupled with restraint of the slab. This kind of cracking is typical for a concrete structure and should not be a cause for concern.

Level P4 ground level floor cracking measure to be approximately 1/32" wide

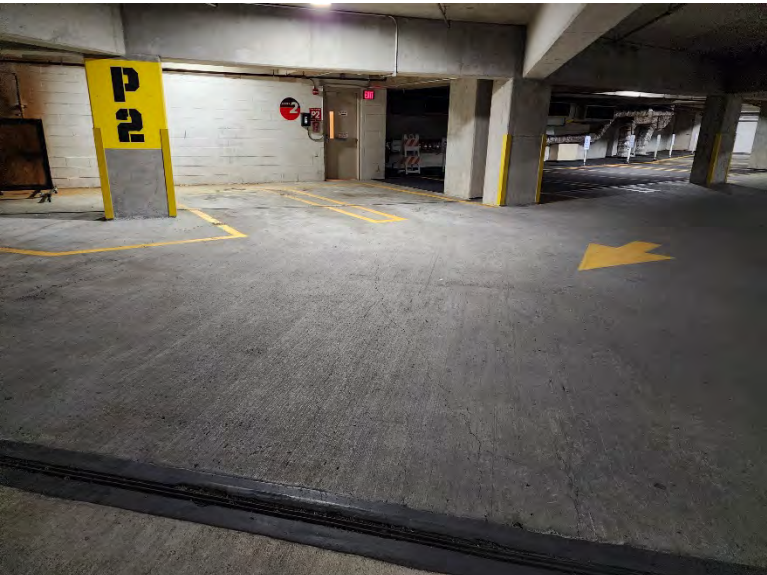
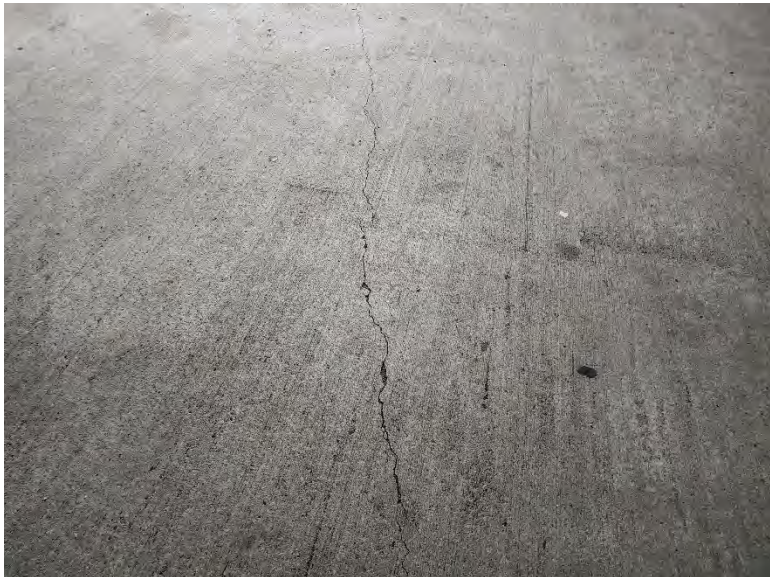
Level P2 below grade floor cracking

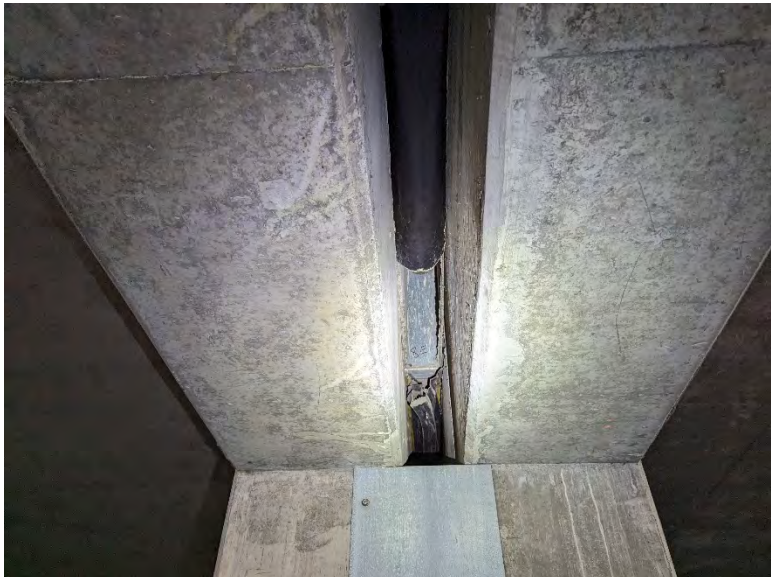
A gutter style expansion joint system was present at levels P5 through P7 and appeared to be located to protect the anchor points of the primary post-tension tendons. There was no report or evidence of water intrusion through these joints. However, it is important that these joints are working properly since water intrusion through the joints can lead to corrosion of the post tension anchors. We recommend replacing the above grade expansion joints with a new expansion joint system within five years.

Level P5 underside of expansion joint

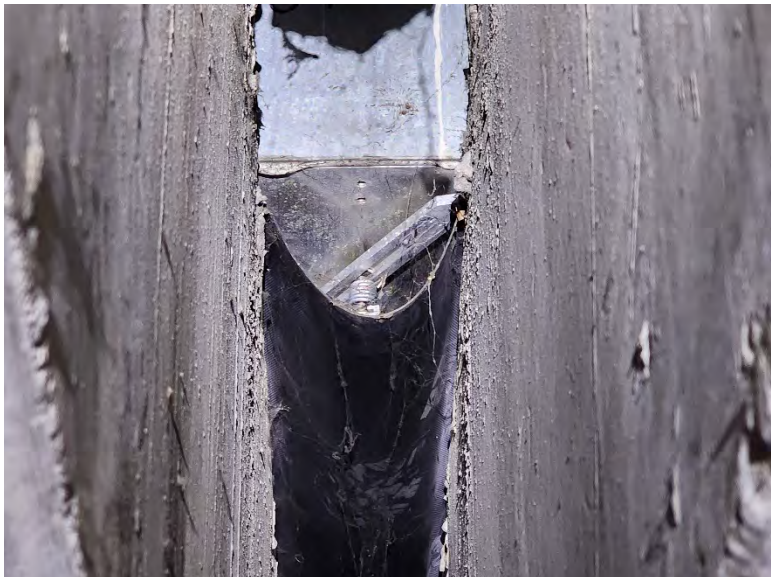
Level P2 underside of expansion joint

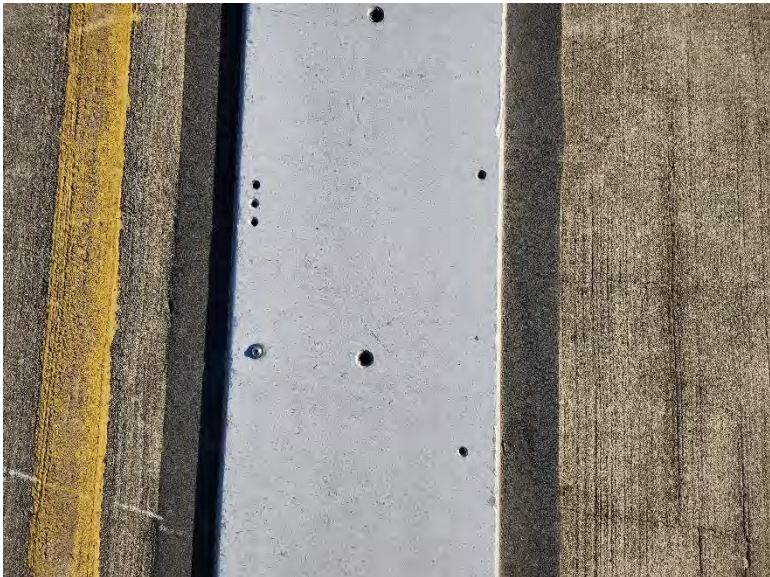
The expansion joint cover plate was missing anchors at some locations.

Level P7 expansion joint cover plate with missing anchors

We recommend replacing missing anchors at expansion joint covers.

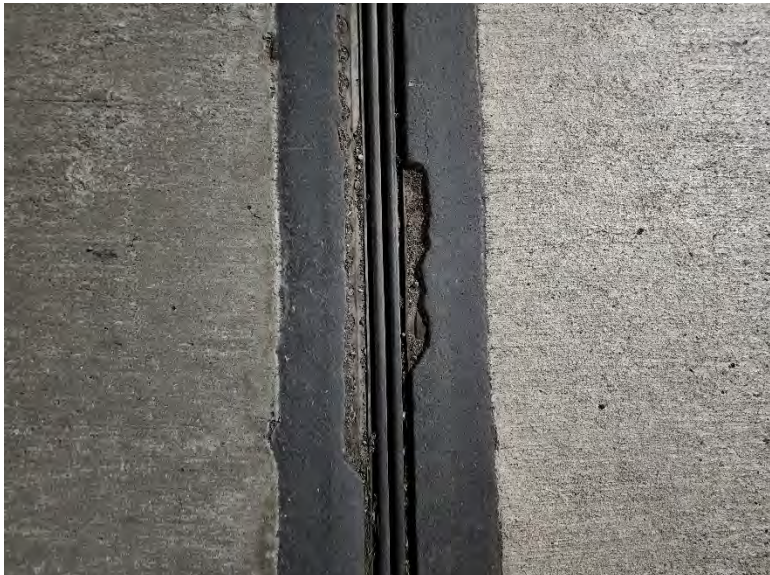
What appeared to be a winged expansion joint was used at below-grade levels to transition between on grade and elevated areas of the floor. The winged headers were damaged at isolated locations throughout the expansion joints. We recommend repairing the below grade expansion joint winged headers and install a metal cover plate to protect the headers within the next two years.

Level P2 compression seal expansion joint with damaged winged headers

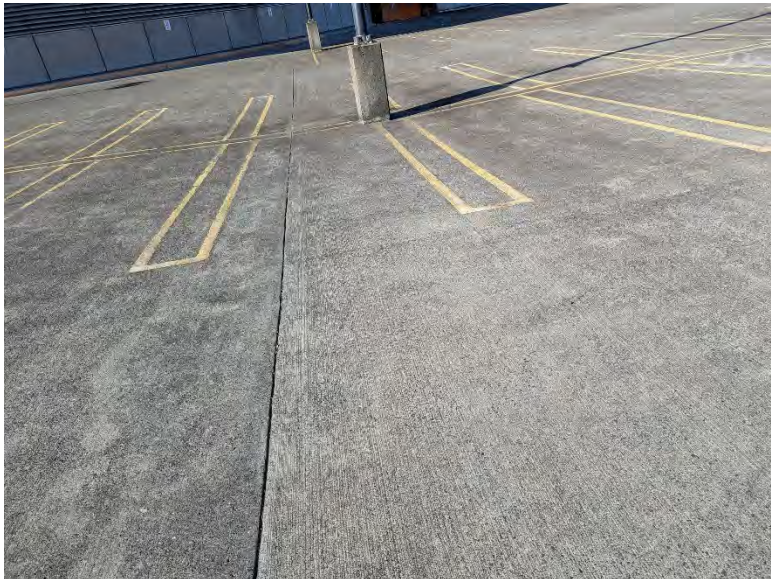
Joint sealant was typically not present throughout the parking structure. The construction joints did not have joint sealant installed. Similarly, there was no cove sealant at the curbs or walls at the perimeter of the parking structure. Efflorescence at concrete slab soffits and at perimeter façade panels indicate that water intrusion is occurring at these locations. We recommend installing joint sealant at construction joints and slab perimeters within the next two years.

Level P7 floor slab construction joints

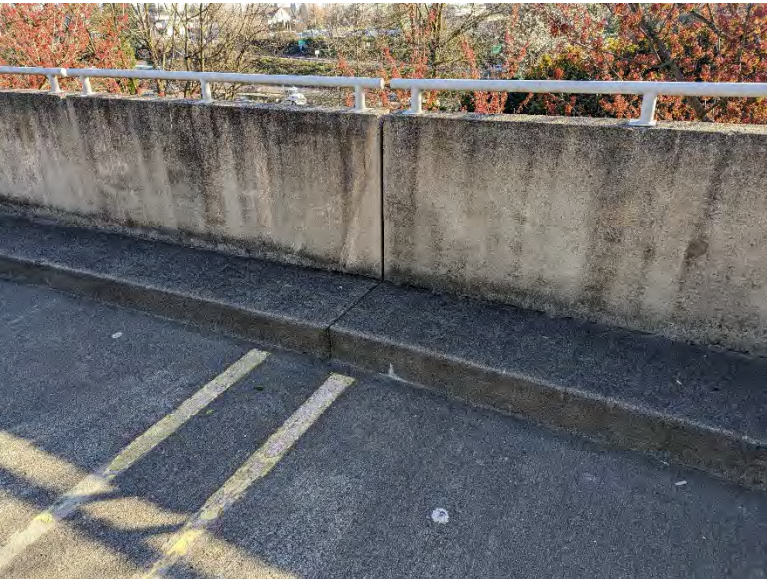
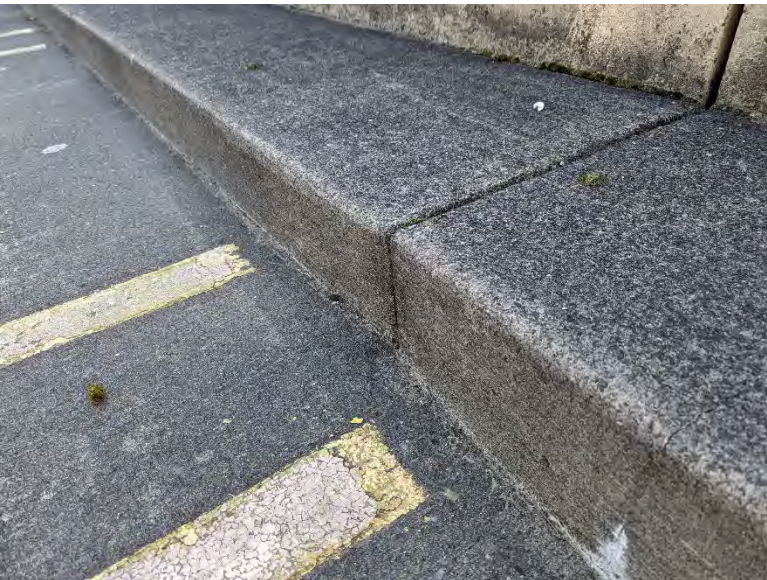
Level P7 perimeter walls and curbs without cove sealant

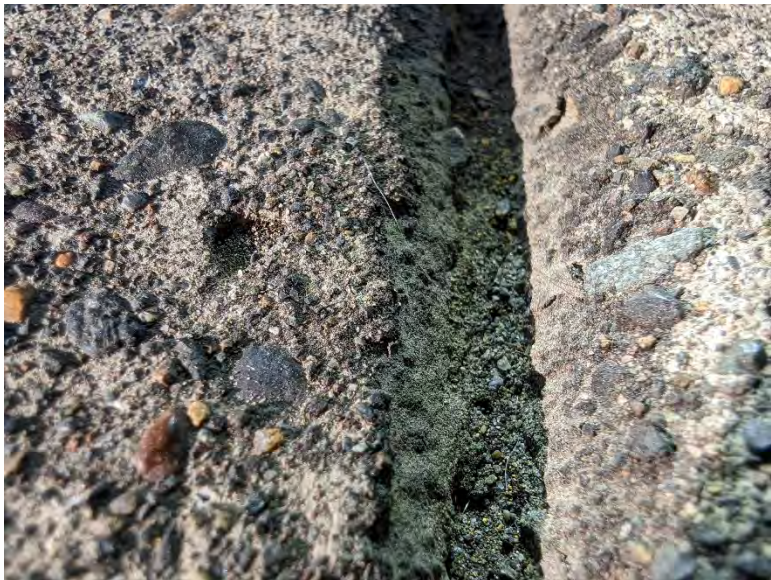
Level P7 floor slab construction joint without joint sealant

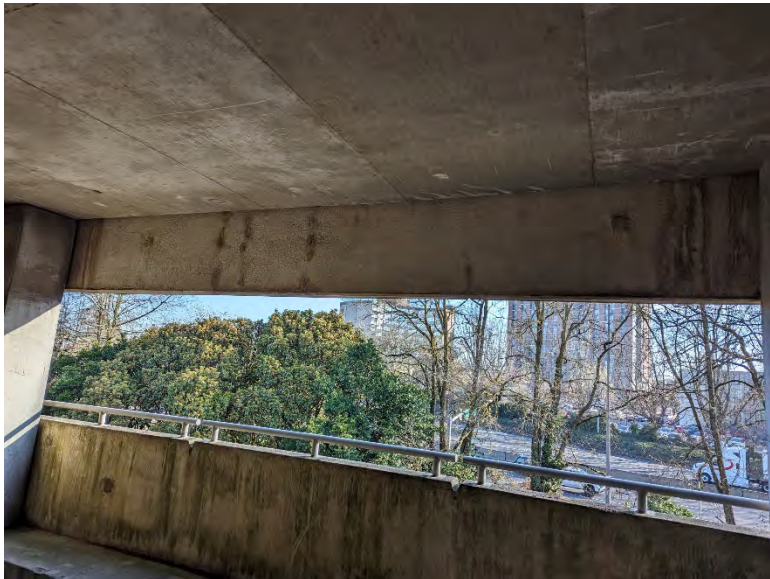
Level P6 efflorescence at perimeter façade panels below walls and curbs without cove sealant

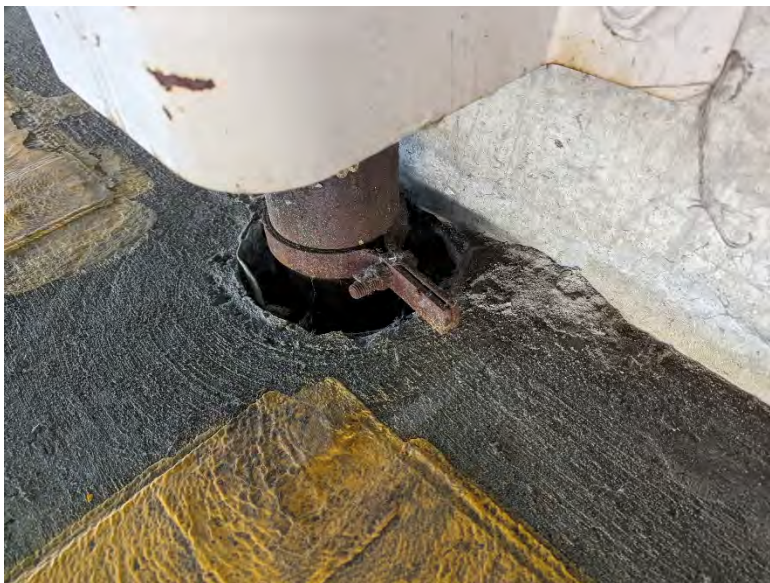
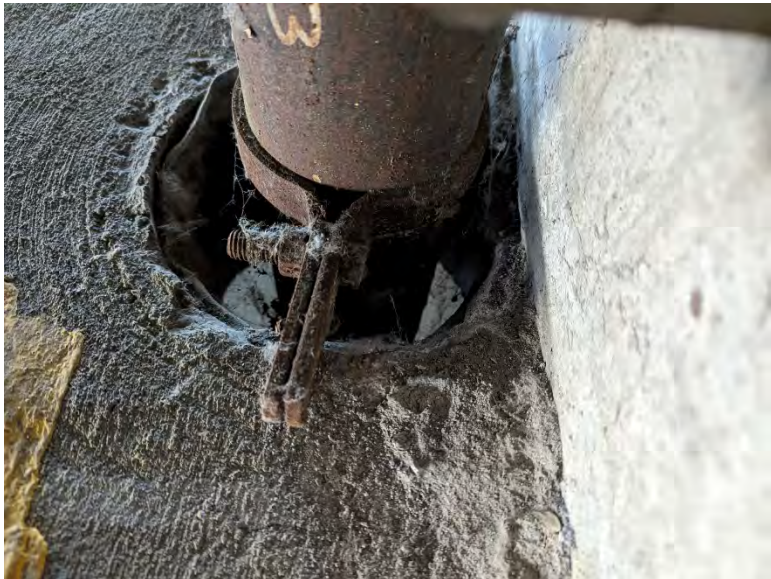
Pipe penetrations through the slab were unsealed throughout the parking structure. Unsealed pipe penetrations are potential sources of water intrusion into the parking structure, so we recommend sealing pipe penetrations within the next year.

Level P6 unsealed pipe penetration

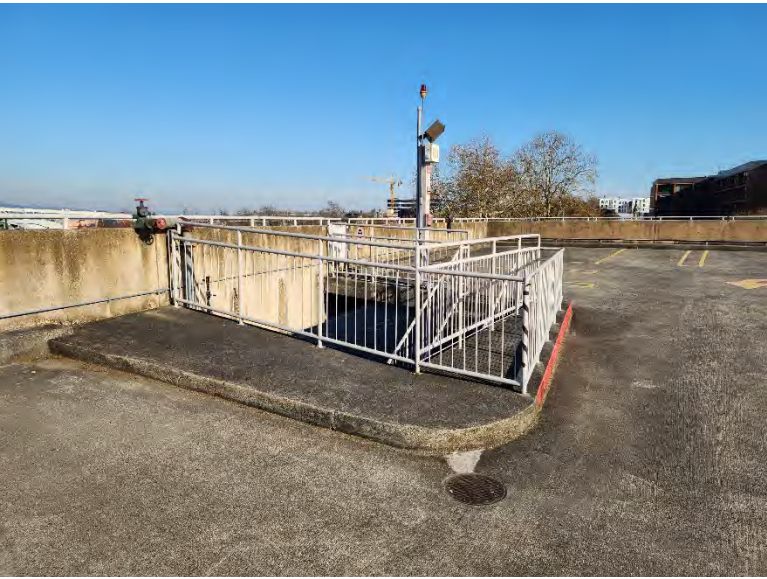
Vehicle barriers were typically not installed around stairwells. Vehicular barriers are typically required where the vertical distance from the floor of a drive lane or parking space to the ground or surface directly below is greater than one foot at the end of drive lanes and parking spots. We recommend installing vehicle barriers around stairwells within the next year.

Level P7 missing stair vehicle barriers

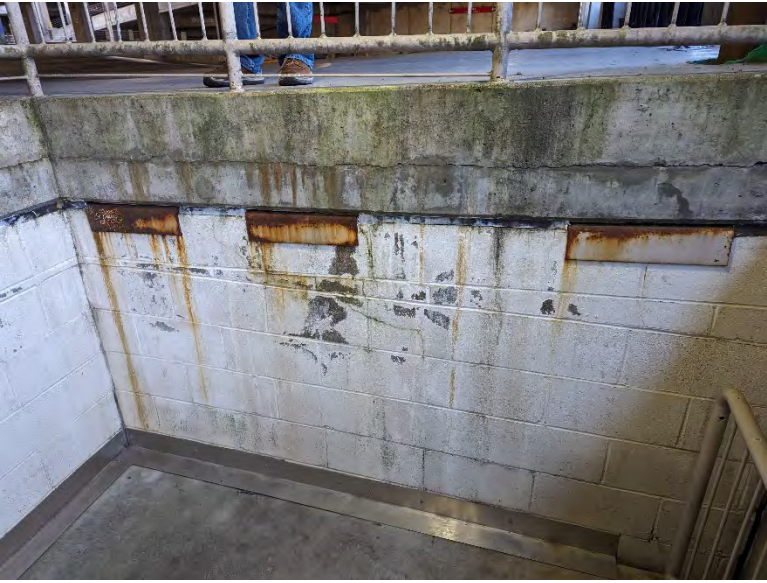
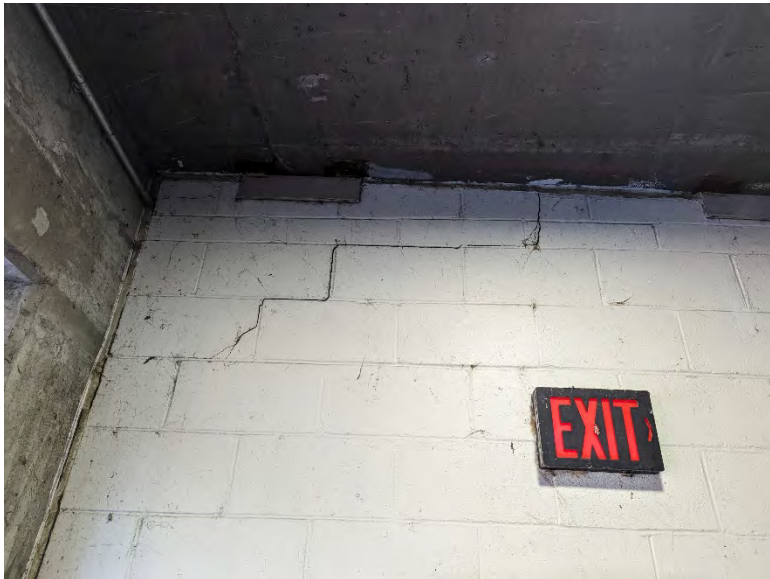
Nonstructural CMU walls were cracked through mortar joints and CMU blocks at the street level stairwell. This may result in instability of the CMU walls, so we recommend replacing cracked CMU blocks and repoint cracked CMU mortar joints within three years.

Level P4 cracked CMU wall

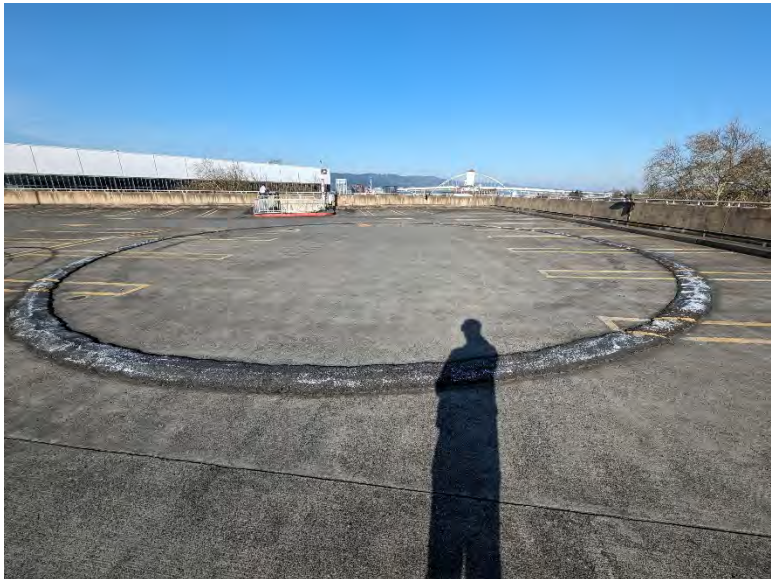
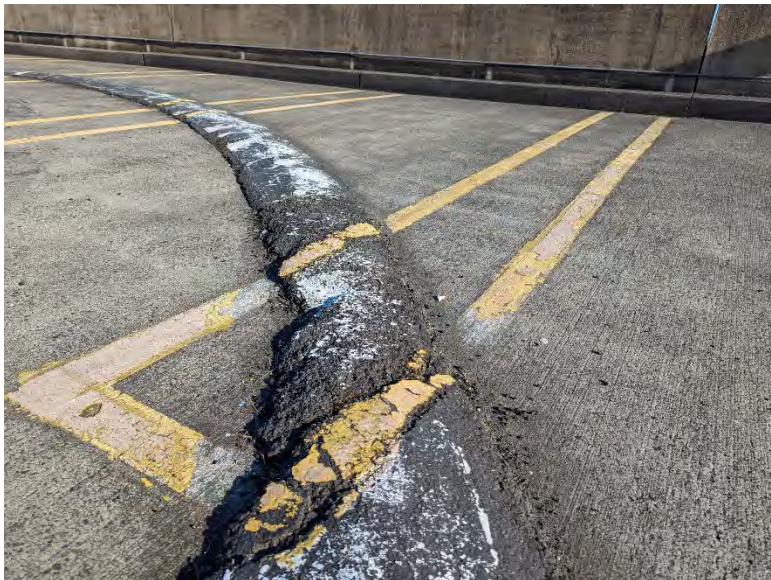
A ring of asphalt was located at level P7 of the parking structure. Moda Center staff stated that the ring was to mark where helicopters could land. A cursory review of the existing structural drawings of the garage, dated July 10, 1993 by KPFF Consulting Engineers, does not indicate that this area of the garage was specially designed to support the extra weight of a helicopter. Cracking and efflorescence appeared to be more prominent and frequent below the designated helicopter pad, indicating that landing a helicopter at this location may be overstressing the concrete slab. However, Moda Center staff mentioned that the garage has not been used as a helicopter pad for several years. We recommend removing the asphalt ring and prohibit helicopters from landing on the parking structure or assess whether or not the parking structure has the capacity to support a helicopter.

Level P7 helicopter pad

Level P7 helicopter pad asphalt ring

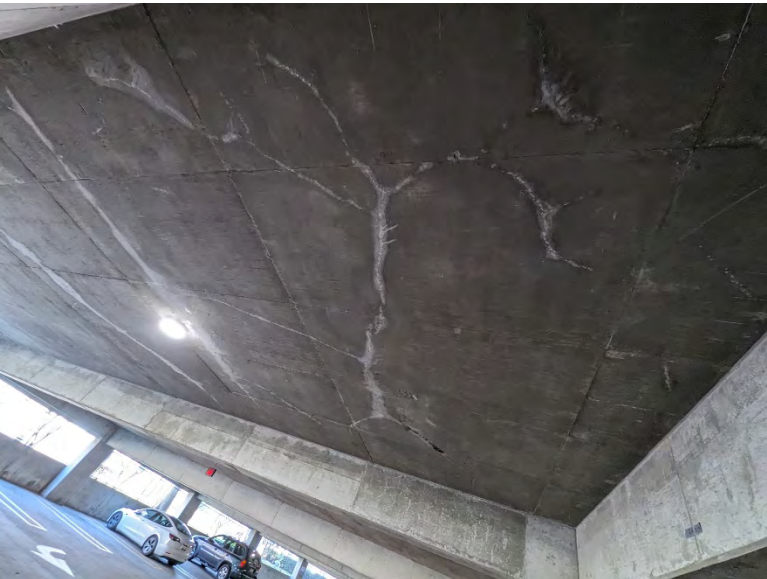
Level P6 soffit cracking and efflorescence below the helicopter pad

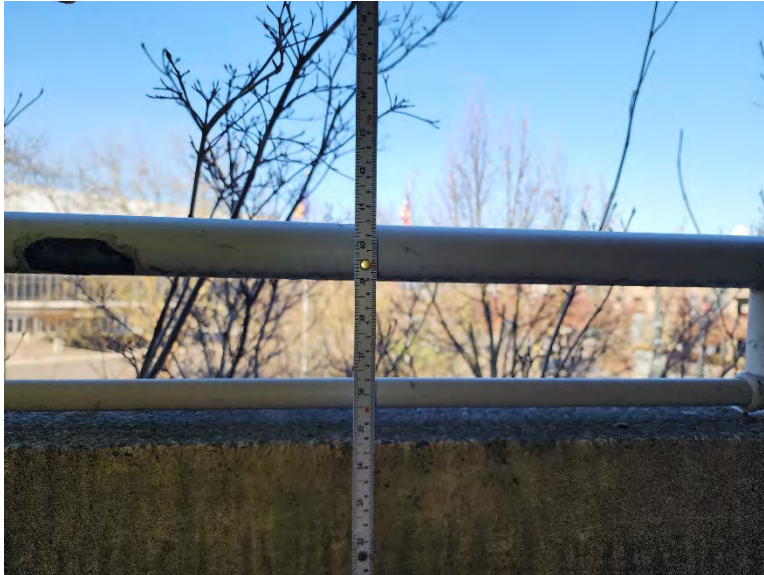
Some parking structure pedestrian barriers were below 42 inches in height required by current code. At some locations, the gap between pretensioned steel cables and concrete parapet walls which were acting in concert as pedestrian barriers had a gap greater than four inches, which is greater than what is allowable by current code. Although not meeting current code requirements, the as-built conditions may be grandfathered in as long as they meet the requirements of the code at the time of construction.

*Level P5 garage pedestrian barrier less than 42 Inches in height*

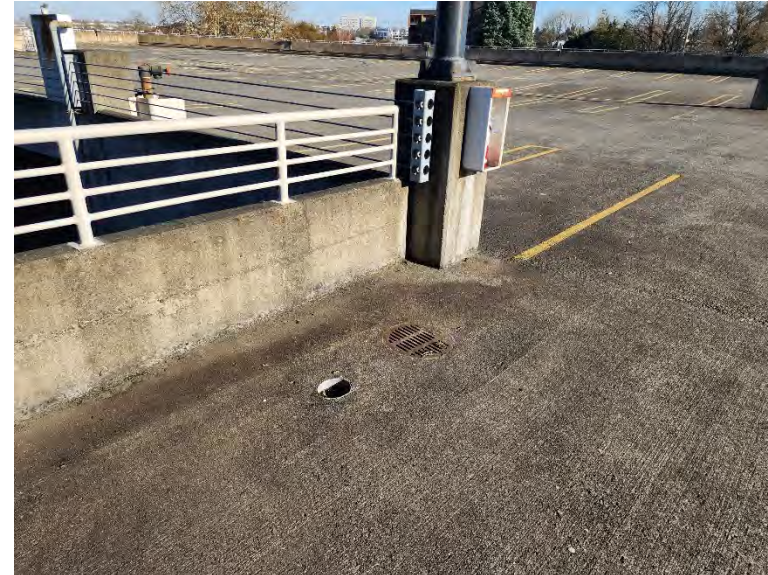
*Level P7 slab penetration trip hazard*

An unused slab penetration at roof level presented a pedestrian trip hazard, so we recommend infilling or covering the slab penetration tripping hazard in the next year.

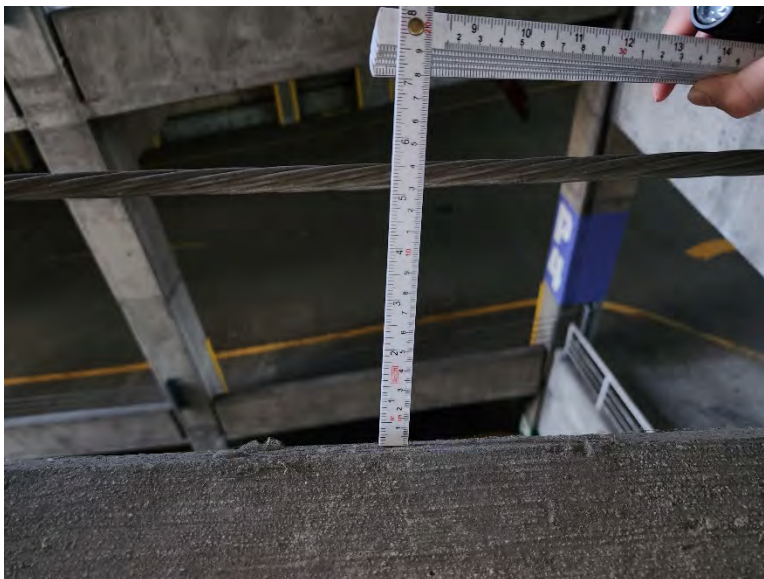
*Level P5 garage pedestrian barrier gap greater than five Inches*

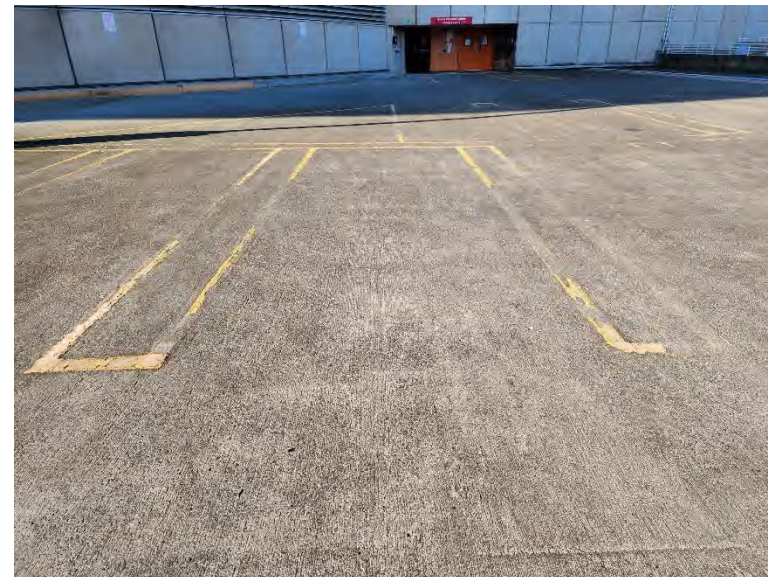
The parking stall striping was faded at some areas of the parking structure, so we recommend restriping the faded parking stalls in within the next two years.

*Level P7 faded parking stall striping*

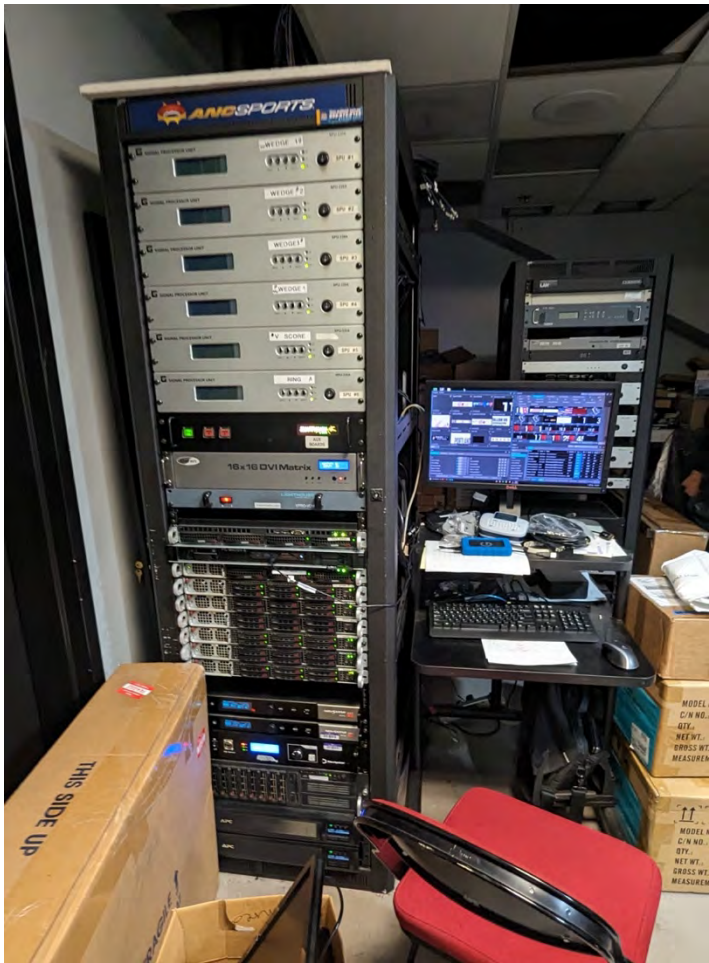
The primary LED processing location is currently housed in two floor standing audio and video (AV) racks located in the old photo processing room. These racks are a significant distance away from the main production area. The room lacks organization and contains a rack with old or non-functioning equipment making movement difficult.

Existing LED processing and scoring system room

A 10' by 16' dedicated AV room should be built on the event level near the main production suite to house five AV racks. Four racks will house the existing and future LED processing and in-venue video control/monitoring. One rack will house the scoring system controllers and distribution.

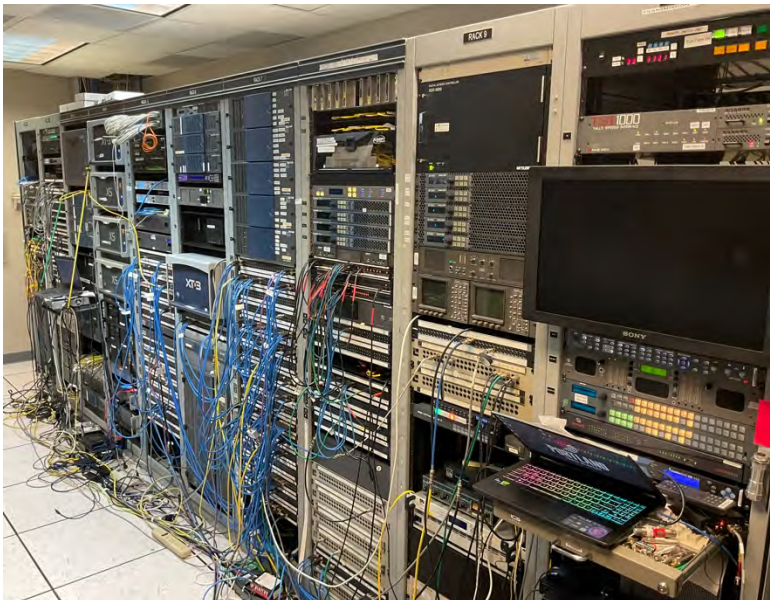
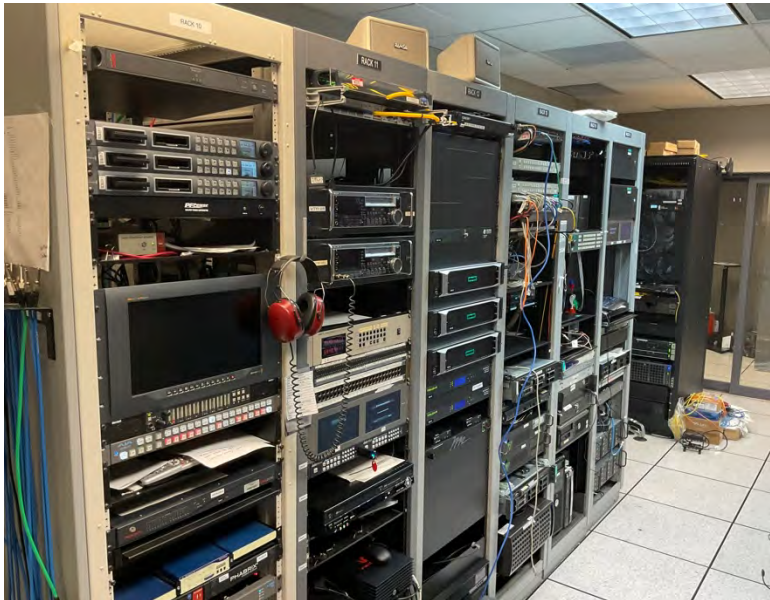
The primary broadcast and in-venue production suite rack room is a shared resource between the Moda Center and the Trail Blazers broadcasting. The rack room houses eighteen racks with all the essential equipment for both the broadcast and in-venue entertainment productions along with NBA required equipment. The room is at capacity and contains equipment that is past its useful age including equipment that is no longer in service.

Production suite rack room viewing row 1 of 2

Much of the core equipment was purchased in 2010 with the high definition (HD) upgrade. The suggested replacement cycle is 10 years for these types of electronic devices. A complete overhaul of existing systems is recommended to meet new technology standards and increase efficient workflows for a better overall fan experience.

Production suite rack room – viewing row 2 of 2

The footprint of the rack room should increase to 36’ by 24’ to accommodate three rows of 12 racks to provide space for all necessary equipment and future expansion.

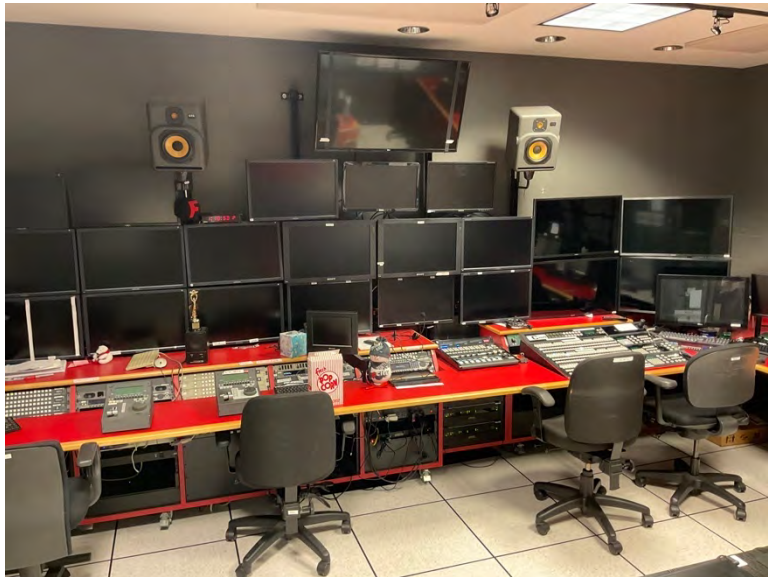
The primary in-venue control room known as “Low Post” contains space and equipment for the videoboard production crew. The room was last updated in 2010 and contains dated production equipment and consoles. The room has space for six crew members.

“Low Post” production control room main bench

Additional space is recommended to accommodate an increased number of user stations and a more efficient layout for production workflows. Room finishes, consoles and lighting should be adjusted to provide the ideal control room setting for operation. Relocating all non-essential equipment into the central rack room to create a quiet and controlled space is recommended.

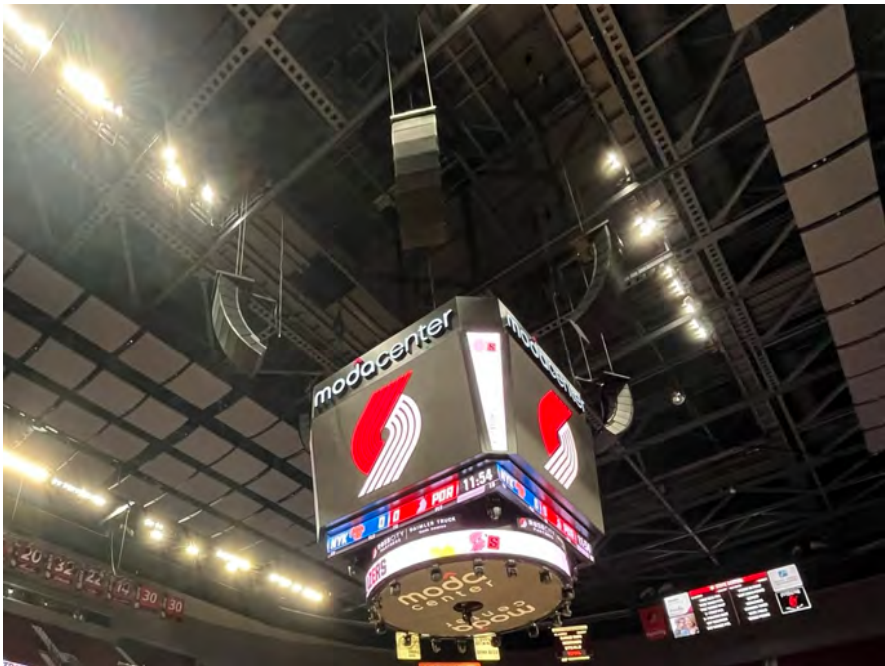
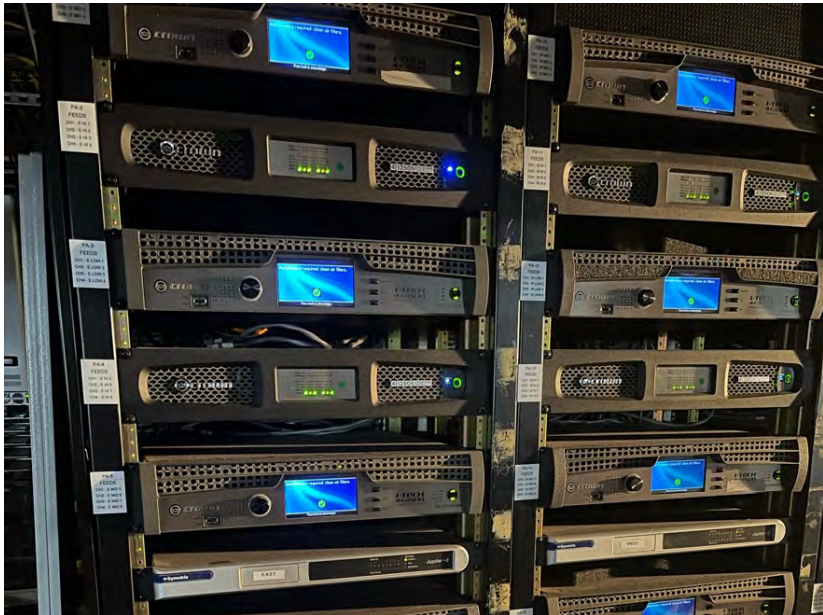
The current bowl speaker system consists of six JBL line arrays. The speakers are powered by a combination of Crown iTech and DCi series amplifiers. The amplifiers are located in equipment racks on the catwalk. Overall, the current bowl audio system is meeting expectations, but it has reached end of life.

Main bowl speaker system

Bowl amp racks

Life expectancy for a modern speaker system is about 8-10 years. This is driven largely by the life of the electronic components in the system in addition to wear and tear on the speaker's drivers. Examples of replacement speaker systems to consider in a renovation should include d&b audiotechnik KSL and L-Acoustics K3. We recommend that the amplifier fans and filters be serviced annually and at the same time check for speaker driver issues.

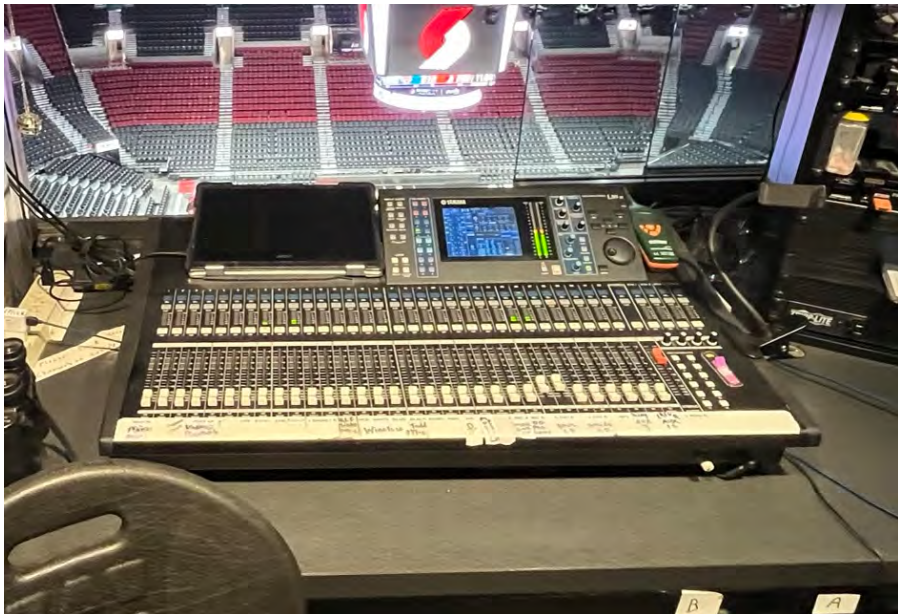
The current mixing console configuration employs a Yamaha LS9-32 digital console as the main console in the control booth. Life expectancy on a digital mixing console is around 10 years. We recommend replacing the current console. Examples include the Yamaha D7 and the Allen & Heath Avantis. Annual maintenance on the equipment fans and cleaning of filters should occur annually along with firmware updates.

Audio mixing console

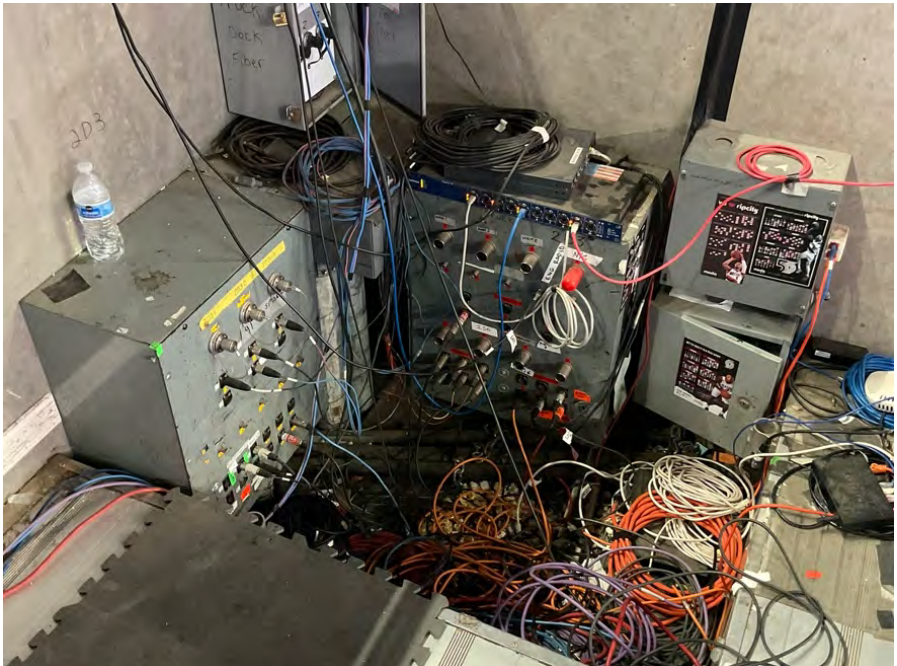
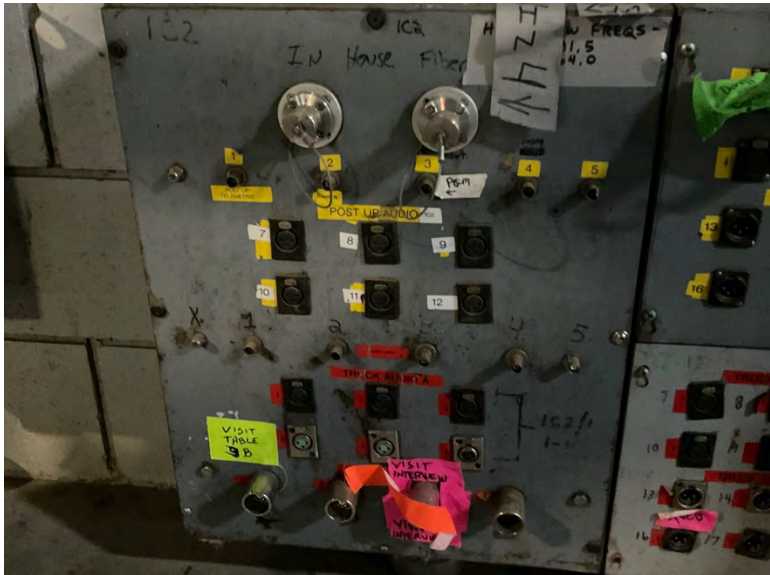
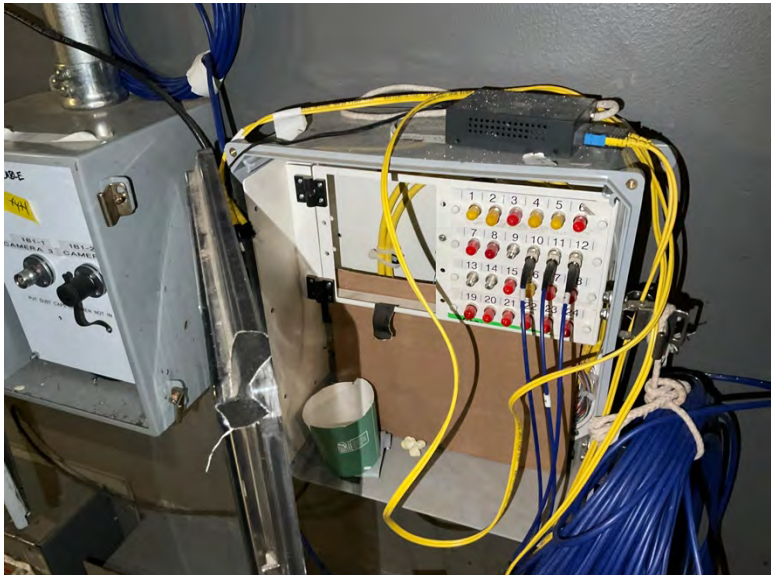
Improving the quality and access to the broadcast cabling will be a much-needed improvement. Broadcast cabling has been slowly added to as league requirements induced improvement. The original cable (audio, triax, coax) is all in poor condition and is sparingly utilized. Newer SMPTE cable and fiber connections have been added to the panel locations or in some locations in their own new housings.

Main camera platform broadcast cable panels

Player tunnel IO panel with temporary labeling

The systems are labeled with temporary labeling and mismatched color coding. The locations themselves are aged and the areas surrounding some junction boxes are poorly maintained.

SM fiber and SMPTE triax housing under seating

As mentioned previously, a complete overhaul of the broadcast cabling is recommended. New, purpose-built enclosures with permanent labeling and custom rack mount bulkhead connections provide a more organized and smaller broadcast cabling footprint in most locations.

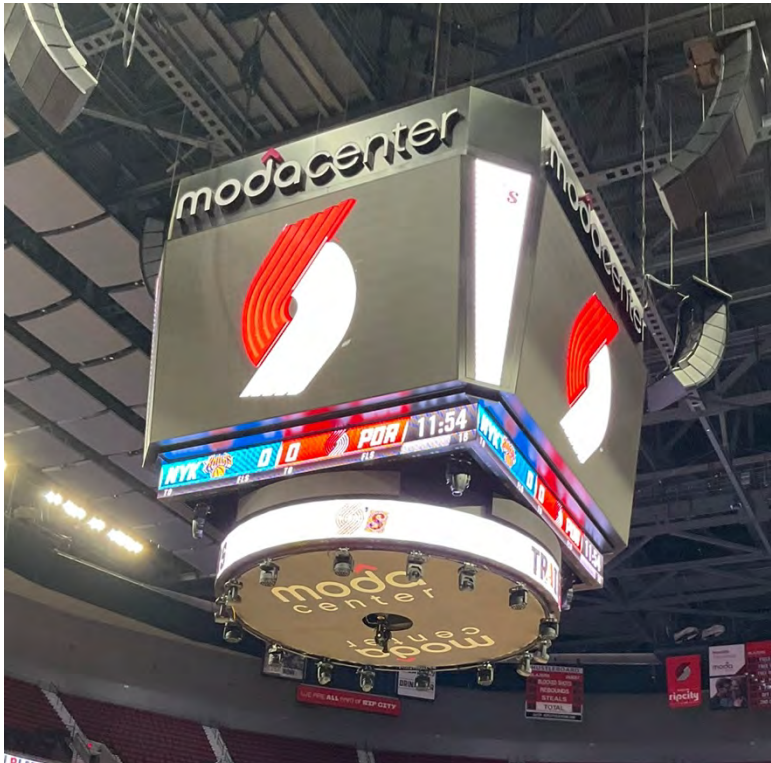
That large center hung display was installed in 2010 making it the oldest surface in the arena. The rings below are also end of life and need immediate replacement. It is recommended that to begin with an immediate replacement schedule for the main center hung display, hoist, and control system.

Arena center hung display

It is recommended to plan for immediate replacement of the center hung display. It is an option to do a complete LED overhaul in the area which could provide cost savings and usher in a single LED provider, making maintenance and service much easier than current conditions. Otherwise, 360 ribbon board replacement is recommended in the next two to three years and vomitory and tunnel LED in the next four to six years.

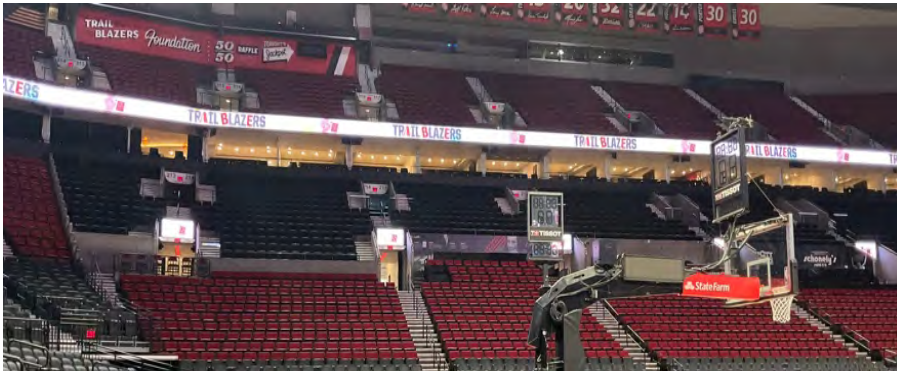
360 ribbon board and vomitory LED's

Additional LED in the arena is newer in comparison to the main center hung but still in need of replacement schedule planning. The 360 LED ribbon displays were installed in 2017 and should be nearing replacement in 2025-2027 based on the recommended 8–10-year life cycle of technology.

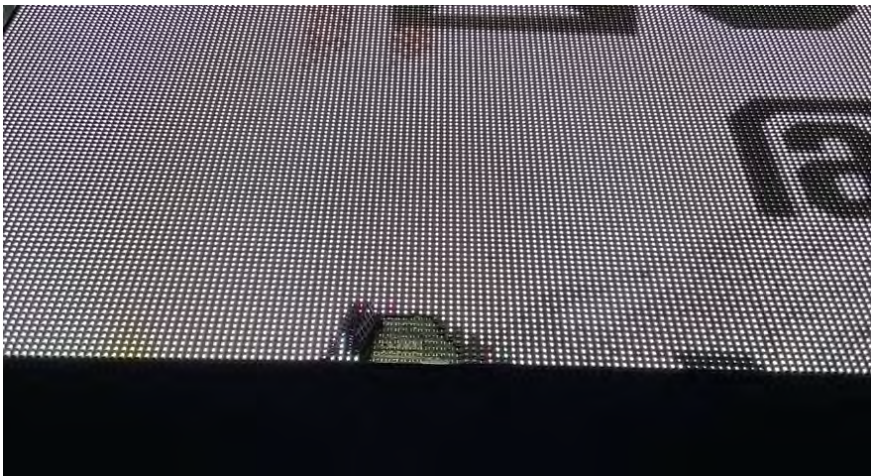
Damage on one of the player tunnel displays

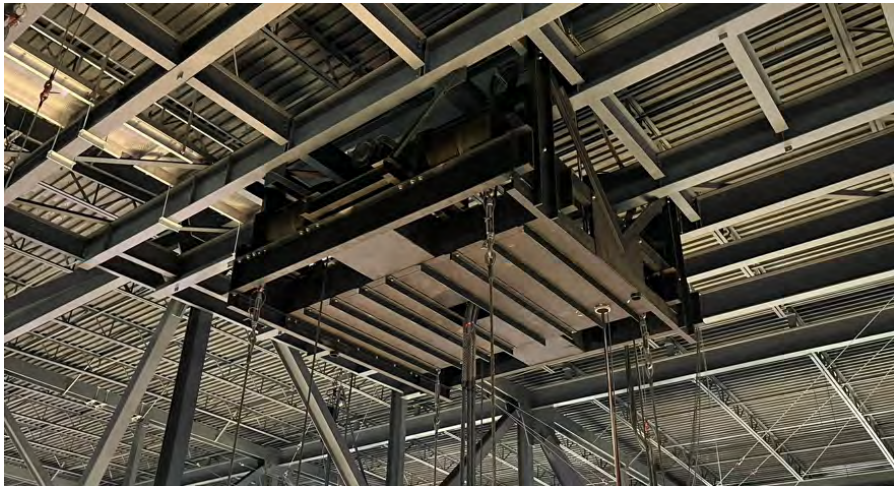
Center hung display hoist

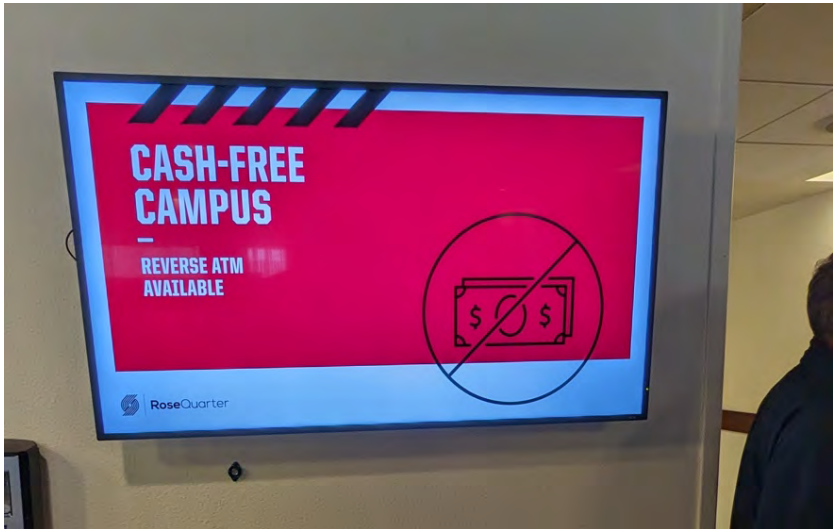
Televisions throughout the venue are currently undergoing an upgrade from LG televisions with MATV distribution to Professional Planar displays with Tripleplay IPTV distribution and control.

Updated televisions in suite

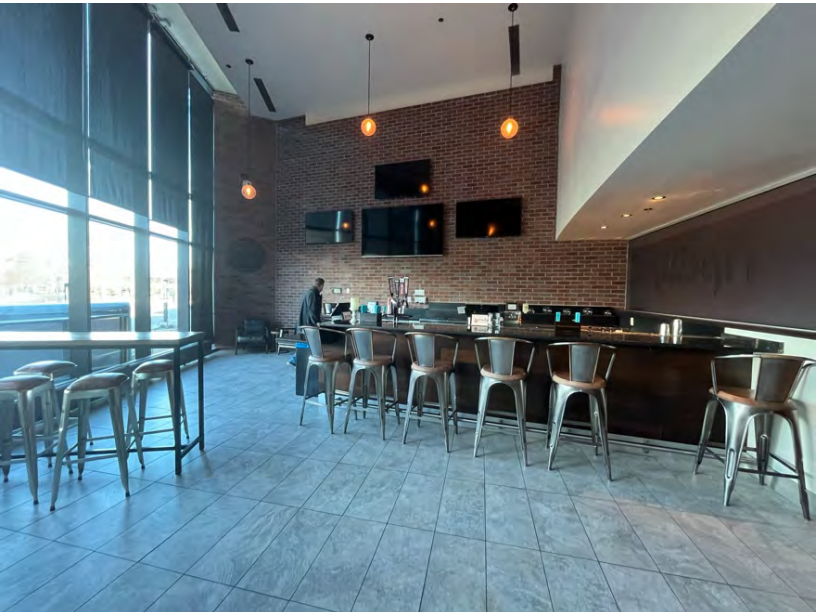
Existing lounge on suite level

Current clubs and lounges are equipped with televisions, speaker systems, wireless microphones, and projection (Skyline Lounge only). These systems are reliant on AV systems that are past their typical life span. Most AV hardware is end of life, so maintenance and support of these systems will be difficult going forward. These systems should be replaced in the next few years.

Each club/lounge currently operates as an island and is not integrated into the facility wide control systems. Most spaces do not include AV control system, so users have to access the AV racks (sometimes in another room) to control the audio volumes. New AV control and distribution systems, with wall mounted AV touchscreens, should be implemented in each space. New systems should be integrated into facility wide AV network and headend.
