# Facility Condition Assessment

Draft Report

May 14, 2024

# Facility Condition Assessment Moda Center & Garden Garage

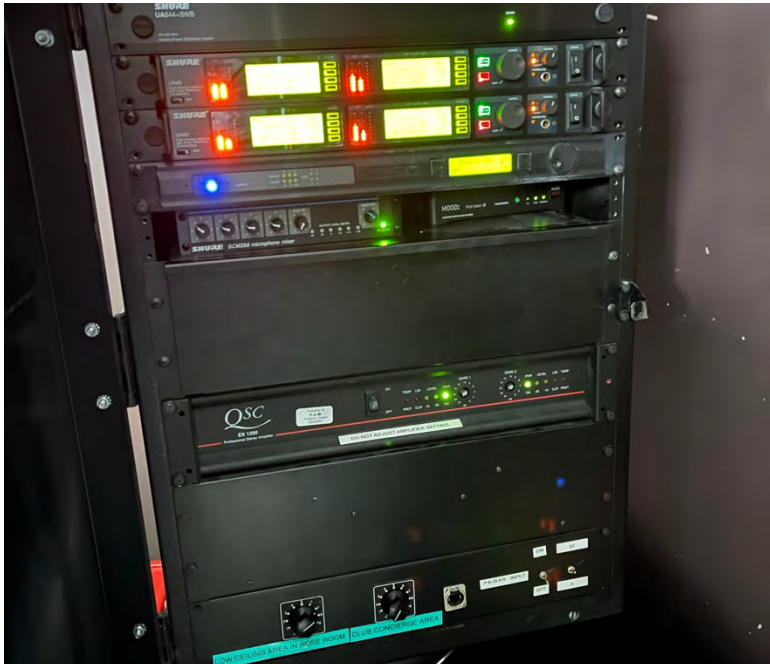
Each club/lounge currently operates as an island and is not integrated into the facility wide control systems. Most spaces do not include AV control system, so users have to access the AV racks (sometimes in another room) to control the audio volumes. New AV control and distribution systems, with wall mounted AV touchscreens, should be implemented in each space. New systems should be integrated into facility wide AV network and headend.

Existing club AV control rack

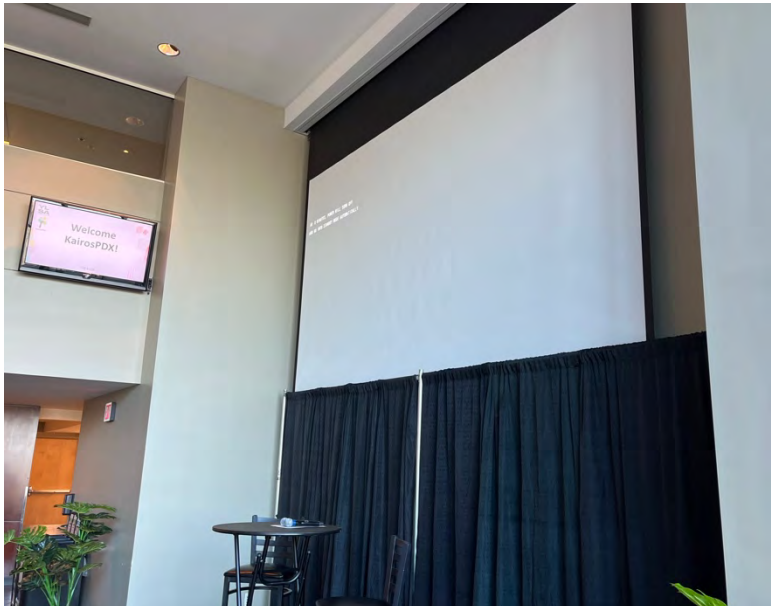
Video presentation is currently included in the Rose Room utilizing ceiling mounted video projection system. The system is currently functional and useful for presentations but not for game day. As spaces are updated, a fine-pitch, direct-view LED display should be added to Courtside Club, Oro Fino, and Rose Club (to replace projection) for video presentation and for fan engagement on game day. Video presentation routing should be updated to AVoIP system on the AV network.

Existing video projection screen

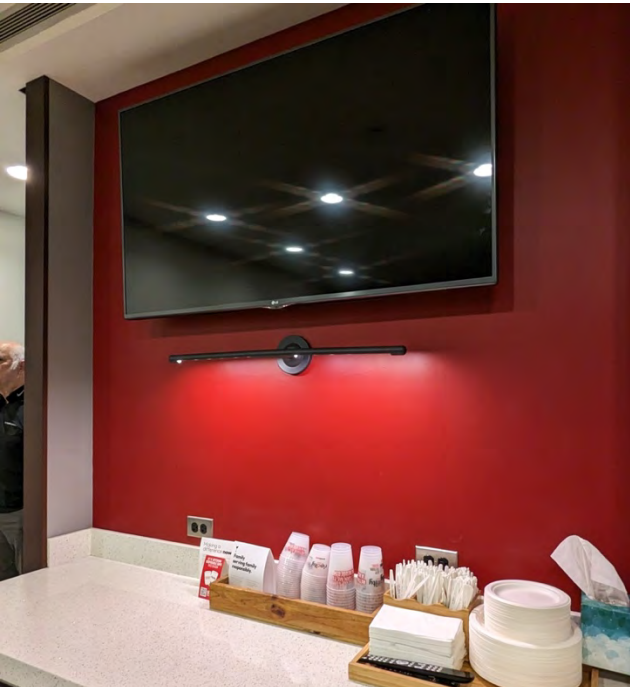
Suites currently include wall mounted televisions that are controlled with handheld remote, and no speakers are included in suites.

Existing suite television

The main television in each suite should be enlarged for local presentation and/or insertion of L-Bar graphics (for stats and advertisement).

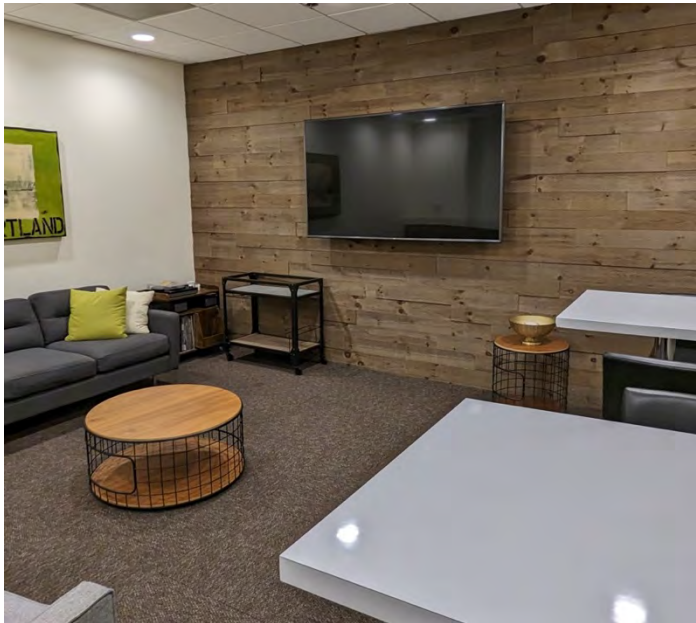
Star dressing room

The star dressing rooms should include overhead speakers and subwoofers with a wall mounted touchscreen. Sources should include bowl audio, background music, Bluetooth input, and local broadcast audio.

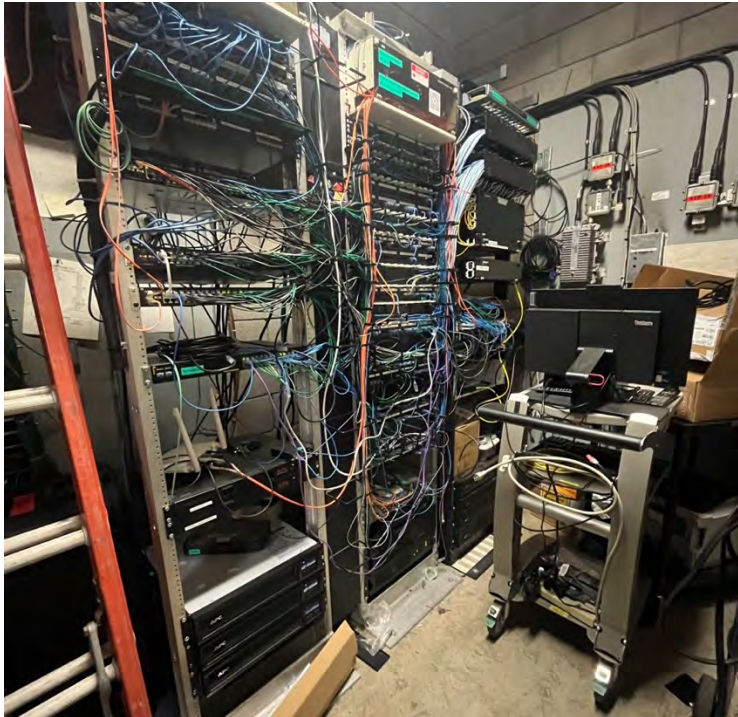
The existing backbone and horizontal cabling are well maintained and in excellent condition. The cables are well secured within dedicated pathways and rooms throughout the facility.

Typical existing telecom room

Overtime, fiber cabling strands from network operations center to each telecom room should be increased to allow for higher bandwidth links between switches. The current fiber count of 24 strands should be increased to 48 or 96 strands as needed.

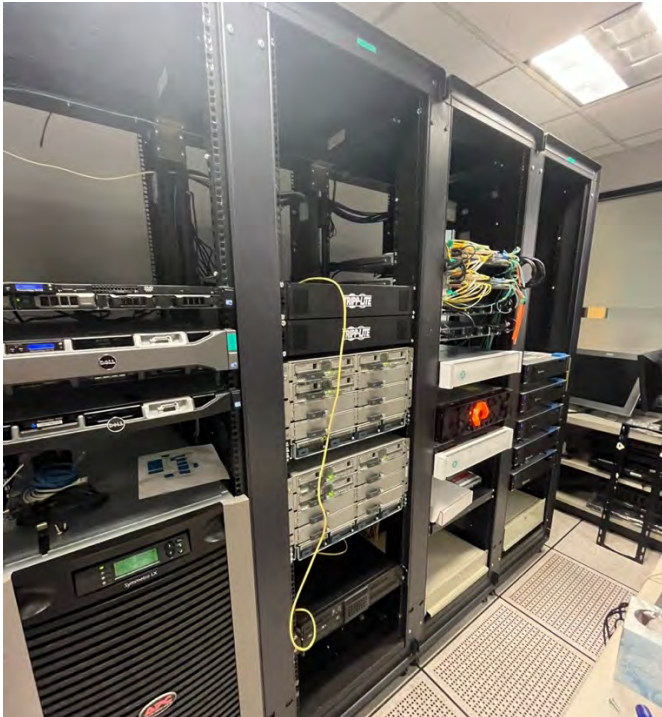
The network operations center (NOC) within the annex is in good condition. It is a raised floor cable distribution system with local CRAC units. The NOC houses the head end of the security system as well as the central networking equipment. At present, the CRAC unit servicing the room had recently failed and the team was awaiting a replacement unit.

Network operations center

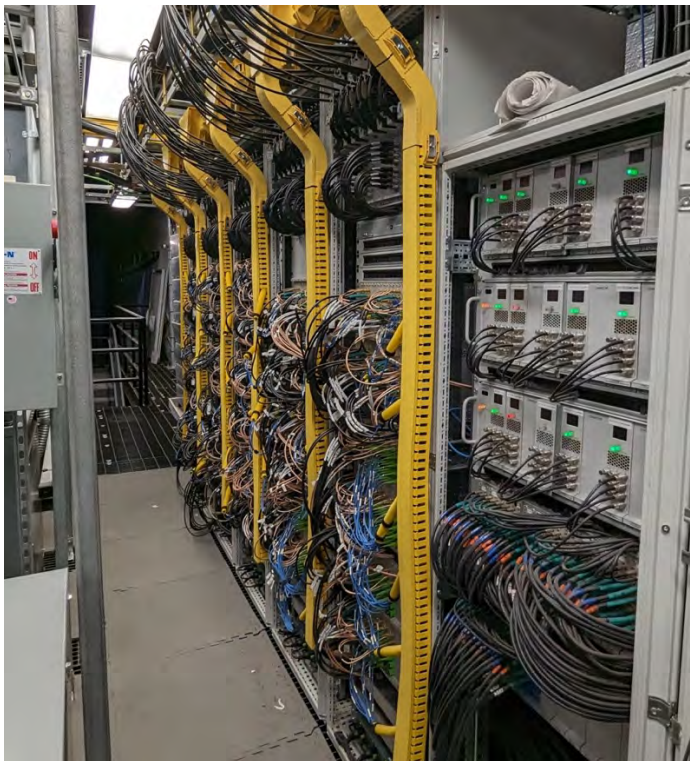
The venue includes a distributed antenna system (DAS) that is currently being upgraded to be 5G compatible. It is being planned as a full rip and replace to achieve 5G capabilities. Carriers include AT&T, Verizon, and T-Mobile. There are approximately 1,000 antennas between the venue and the annex building.

*DAS system on catwalk level*

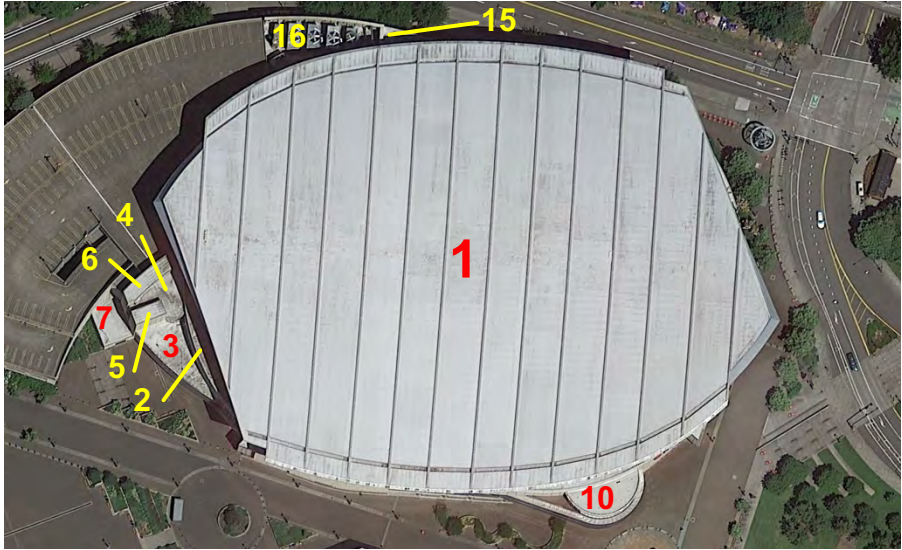
Aerial view of the arena and roofs

The various roof areas that are visible are identified above. Many roof areas are concealed beneath the overhanging “barrel” roof above the seating bowl (Roof Area 1, in the center).

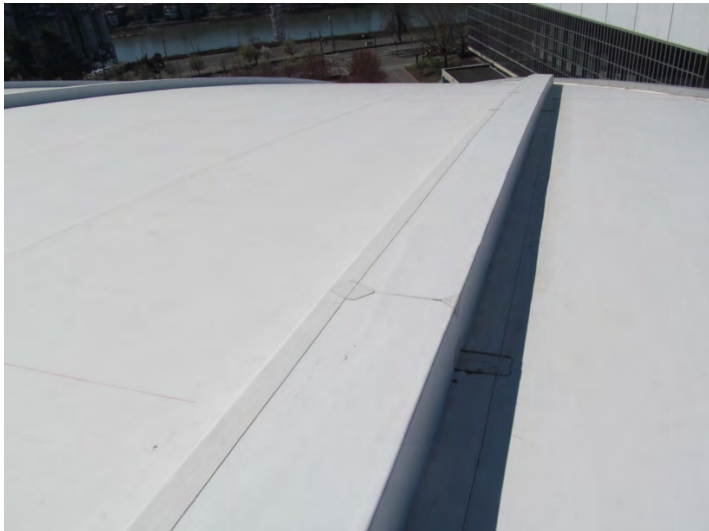
TPO single-ply membrane roof covering system on Roof Area 1 (main roof above bowl) and “ribs” that transverse the roof are flashed with TPO membrane

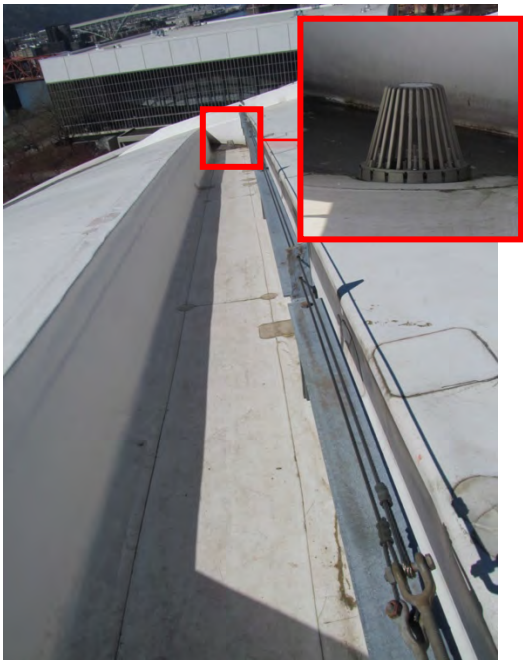
TPO membrane-lined built-in gutter/trough for drainage of Roof Area 1; internal roof drains discharge water from the troughs

Water is removed from the roof surfaces by a system of interior roof drains that discharge into the storm drainage system. Secondary drainage is provided primarily via through-wall overflow scuppers and/or overflow drains. Roof Area 1 utilizes a large built-in gutter/trough system near the east and west roof perimeters, and water drains from the troughs into interior roof drains. On Roof Area 1, a system of rigid steel members and steel cables is installed along the roof edges; the steel/cabling system appears to serve two purposes: to provide fall protection for personnel on the roofs, as well as to function as a snow rail system, to prevent heavy snow/ice from clogging or damaging the built-in gutter systems and/or falling over the roof eaves above public access areas at grade.

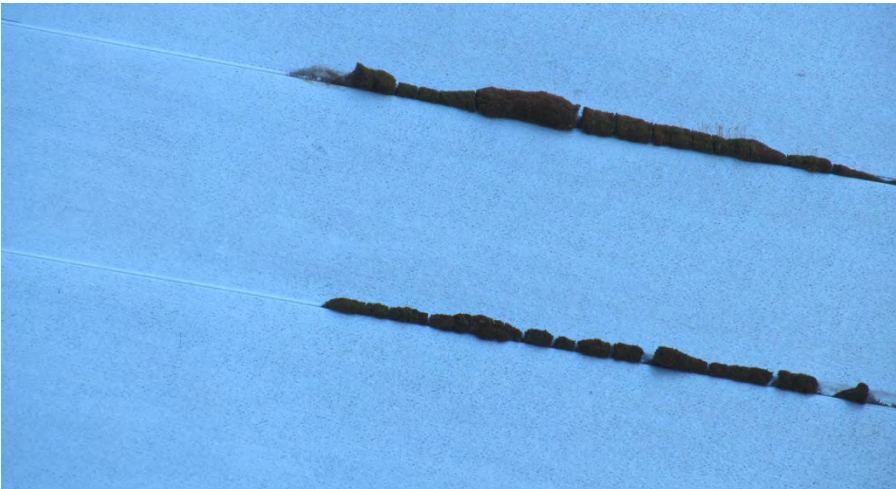
*What appears to be mossy vegetation growing in seams of the mansard panels on the north elevation*

The general, overall condition of the existing mansard panels appears to be fair. Based upon visual observations in areas of the mansard panels that could be safely accessed for viewing, the panels generally appear to be free of physical damage. The paint/finish on the panels has some appearance of minor deterioration, yet there was not any visible rusting/corrosion. There is, however, what appears to be significant growth of mossy vegetation along the seams between metal panels, particularly on the north-facing areas of the mansard. The vegetation and associated roots can potentially cause

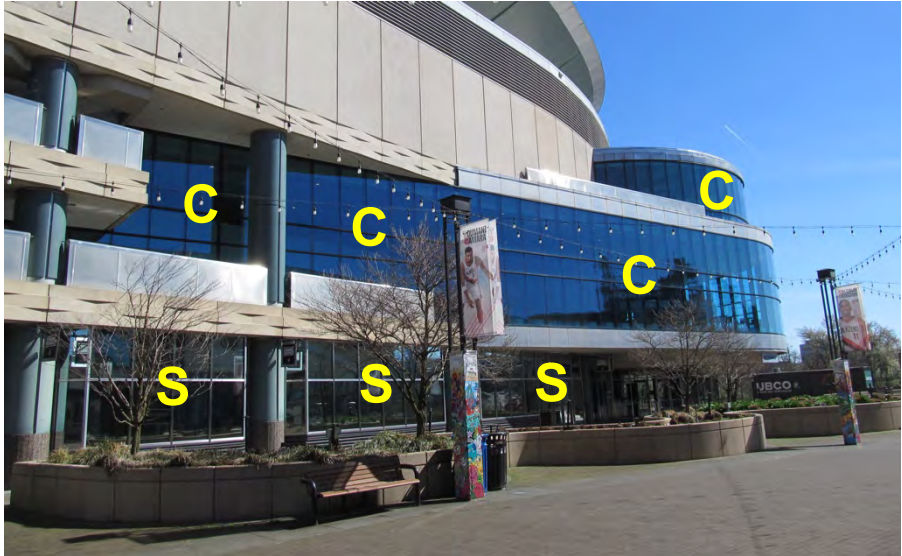
Curtain-wall systems are utilized in large, open areas of the building with multi-story vertical spans of exterior walls, such as the “half-round” area on Levels 3-5 (above the South Entrance), a meeting/banquet hall above the North Entrance (Level 3), the north elevator tower, and three emergency egress stairwells. The storefront and curtain wall construction appears to be similar, with the exception that the curtain-wall systems are typically taller, exceeding one story in height. During our inspections, only two small moisture stains were noted on curtain wall systems, with one being in the “half-round” area at Level 3, and the other being in the meeting/banquet room on Level 3. No other deficient conditions were noted.

Areas of glass storefront (marked “S”, and curtainwall (marked “C”) along the west façade of the building

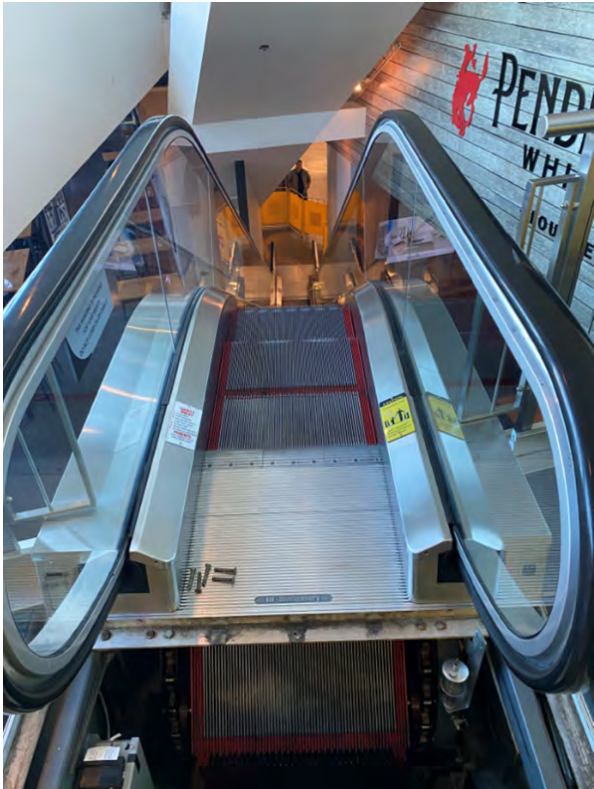
Proper protection from wall to unit

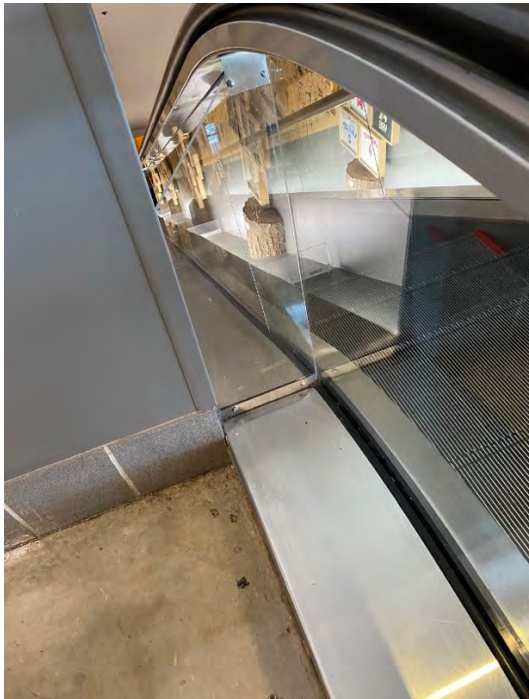
Proper protection from wall to unit

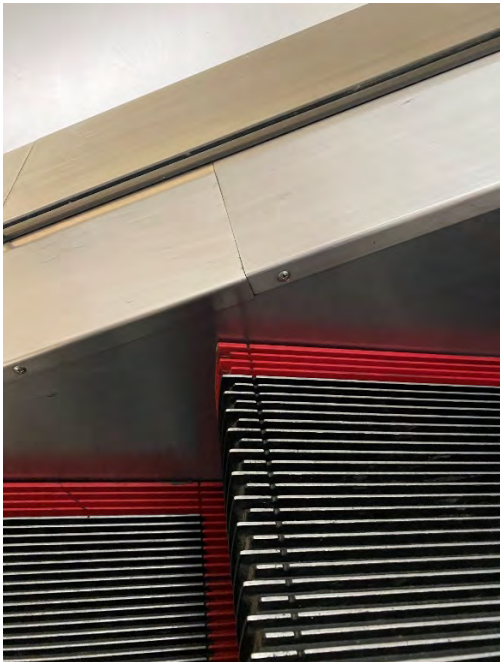
Stainless steel skirts are in good condition and proper step clearance evident on all units

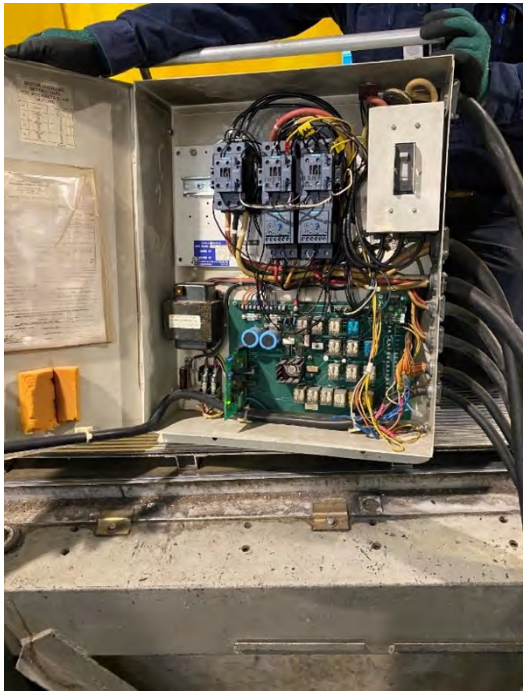
Typical controller in all escalators

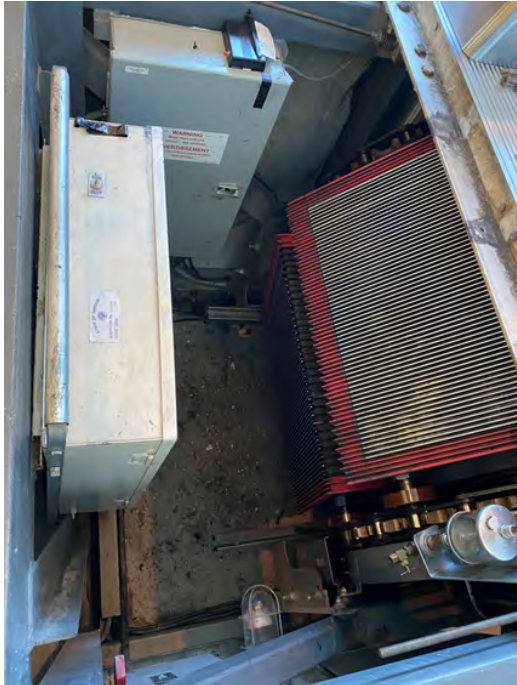
Escalator Esc. No. 2 with chains and tracks in good condition as well as the drive chain sprockets

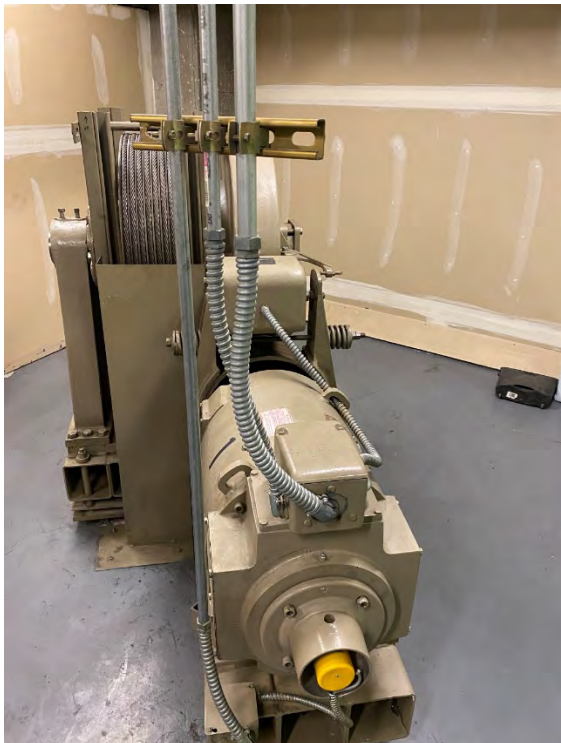
Montgomery geared traction elevator well maintained

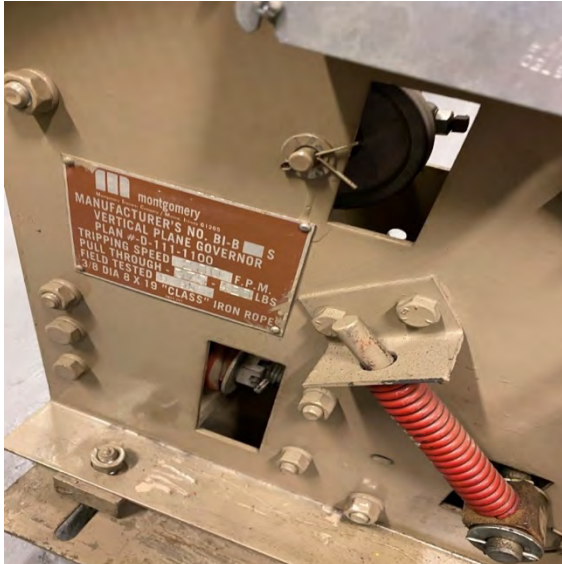
Governors are well maintained

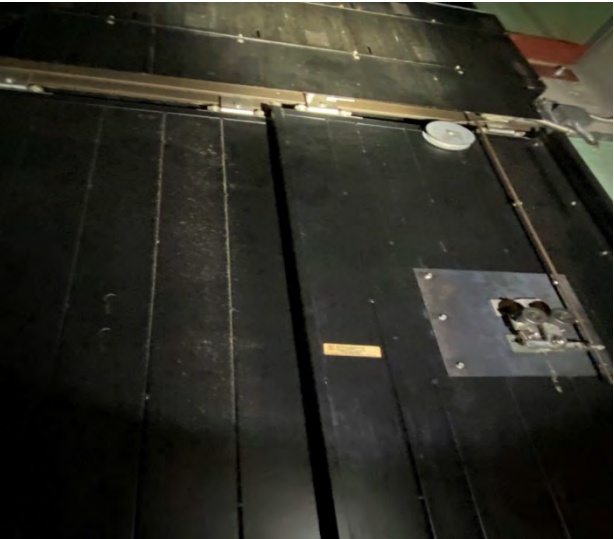
Equipment includes car and hoistway door equipment, elevator car and hoist ropes. Most of the equipment was found to be in good overall condition. The car and hoistway door equipment was clean at the time of our review. Newly replaced door gibs were observed on several hoistway doors.

Typical hoistway door

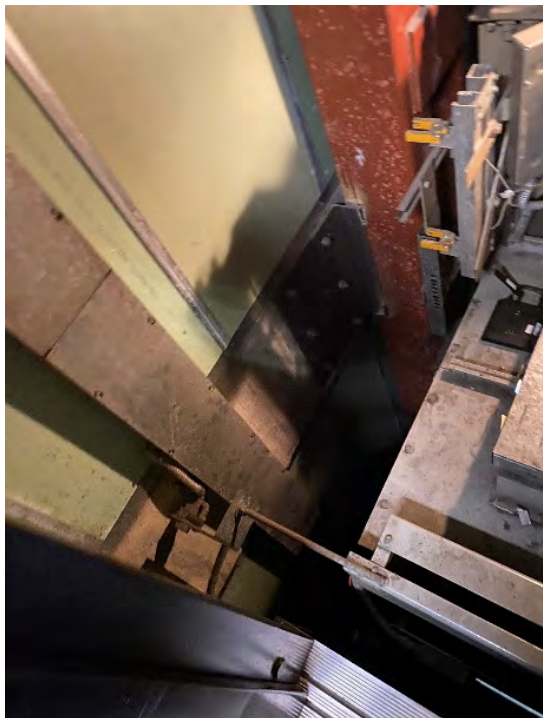
The existing opening between the car and the shaft wall is 26" x 28" wide

The top of the car and related equipment is in good condition and well maintained. It is recommended that barricades be installed to mitigate the fall hazard where opening exceed 12". Pads are used and regularly changed to collect debris from rail oilers on top of the car.

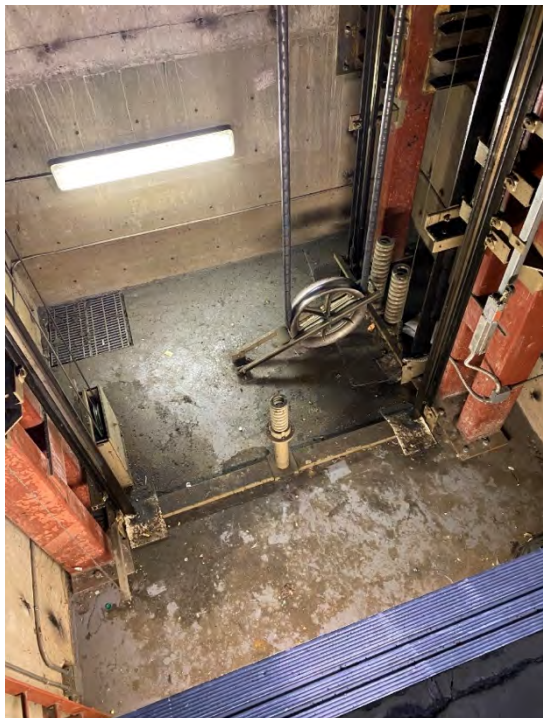
Pit equipment is good quality and in good condition to include the spring buffers, GFCI circuits and has adequate lighting.

Pit view

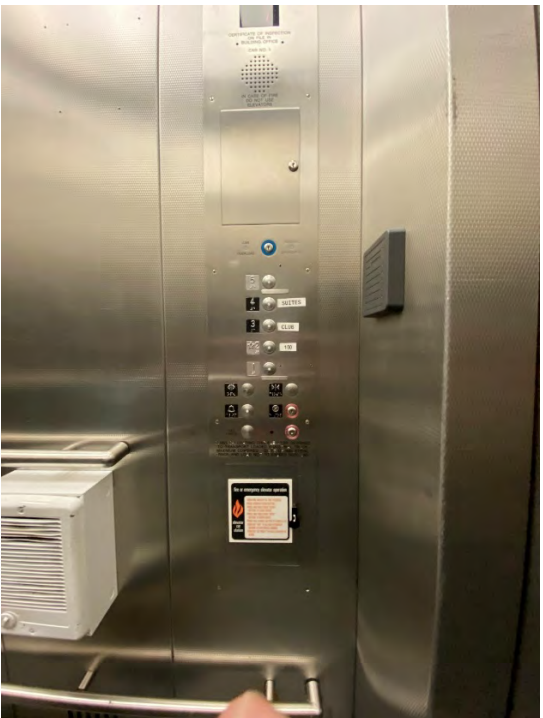
The elevator cab is in good condition; ADA requirements are met except for the phone cabinet. A heater is installed in the elevator to keep the space warm during inclement weather.

Elevator cab

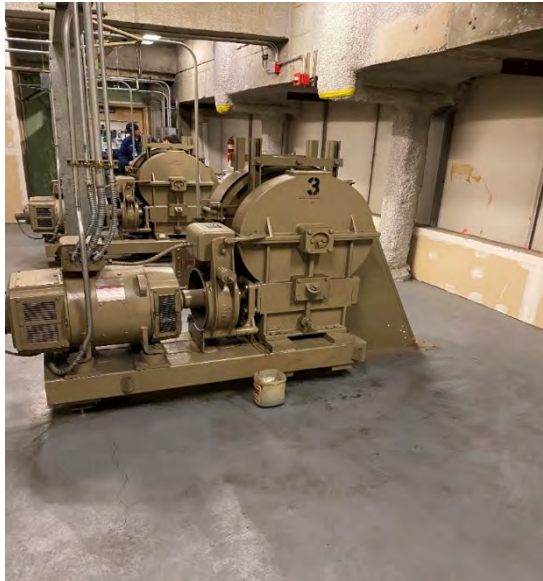
The machine room area was found to be generally clean and in proper order. The machines are in very good condition for their age. The required Category 5 (CAT5) safety tests appear to be current. Category 1 (CAT1) tests are overdue (Cat 1 – February 2023 and Cat 5 - April 2020).

Elevator machine room for the Elevators PE2 and PE3 group

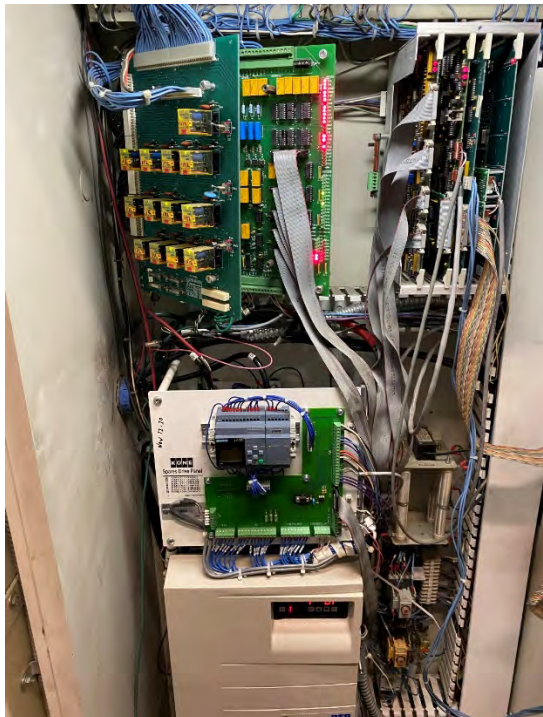
The elevator controller is in good condition

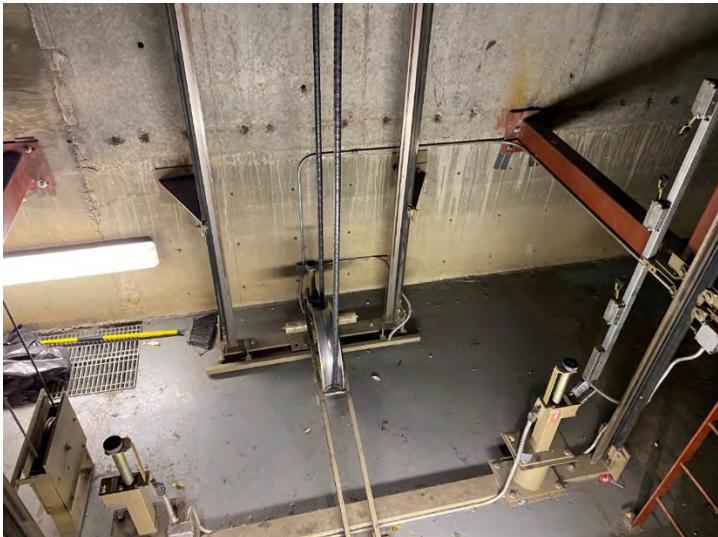
The pit equipment is good quality and in good condition includes the oil buffers. GFCI circuits are present and adequate lighting is provided. The compensation sheave is clean and well maintained. It is recommended to close off the unused hoistway.

Pit equipment is clean and well serviced

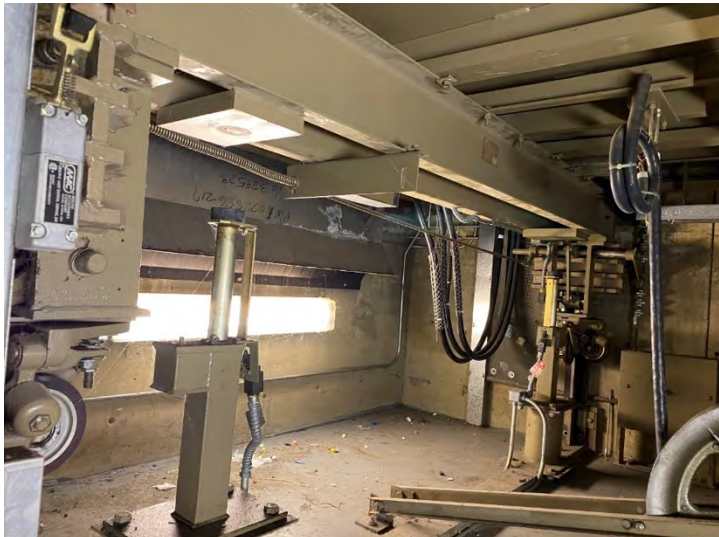
*Underside of car is clean, well serviced with buffer tags attached per code*

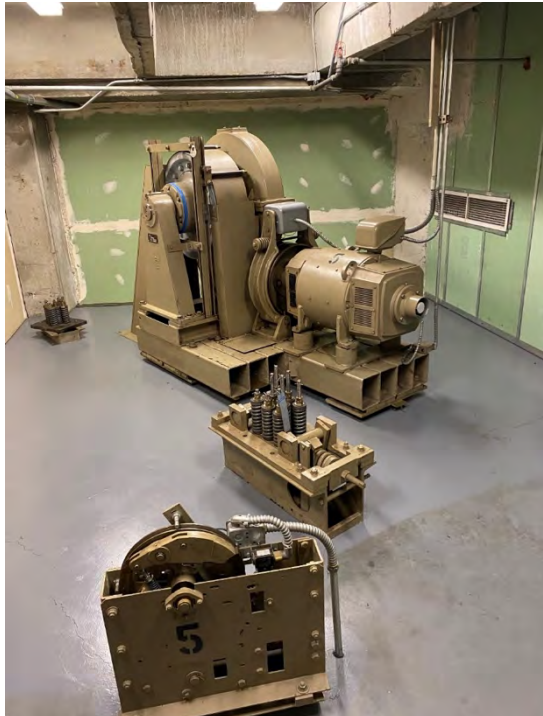
*The machine room is clean and well organized*

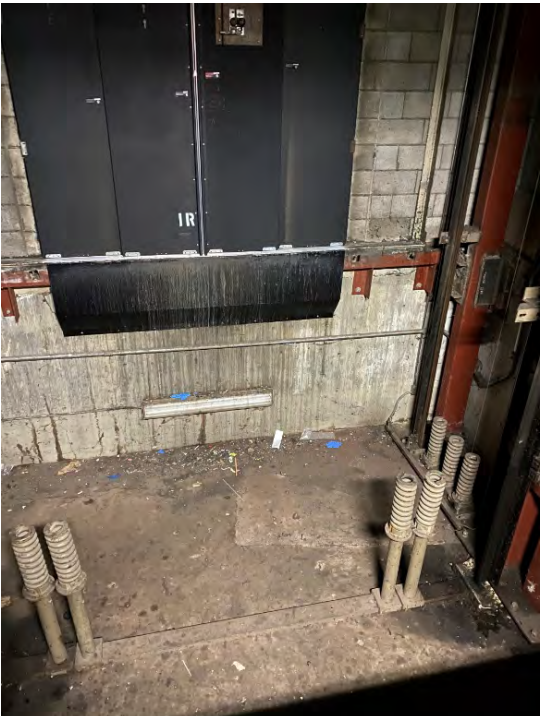
All pit equipment is in good condition; however, periodic cleaning of the pit is due.

*Pit of Elevator PE5 in need of cleaning*

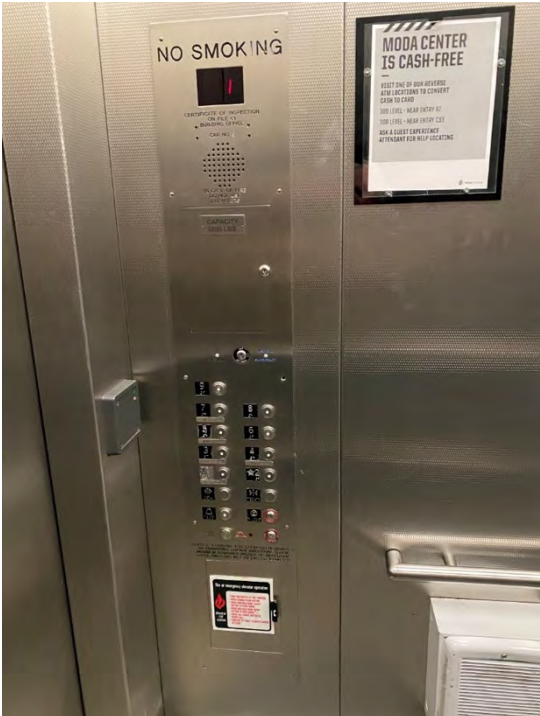
The elevator has a total of nine landings (there is a 9<sup>th</sup> floor car button, but floor 9 is inaccessible), serves Floors 1 - 9, and is equipped with a MAC door operator. The hoistway and car doors are two-speed side-opening doors measuring 60" wide x 84" high.

Elevator PE6 car operating panel showing Floor 9 button

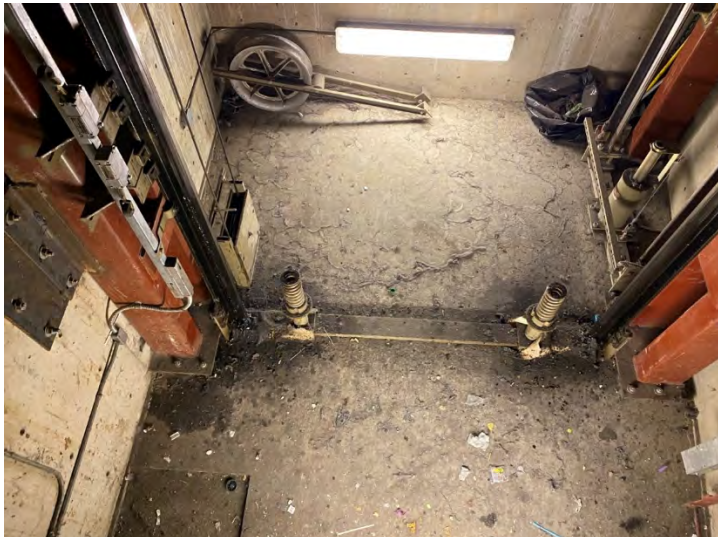
Pit cleaning needs to occur and excess materials removed.

Pit in need of cleaning and remove the excess material

- Remove the unnecessary equipment in the pit
- Pit cleaning needed
- Replace the disintegrating grommets in the counterweight frame.

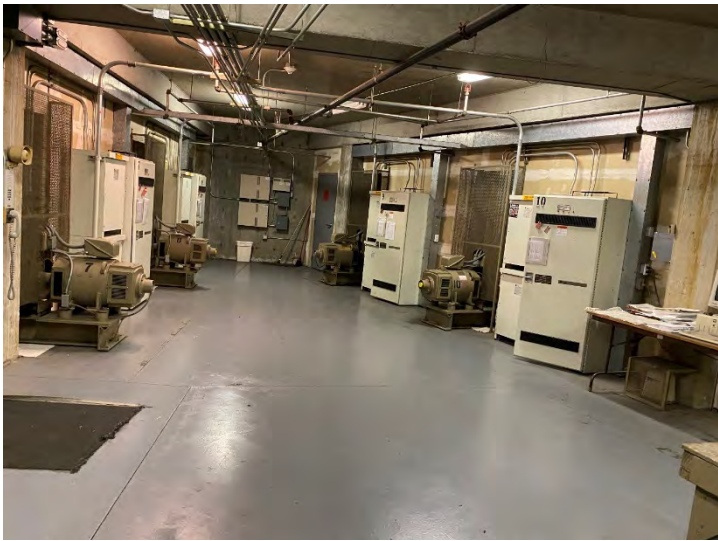
The seismic device serves all elevators. If a seismic event occurs all elevators will be inoperable until the cars are inspected and the switch re-set from the garage machine room.

The machine room is clean and well organized with a seismic switch located in the Garden Garage machine room

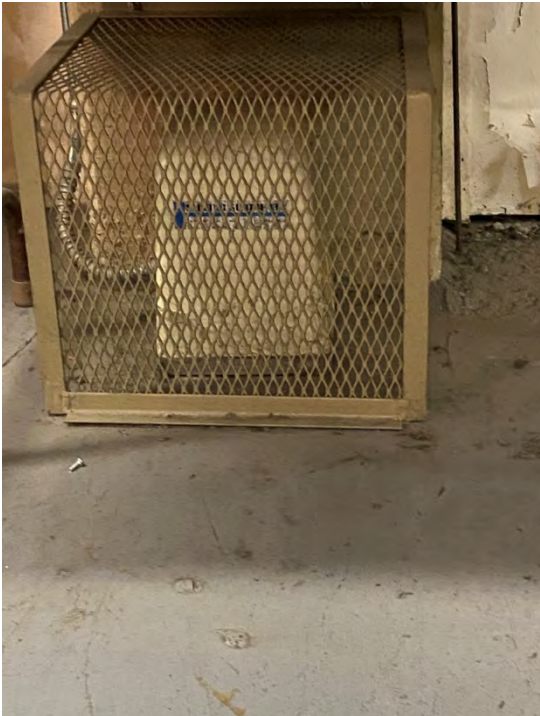
One seismic switch for all elevators in the Rose Quarter located in the Garden Garage machine room

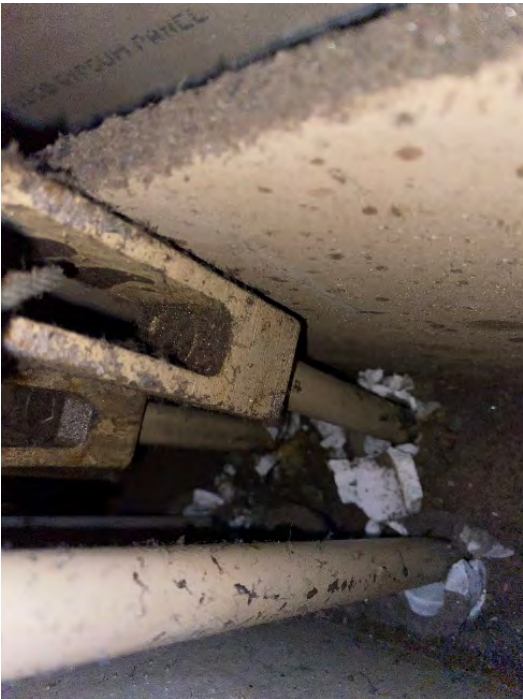
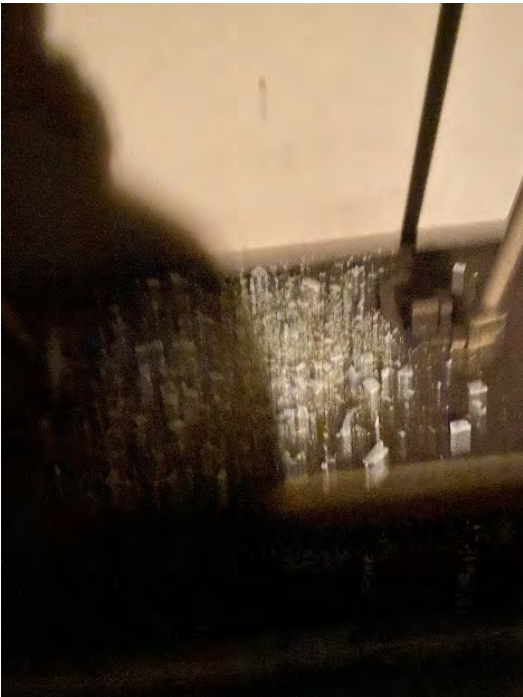
All elevators in this group and Elevator PE6 show deterioration of the grommet buffering the rods within the counterweight above the springs. These grommets require replacement.

Disintegrating grommets in the counterweight

Disintegrating grommet material on the top of the counterweight

- Replace the disintegrating grommets in the counterweight frame.
- Monitor car ropes on Elevators PE7, PE9, and PE 10.

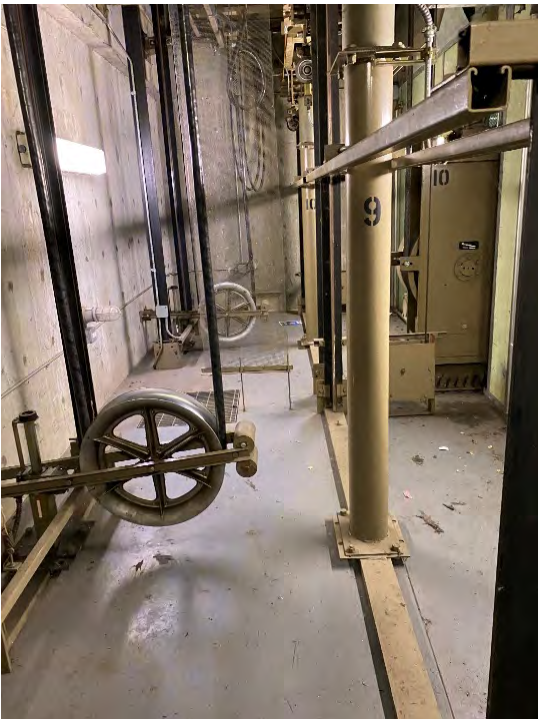
The pit is a walk-in pit. The equipment is of good quality and in good condition. Oil buffers are used in the pit with GFCI circuits available and adequate lighting provided. The compensation sheave is clean and well maintained. It is recommended to close off the unused hoistways.

Pit equipment is clean and well serviced

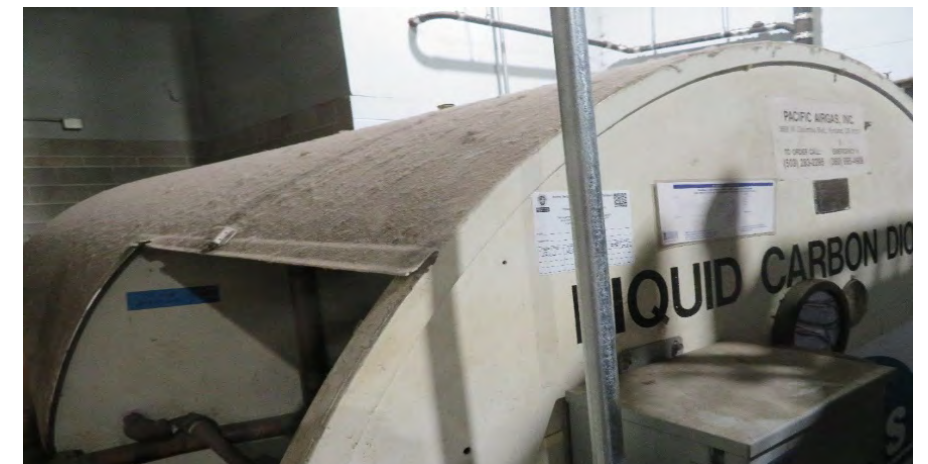
*Unused central CO2 carbonator*

Levy indicated they stopped using the central system due to leaks and mechanical failures. Current central systems are more efficient with stainless steel tanks (6 or 8) to serve an entire arena, rather than this mechanical system currently sitting idle here.

Normally, we recommend eliminating central beer pumping systems. Still, if Moda Center wants to retain theirs, then we definitely recommend replacing the broken CO<sub>2</sub> generator with modern CO<sub>2</sub> tanks that are then filled by a delivery truck at the loading dock as needed by usage. This would require repairing or replacing any leaks in the piping system.

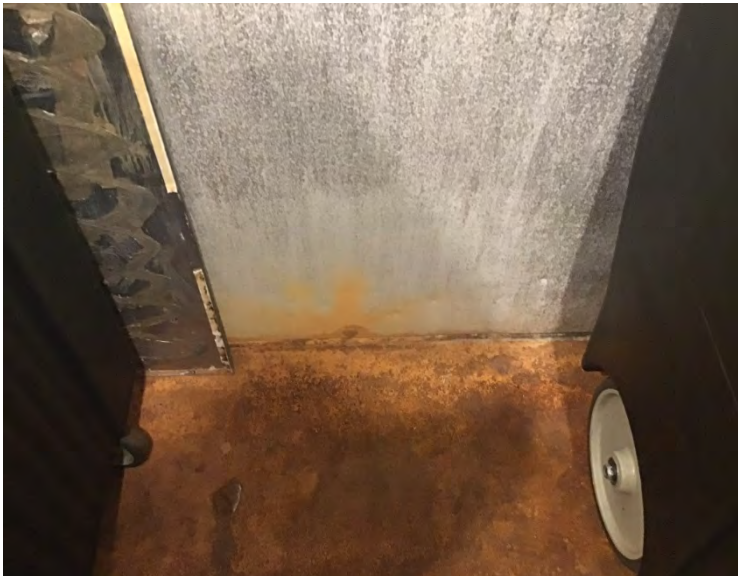
We have noted that some of the coolers, with interior metal floors, are in need of repair due to damage caused by the heavy kegs, denting the walls and opening seams, as well as rusted floors. Damaged walls and floors allow cooling to escape and

can also begin to rot the insulation due to water and beer leakage.

Rusting interior cooler floors

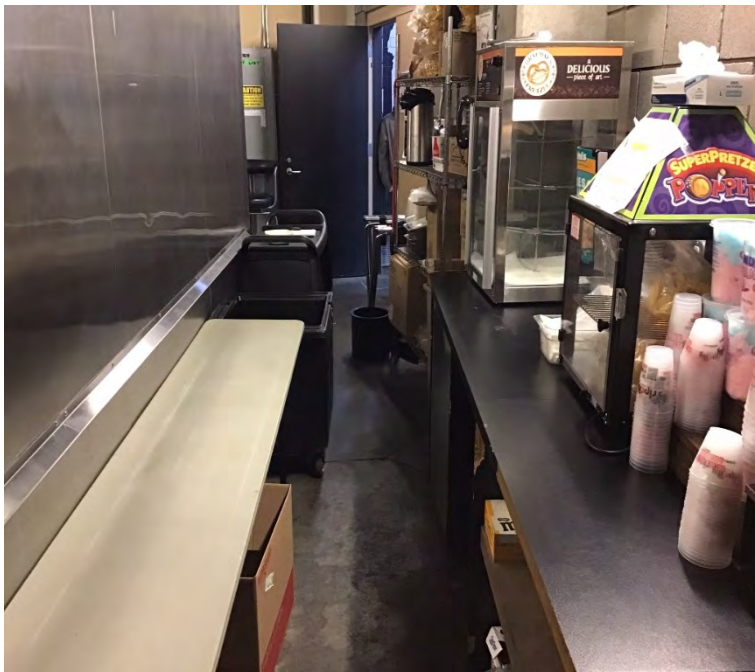
The event level south pantry is used for in-seat service, and while not necessarily visible to the public, it has old wood and laminate counters and cabinets that should be upgraded to stainless steel shelving.

Courtside service stand with laminate countertops

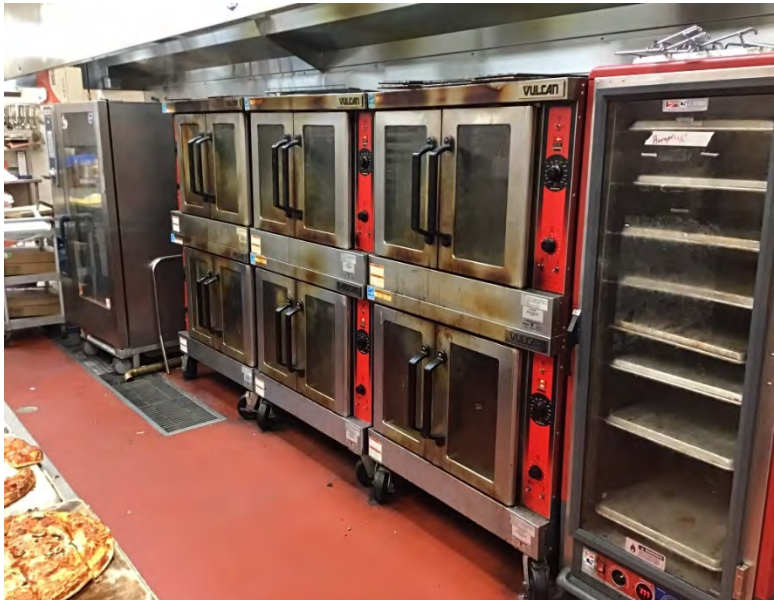
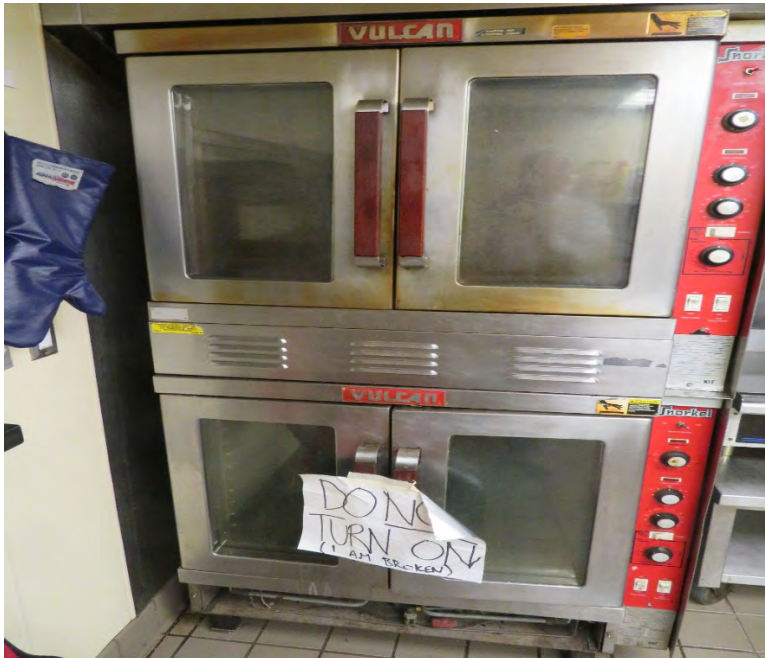
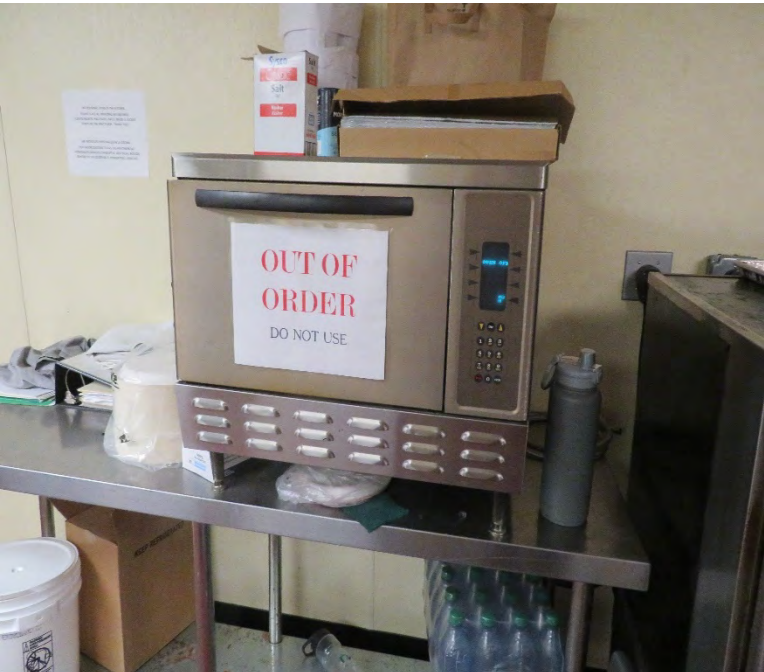
While most equipment was in good working condition, the combi oven, the convection ovens, and the pizza impinger ovens (conveyor style) showed the most wear and tear, and some were inoperable. Levy management did label the broken equipment, so employees did not try to use the ovens, but were waiting for repairs to be performed. We have listed those items for replacement in our equipment spreadsheet.

A bank of older convection ovens

Signage on non-working equipment

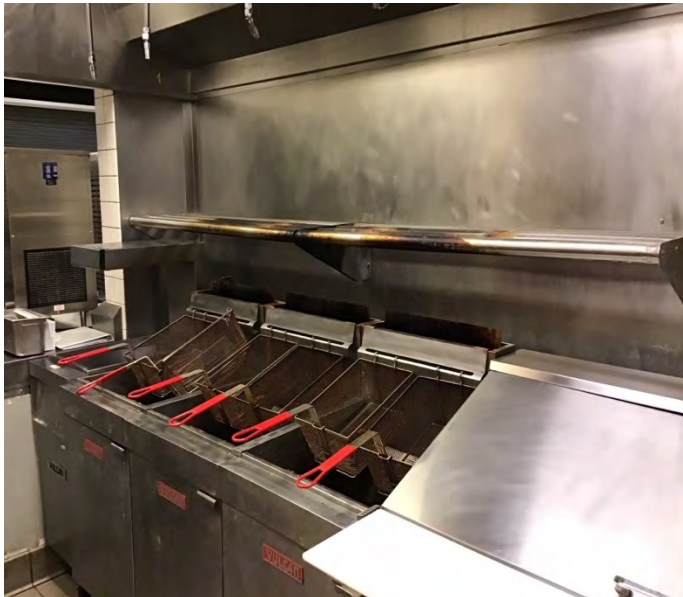
The fryers also receive heavy use, and some were showing signs of wear. Levy uses a third party, Filter Fry, to clean the fryers and recycle the oil. This company needs to be more diligent in keeping the fryers in optimal condition.

Fryers

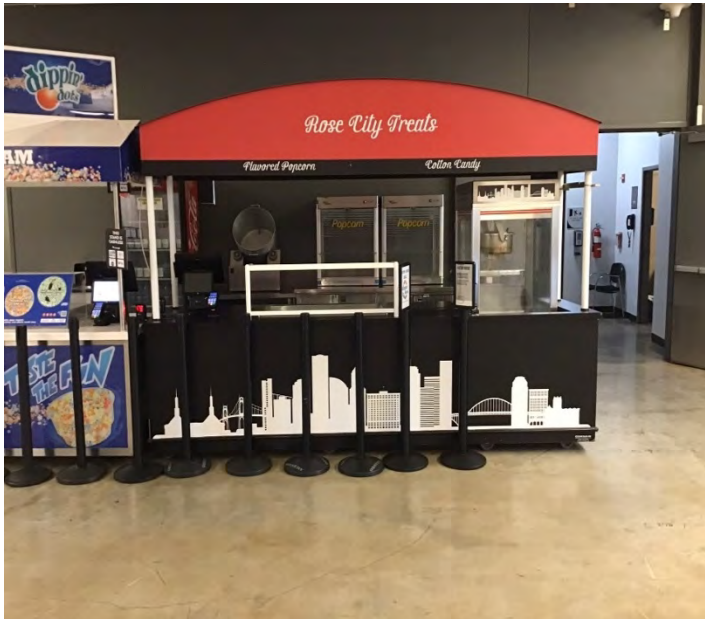
Several of the portable concession stands are owned and/or managed by a Levy subcontractor, Observ. We did find a few of their locations were not as clean as the Levy-managed stands, but the majority were attractive and in good condition. This sanitation situation is easily corrected with a nightly inspection report required by the subcontractor.

Observ subcontractor portable cart

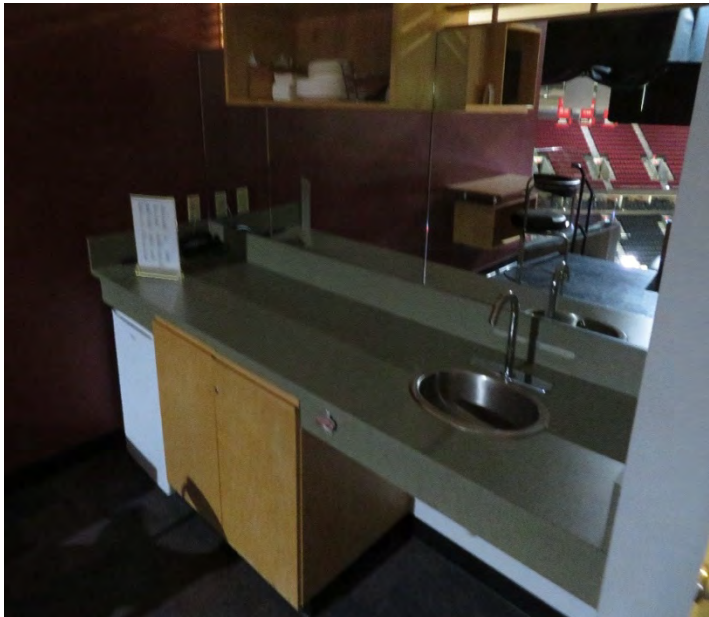
The suites in the Moda Center were equipped with only a sink and an undercounter refrigerator. All other foodservice equipment is portable smallwares for buffet service. Many venues now are building in more permanent food equipment, such as induction warmers, like the ones used in the arena’s clubs.

Suite sink and undercounter refrigerator

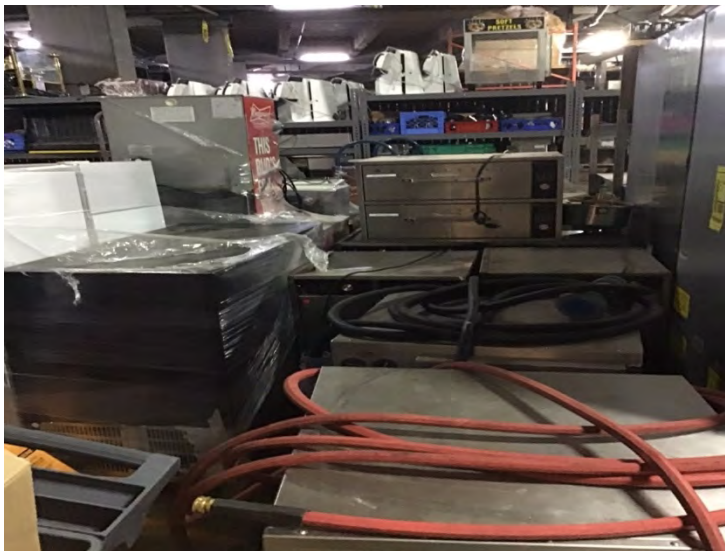
Unused equipment in storage area

However, if the equipment is unusable, even for spare parts, it should be sold, if possible, or removed from the building.
