# Facility Condition Assessment

Draft Report

May 14, 2024

# Facility Condition Assessment Moda Center & Garden Garage

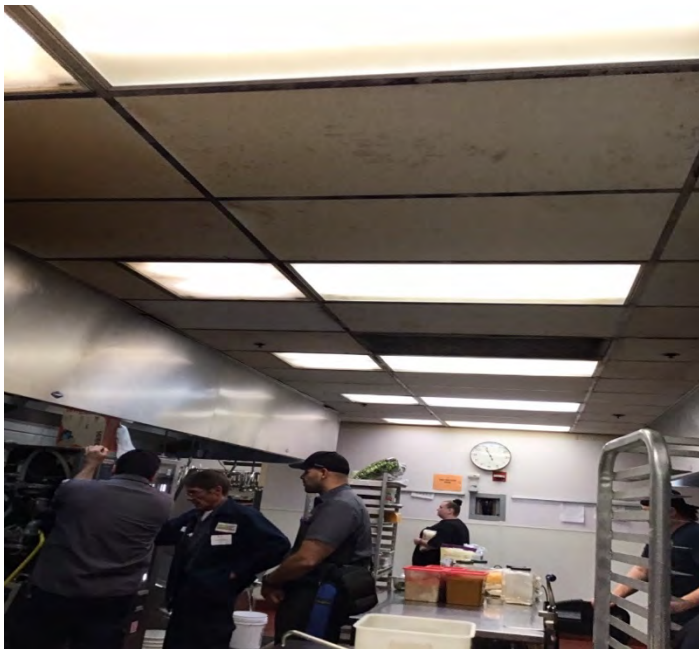
Ceiling tiles should be replaced when they become yellow and dirty. While most of the venue's food service areas are in good condition, this discoloration was noticeable in the court-side kitchen and other heavily used cooking areas.

Kitchen ceiling tiles discolored
